Service Bulletin

Subject: Poor Finish On Camshafts

Models: 2011-2015 Chevrolet Express, Silverado HD
2011-2015 GMC Savana, Sierra HD
engine RPO L96 LC8 6.0L

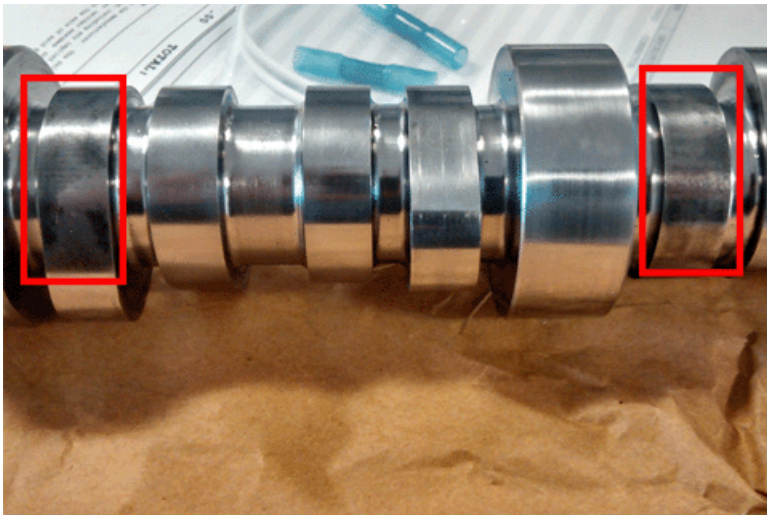
If the cam is discolored or has chatter marks, have parts department send the cam back as MR code7 new defective.

Try to get a different camshaft with a different date code and inspect it before installing.

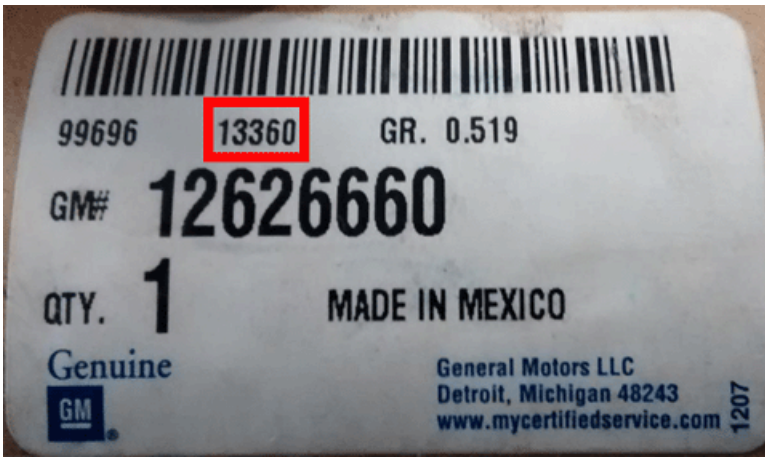
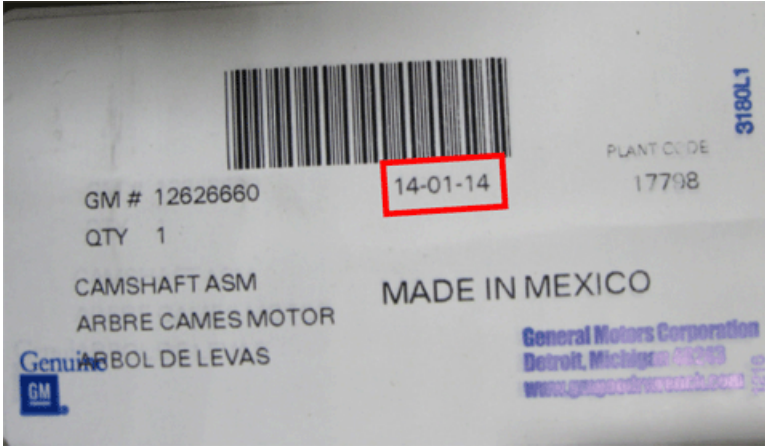
If the date code is 13360 or 14-01-14 these would be suspect camshaft.
