Service Bulletin

Subject: Rear A/C Blows Warm Air (Rear TXV)

Models: 2015 Cadillac Escalade
2015 Chevrolet Tahoe
2015 GMC Yukon

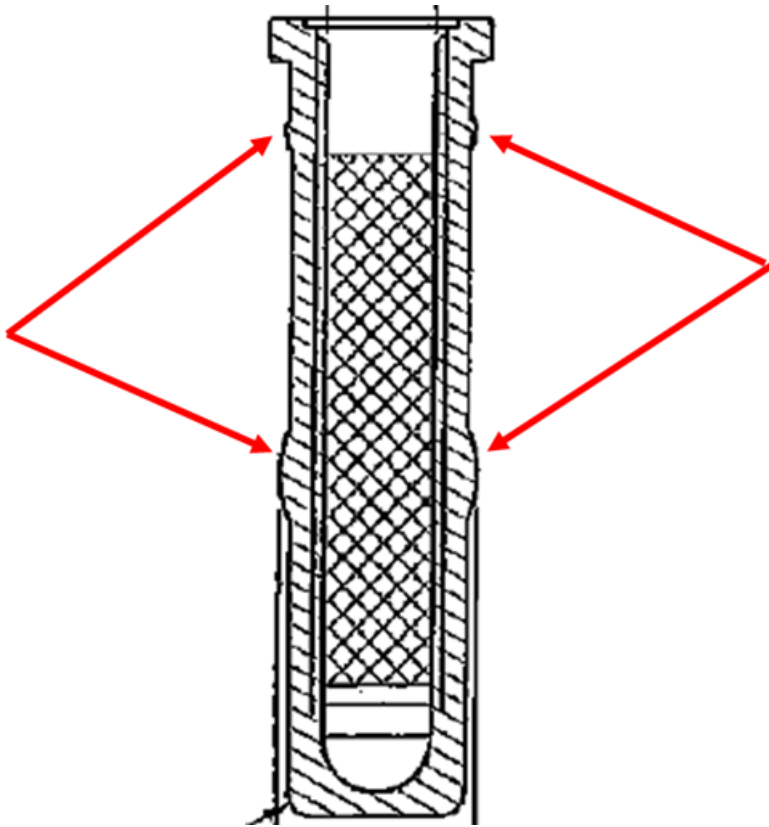
To correct this concern, replace the rear TXV and install a liquid line filter to stop any additional debris from plugging the new TXV. Remove both a/c lines from the rear TXV and install filter part number 25914263 into the liquid line. The filter will slide inside the liquid line, but in some cases, the ribs on the filter will need be cut off with a razor blade to fit properly. See picture below.

After reassembly, pull a vacuum on the system for 1 hr. then recharge with refrigerant.
