Service Bulletin

Subject: Normal Characteristic - Missing Underhood Trim At Front Left Fender Area

Models: 2015 Chevrolet Colorado
2015 GMC Canyon

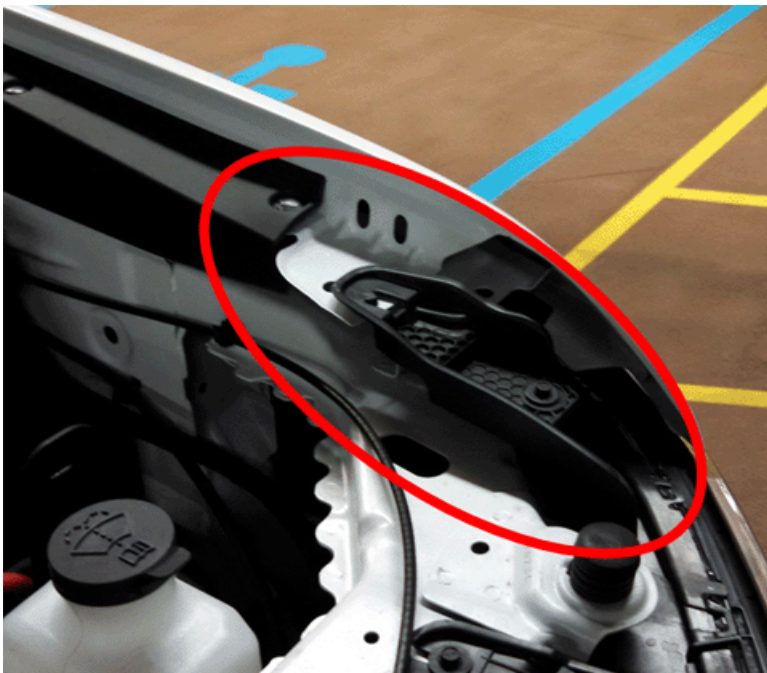
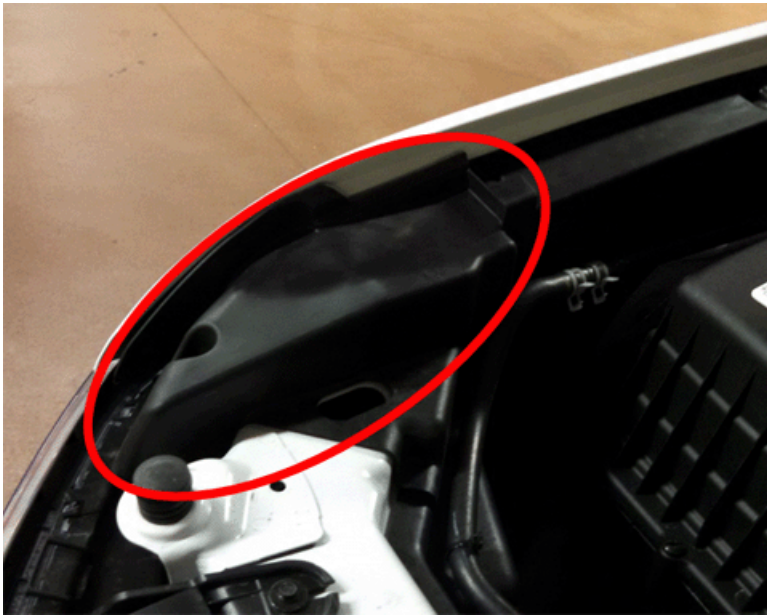
A dealer or customer may report that a trim piece is missing from the left front of the engine compartment where the fender and radiator support meet.

The upper intake air baffle is present on the right side to protect the engine air filter inlet. Since no engine air inlet exists on left side, no baffle was used there. Make no repair attempts or modifications to the vehicle, this is built to design intent.

Please communicate to the customer this condition is a normal build characteristic of their vehicle. It will not impact the designed performance or reliability of the vehicle. Please share this information with the customer, including a copy of this message.
