# Service Bulletin

**Subject:** Normal Characteristic - Appearance Of Uneven Bed Or Accessory Rails After Installation Of Accessory Tonneau Cover

**Models:** 2015 Chevrolet Colorado  
2015 GMC Canyon

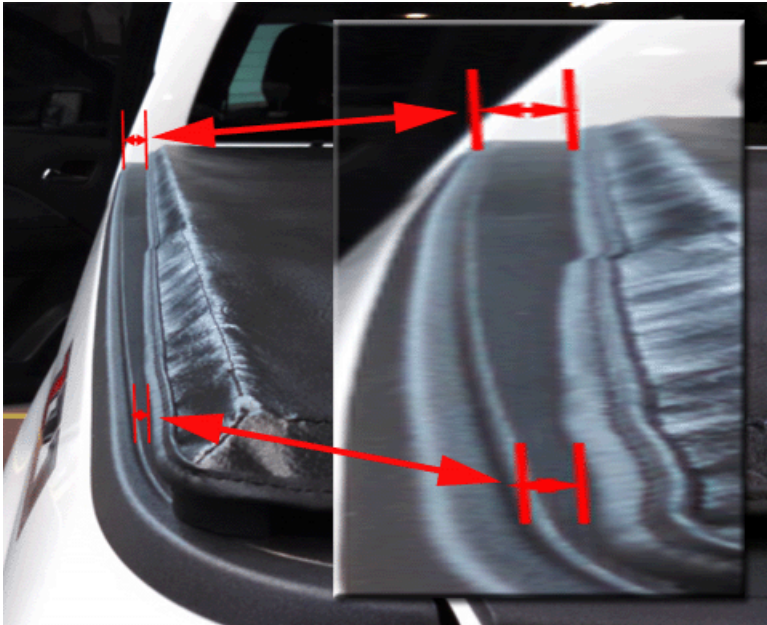
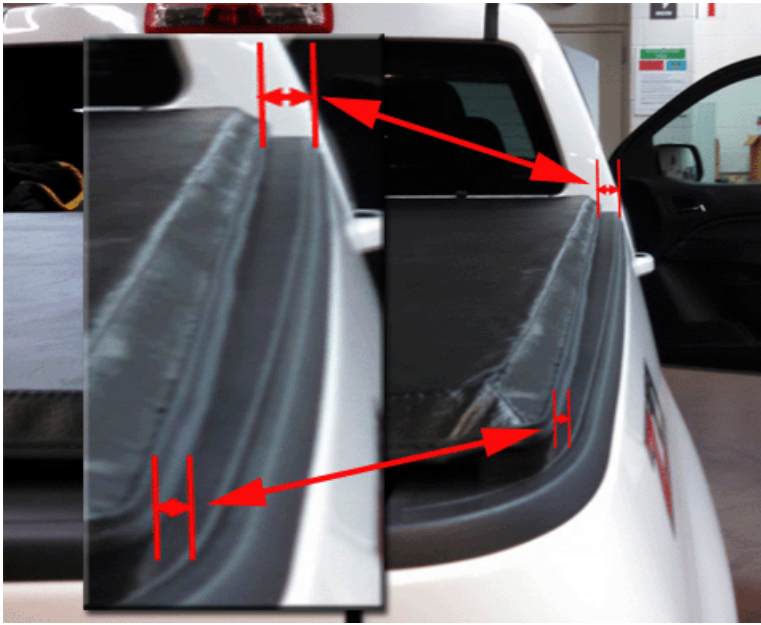
A customer or technician installing accessories on the bed rail caps may notice the rails are not as wide at the rear of the pickup bed as they are at the front of the bed. This is typically noticed after the installation of GM Accessory Soft Folding or Soft Roll-Up Tonneau Cover rails.

Some may think the accessory install was incorrect or that parts of the accessory kit are damaged

**Important:** Do not attempt to repair or replace parts for this condition.

The changing width of the bed rail cap is by design and part of the sleek appearance of the truck; no repairs are necessary to correct it.

Because the bed rail caps narrow as they go toward the rear of the vehicle, and the tonneau cover rails maintain a rectangle shape, the narrowing of the bed rail caps is highlighted and more noticeable.
