# Service Bulletin

**Subject:** Paint Peeling Above Anti-Chip Area

**Models:** 2014 Chevrolet Silverado 1500  
2015 Chevrolet Silverado 2500/3500  
2014 GMC Sierra 1500  
2015 GMC Sierra 2500/3500  
Built at Ft. Wayne Assembly (11th VIN Position = "Z")  
Built Prior to 5/15/2014

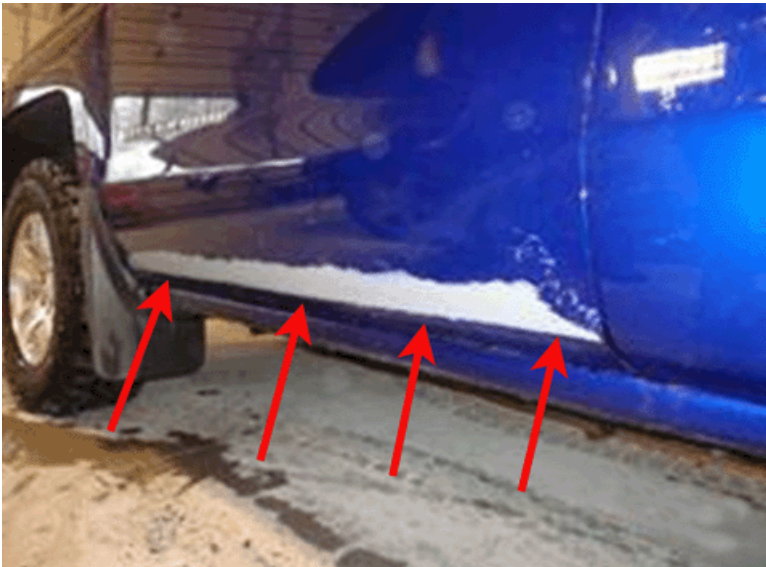
Some owners may comment of the paint peeling above the anti-chip area, as shown below:

**Note:** Process revisions were made at the vehicle assembly plant to resolve this issue effective 5/15/2014.

Refinish the affected areas using the appropriate material supplied by the refinish material supplier being used by the repair facility for finish repairs.
