Service Bulletin

Bulletin No.: PI1347

Subject: Lane Departure Warning Intermittently Defaults Back to Audible Sound Only, DTCs B172E, B172F Set

Models: 2014 Cadillac ELR

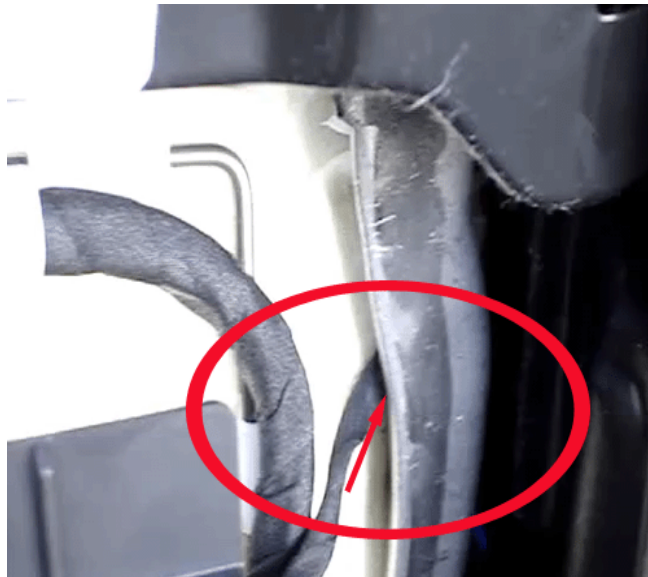
3999915

Note: The haptic motor is on the outboard side of the driver seat as shown above.

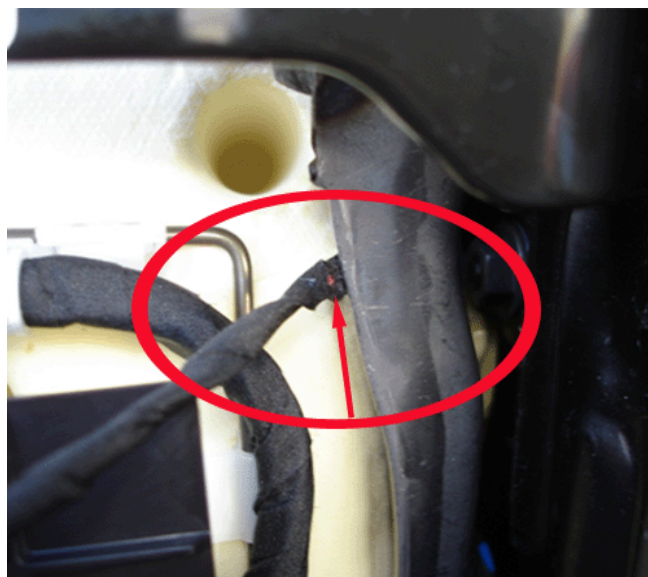
3999932

This condition may be due to pressure while sitting in the seat, and the haptic motor wire harness pigtail getting chafed when it comes in contact with the sharp edge of the cushion linkage.
