Bulletin No.: PIC6045

Service Bulletin

Subject: Front Seat-Mounted Speaker Buzz

Models: 2013 Cadillac XTS
Equipped with RPO UQS

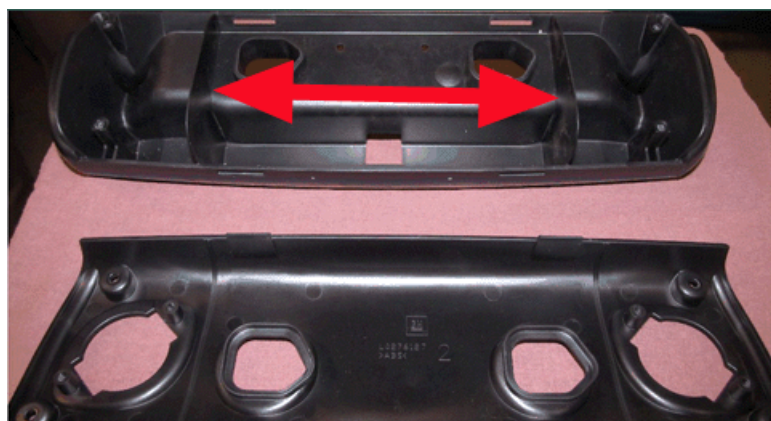
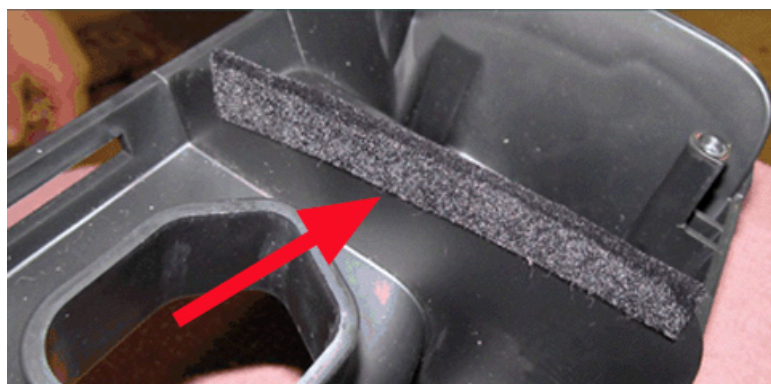
Some customers may comment that the speakers on top of the seats make a buzz noise. This concern is most likely to be evident on AM or Talk radio.

Verify Service Update 13004 has been performed first, if applicable. If this concern is still present, separate the speaker housing and apply felt tape to the raiser section as shown below.
