# Service Bulletin

**Subject:** Diagnostic Tip - Clarification Of Vehicles Equipped With Fog Light (RPO T3U)

**Models:** 2014 - 2015 Buick Lacrosse

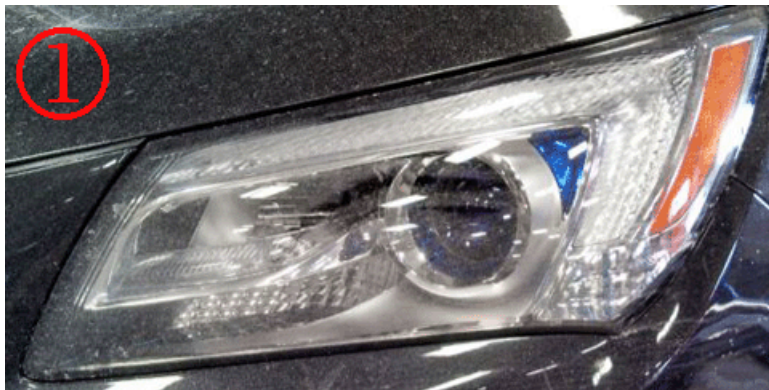
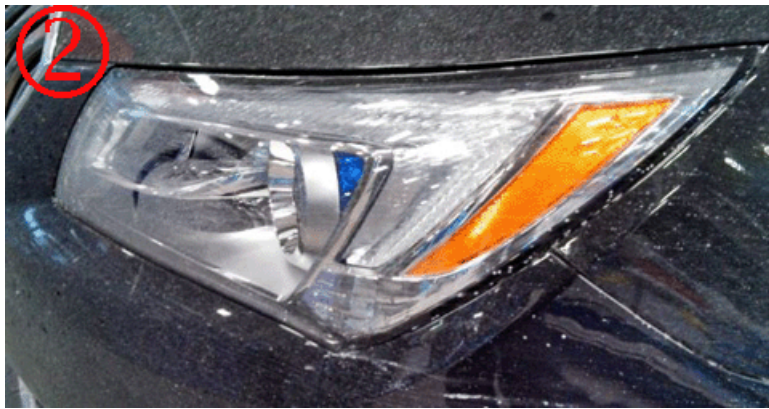
BASE equipped RPO T4A (HEADLAMPS-HALOGEN) without (RPO T3U) Images 1 and 2.

Vehicles equipped with RPO T4A (HEADLAMPS-HALOGEN) use the Lamps in the lower right / lower left portion of the Front Bumper Fascia as Daytime Running Lamps (DRLs).

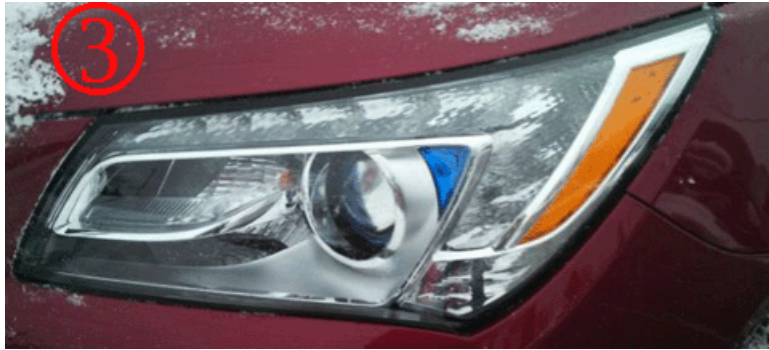
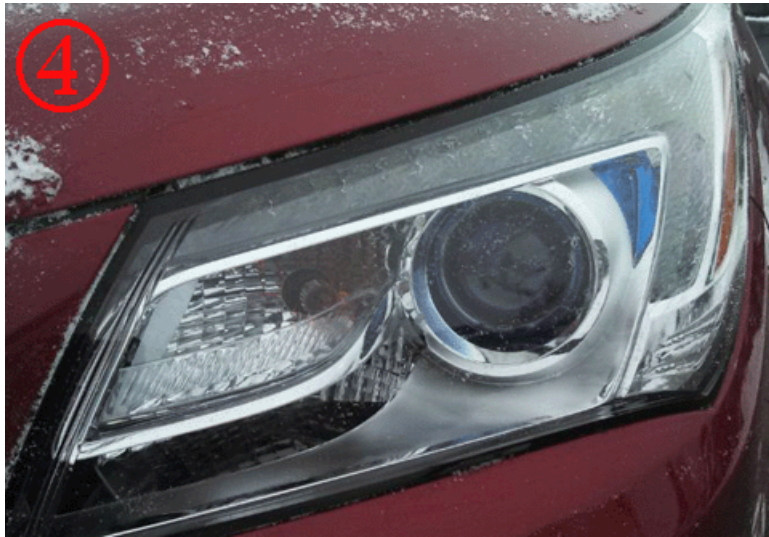
UPLEVEL equipped RPO T4F (HEADLAMPS-HIGH INTENSITY DISCHARGE) Images 3 and 4.

Both RPO T4A (HEADLAMPS-HALOGEN) and RPO T4F (HEADLAMPS-HIGH INTENSITY DISCHARGE) have hockey stick shaped lights as part of the headlight assembly.

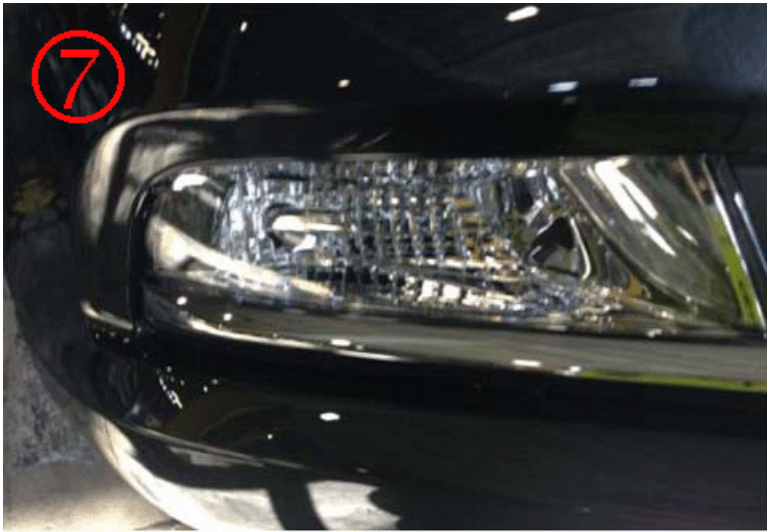
Daytime Running Light (base)

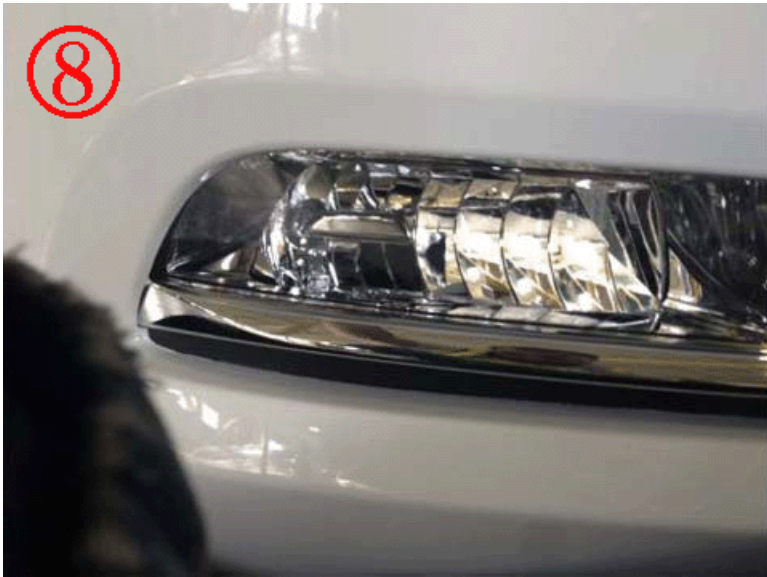
Fog Lamp (uplevel)

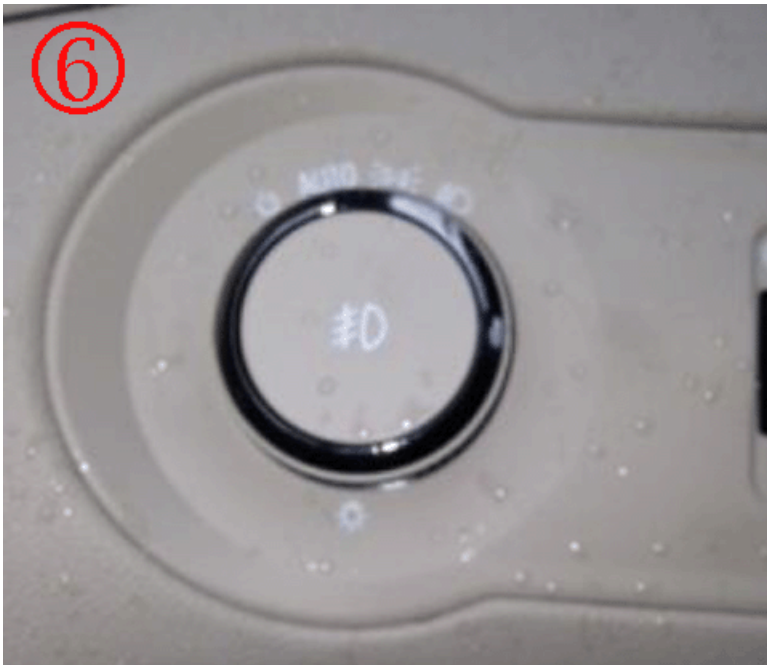
Fog Lamp Switch RPO T4F (HEADLAMPS-HIGH INTENSITY DISCHARGE and RPO T3U) is in the center of headlight switch.

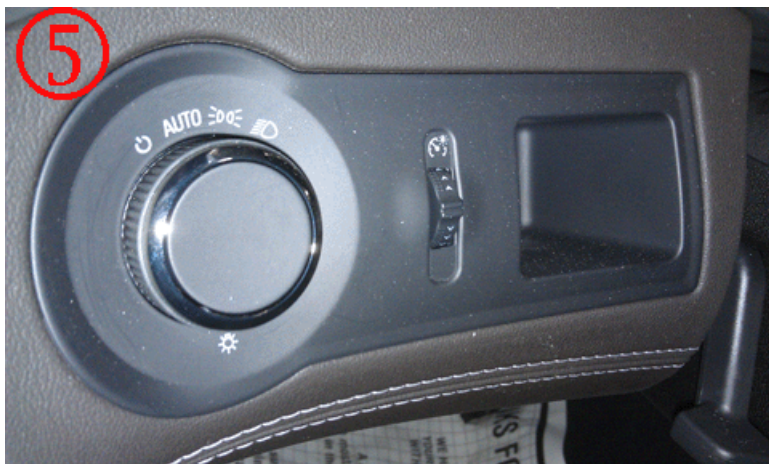
No Fog Lamp switch RPO T4A (HEADLAMPS-HALOGEN)

For vehicles not built with Fog Lamps (RPO T3U), please communicate to the customer this condition is a normal operating characteristic of their vehicle. Please share this information with the customer, including a copy of this message.
