Service Bulletin

Bulletin No.: PIT5287A

Subject: Diagnostic Tip - Front Shock Electrical Connector Terminal Removal

Models: 2015 Cadillac Escalade Models

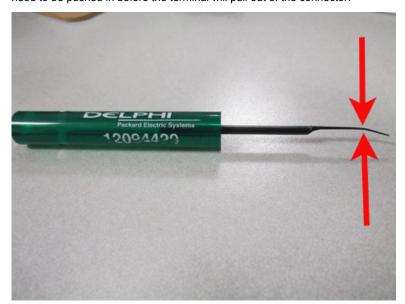
Certain repairs to the front suspension require the removal of the front shock electrical connector terminals. Because the terminals are positioned deep into the connector body, it may be difficult to remove the terminals.

The use of terminal release tool J-38125-12A (Delphi # 12094429) with a small modification has been found to make removal of the terminal(s) much easier.

Slightly bend the end of the J-38125-12A release tool, as shown in the photo below. While looking down into the connector body at the terminals, there is a purple TPA that will align itself in the release position when the release tool is inserted into the release hole. There is a metal locking tab on the terminal that will need to be pushed in before the terminal will pull out of the connector.
