# Service Bulletin

**Subject:** RKE / Passive Entry And Start / No Audio / SWC / Touch Screen Rear Wiper And Rear Power Windows Inoperative / Dead Battery / Service Tire Pressure System DTC B3101 B144C C0710 C0544 U0028 U0029 U0077 U0126 U0151 U0415 U1548 U1549 U154A

**Models:** 2015 Cadillac Escalade Models  
2014 Chevrolet Silverado 1500  
2015 Chevrolet Silverado, Suburban, Tahoe  
2014 GMC Sierra 1500  
2015 GMC Sierra, Yukon Models

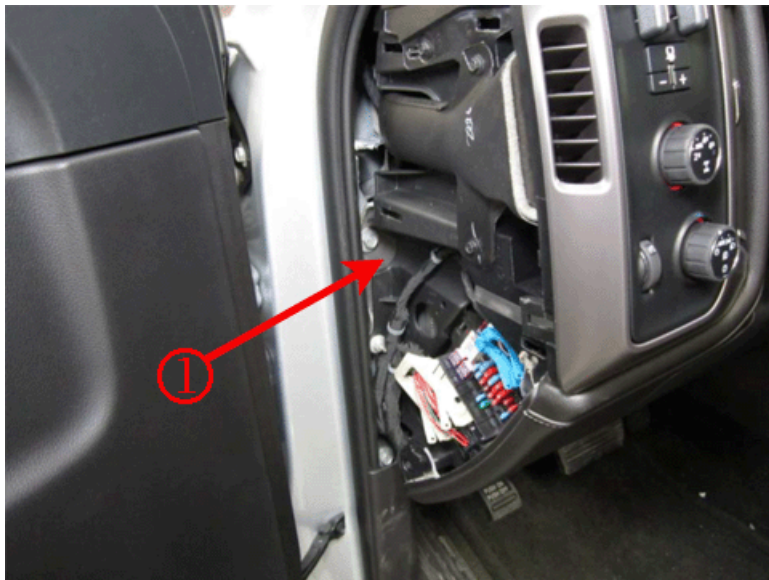
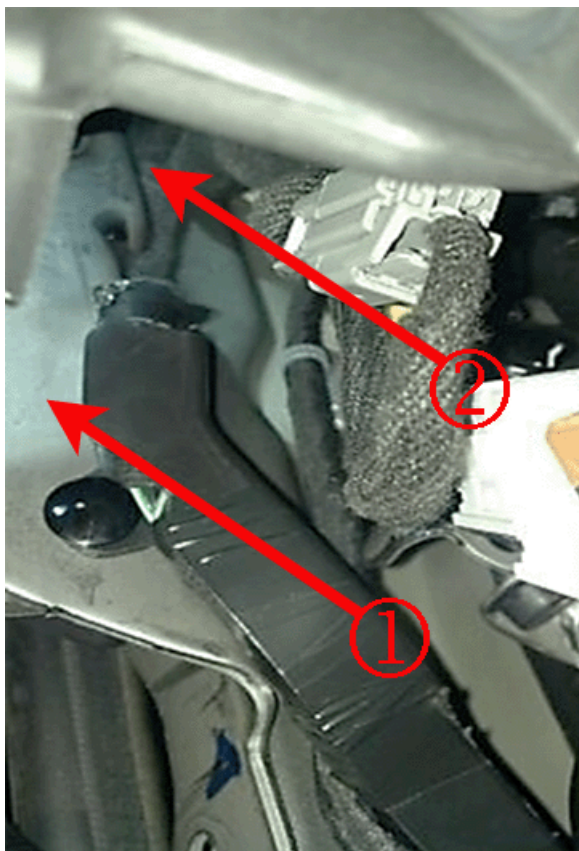
These concerns could be caused by the dash harness (2) being pinched between the left I/P dash mounting bracket (1) and the body, as shown below. In many cases, the complete harness is not pinched and may not be as apparent as shown in the below photo. When inspecting for a pinched harness, make sure the harness can be moved freely away from the bracket to body interface.

To repair this concern, loosen the left I/P dash mounting bracket bolts and pull the harness free. Open the harness and repair any damaged wires as necessary.
