**Document ID:** IK1600034  
**Revision:** 3  
**Created:** 5/18/2007  
**Last Modified:** 3/12/2014  
**Author:** Patrick Gotschall

**Title:** Rubbing Between Front and Rear Skirts on ProStar

**Applies To:** All ProStar

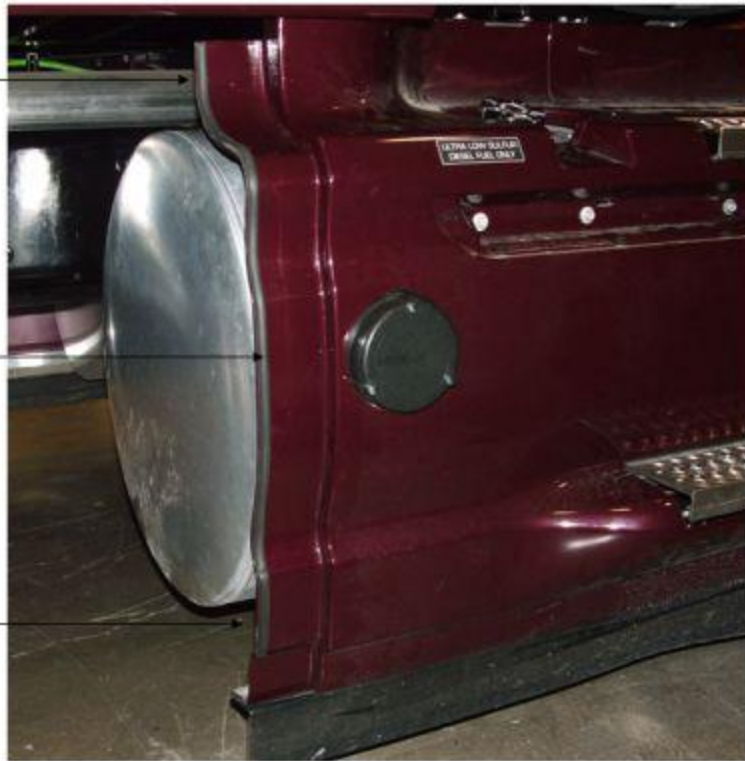
Add bulb  
seal along  
this edge

In case of rubbing between the front and rear skirts on ProStar, add a length of 3810890c1 bulb seal to the rear edge of the front skirt. You will need 6 ft. of bulb seal(3 ft. for each side). See picture below:
