**Major System:** CAB / SLEEPER / HOOD

**Title:** ProStar Sleeper Buzz, Squeak, Rattle

**Applies To:** ProStar

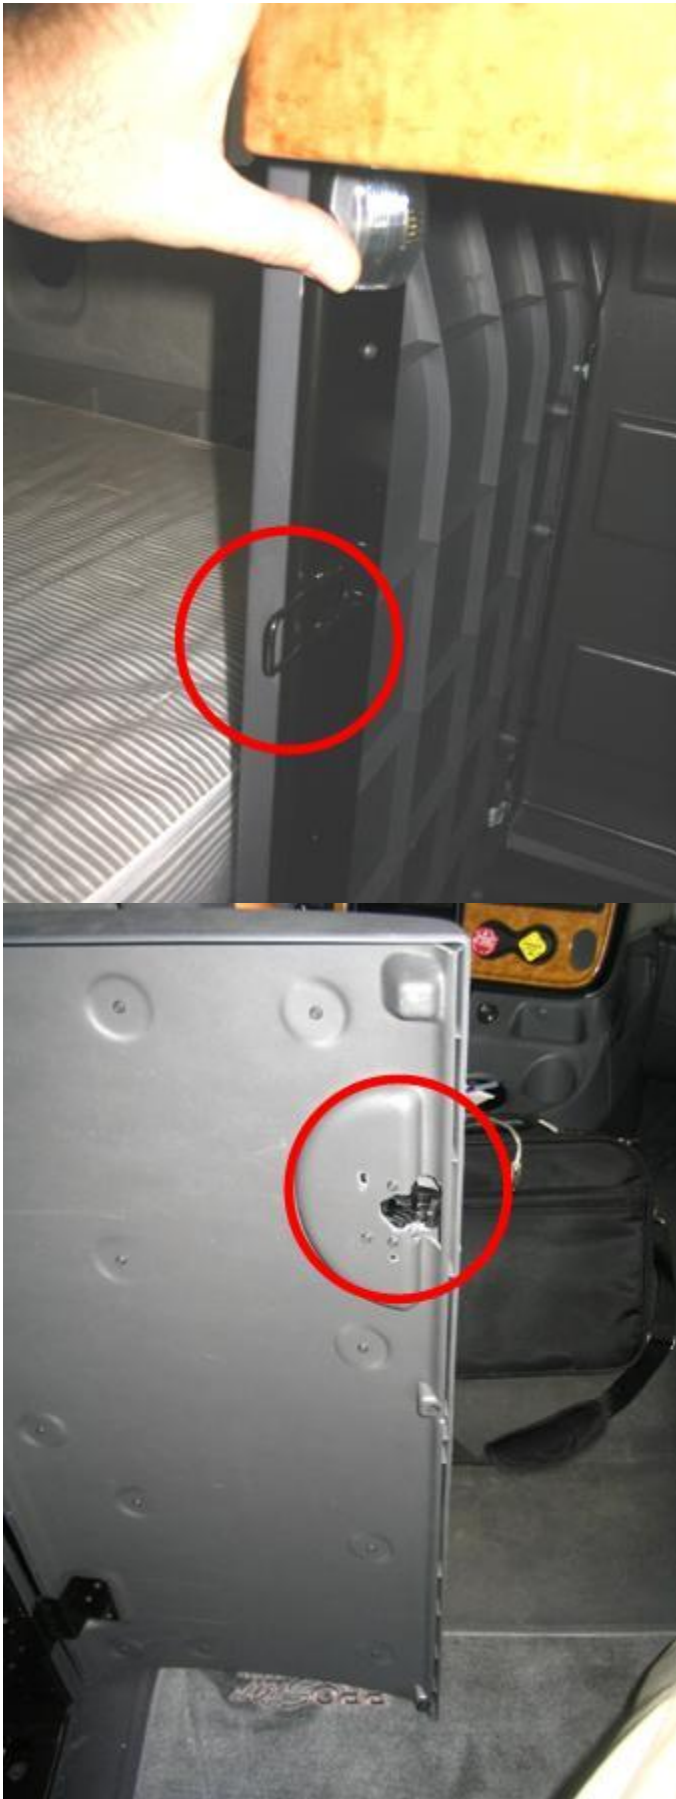
**Tower cabinet door squeaks.**

Spray latch and striker with Silicone dry film lubricant.
