| <b>Countries:</b> | AUSTRALIA, CANADA, UNITED STATES, MEXICO, PUERTO RICO | <b>Document ID:</b> | IK1201090 |

**Title: 2010 - 2013 11/13L Coolant in the Intake**
**Applies To: EPA 2010 MaxxForce 11/13 and N13 Engines**

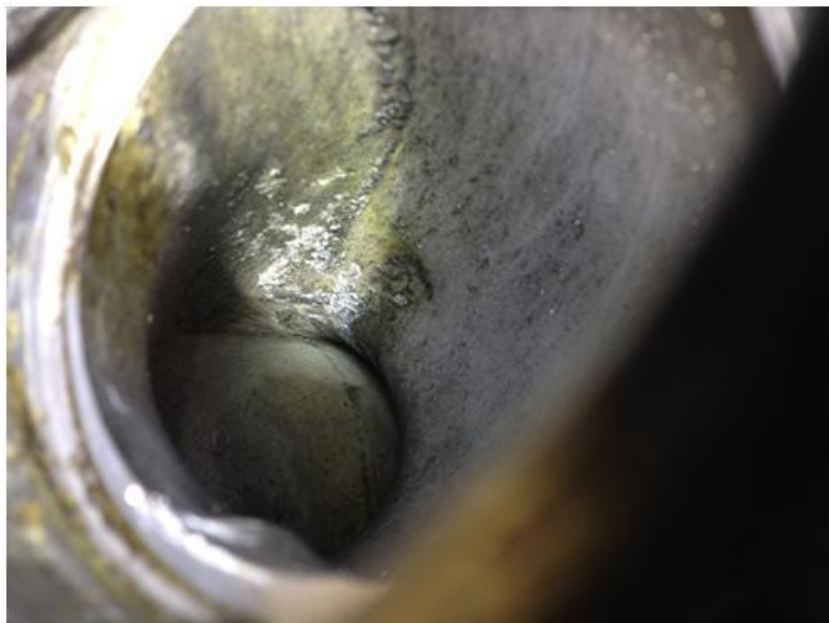
**Figure 1: Porous HP turbocharger air inlet duct leaking coolant into the intake.**

| <u>Step</u> | <u>Action</u> | <u>Decision</u> |
|---|---|---|
| <b><u>6</u></b> | <b><u>Visually inspect HP turbocharger air inlet duct for signs of coolant and/or coolant residue.</u></b><br>-<br>-<br>-<br>-<br>• <b><u>Inspect for coolant seeping through the casting (porosity).</u></b><br>• <b><u>Figure 1 shows a porous HP turbocharger air inlet duct leaking coolant into the intake.</u></b><br>-<br>-<br>-<br><b><u>Is the HP turbocharger air inlet duct leaking?</u></b> | <b><u>Yes: Replace HP turbocharger air inlet duct following the procedure in the Engine Service Manual. Repair complete.</u></b><br>- |
