V O L U N T A R Y C A M P A I G N B U L L E T I N

SUBJECT:	ECU Software Enhancement – DPR (Diesel Particulate Reduction)
DATE:	2/21/2014
BULLETIN NO.:	RCB-010-12
CAMPAIGN NO.:	A8440
AFFECTED MODELS:	Certain 2008-2010 model years NA6J, NB6J, NC6J, ND8J, NE8J, NJ8J, and NV8J model vehicles.

CONDITION:

When soot accumulates in the DPF (Diesel Particulate Filter) due to aging degradation of the fuel injector, the engine control program could potentially work improperly, which may cause the CEL (Check Engine Light) in the instrument cluster of the vehicle to turn “ON”. An enhanced ECU (Engine Control Unit) software program has been released to provide improved DPR (Diesel Particulate Reduction) operation.

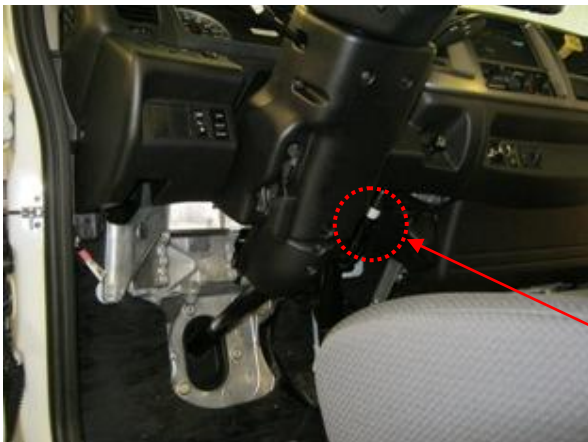
Diagnostic Link Connector

3. Connect the electronic interface cable connector to the vehicle's DLC connector. The vehicle's DLC connector is found under the dash on the right side of the steering column.

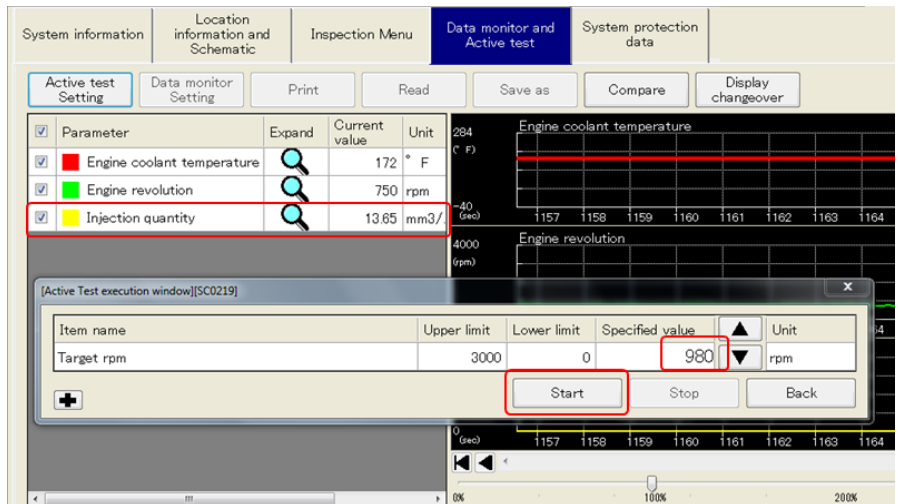
8. The Active Test Execution Window should now appear. Enter 980 RPM for the specified value of Target RPM then click the "Start" button. The engine speed should elevate to 980 RPM's. After approx. sixty (60) seconds, make a note of the Injection Quantity shown on the Data Monitor. Injection Quantity for this step is for Exhaust Brake OFF.
