| Tech Tip No: | TT-14-018 |

## TECH TIP

### 2012MY – 2015MY Chassis Wire Harness Connector Lever

2012 through 2015 model years (XFC710, XFC720, XFC740, XJC700, XJC710, XJC720, and XJC740 cab-over-engine (COE) trucks).

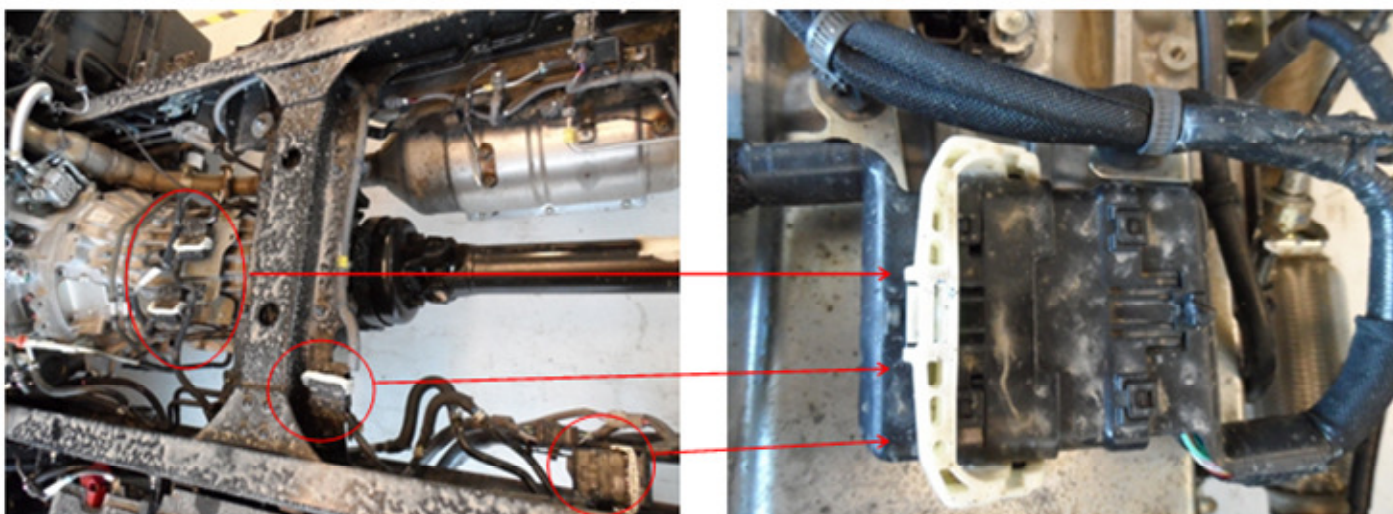
When disconnecting one of the inline chassis harness connectors on the vehicle, there is potential that the white connector lever may break due to degradation of the white plastic material. In the event that the connector lever does break, a replacement connector shell which includes the lever has been made available to service the broken lever. The new connector lever will be black in color and can be transferred to the existing connector shell.
