# SERVICE BULLETIN

SB1263

| <b>SUBJECT</b> | : <b>To change blower of driver's cab climate unit</b> |

Change of twin radial blower with HeaVac description DRB1100BL as used on demister units.

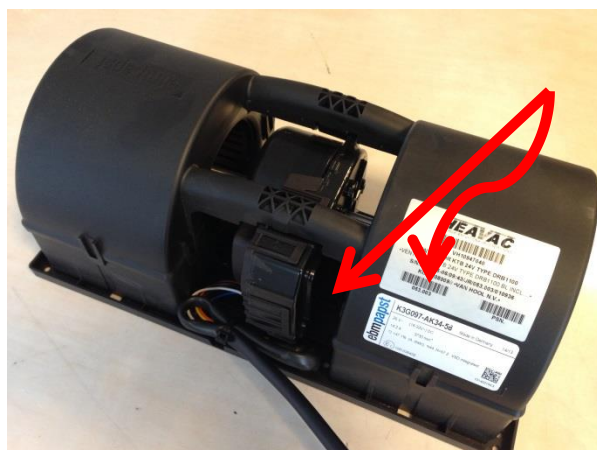
**053.003**

Improved blower 053.015 can be identified from information on product labels as well as cooling fins on the motor housing (see pictures below).

Changed and improved EC <sup>(1)</sup> - motor construction: housing and electronic controls have been changed for higher reliability.
