Technical Bulletin

44 14 01 January 17, 2014 2031249 Supersedes TB 44 12 02 dated November 1, 2012 to correct part number.

Tire Pressure Monitor Warning Indicator ON

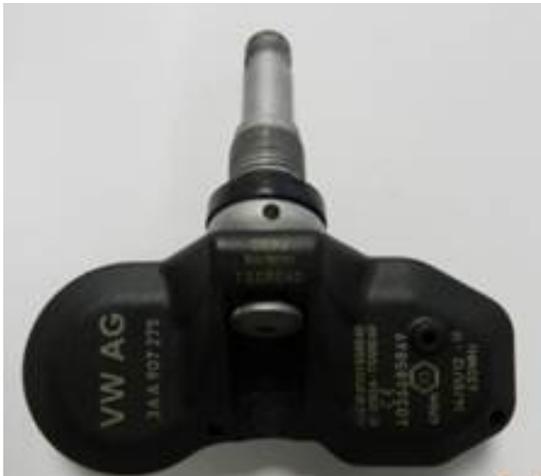
- Replace original BERU sensors part number 3AA 907 275.

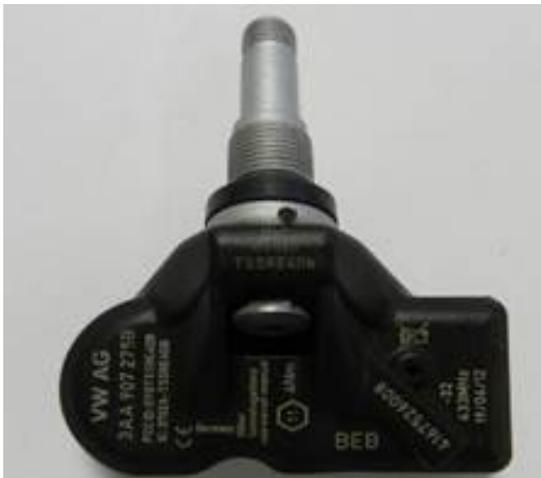
- Install new HUF sensors **3AA 907 275 B**.
