Technical Bulletin

55 14 02 January 30, 2014 2036334 Supersedes V551401 dated January 29, 2014 to adjust labor time.

Fuel Door Sticks or is Difficult to Open

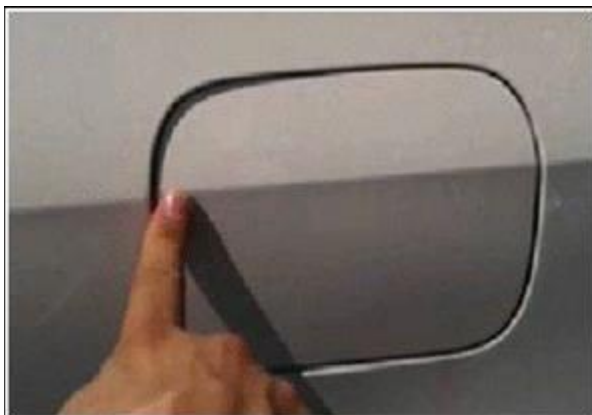
Figure 1

- Open the fuel door.

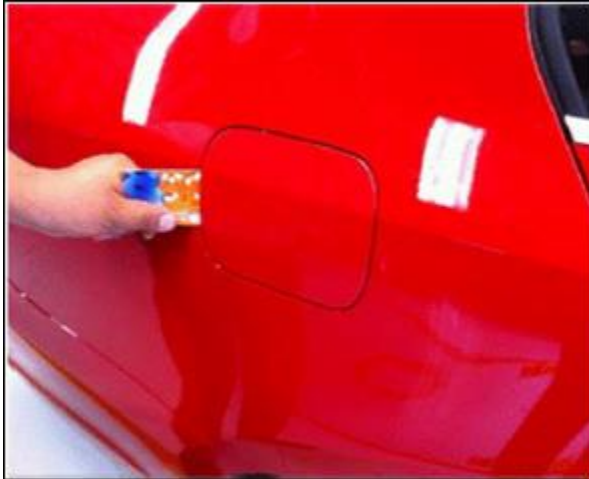
Figure 2

- If the fuel door will not open, insert a plastic card between the body and the door to release it.

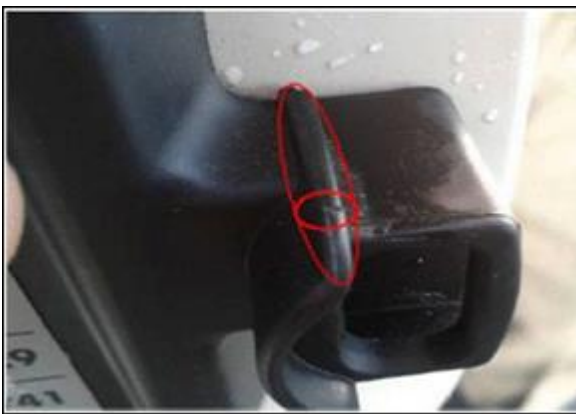
Figure 3

Fuel door binding or sticking due to excess material inside of the fuel door housing.

- Note the area with excess material (burrs) that need to be modified.
