# Technical Service Bulletin

#### 87D9 UPDATE - AC Pressure/Temperature Sensor (NVLW)

April 3, 2014

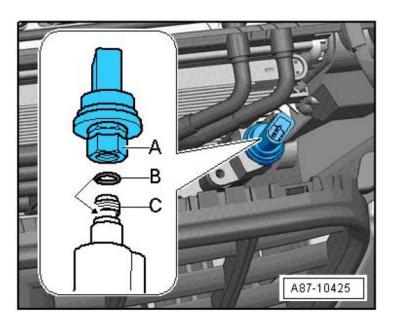
Remove the refrigerant pressure sensor
-G395- <A> by following the instruction in
ElsaPro >> Repair Manual >> Heating,
Ventilation and Air Conditioning >> 87 Air
Conditioning >> Removal and Installation >>
A/C Pressure/Temperature Sensor G395.

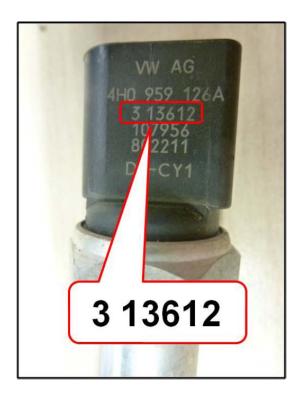
2. Check production date of sensor.

Example: 3 13612

3: Shift 1: Day 36: Week 12: Year (2012)

- Replace sensor if the date is between:
  - 1 13212 to 3 73912 or 1 54612 to 3 54612
- If the sensor date is not within these ranges reinstall sensor with new o-ring, PN 7H0820896.
