**Freightliner  
 Service Bulletin**

## General Information

## DEF Return-Line Fitting Heater Installation

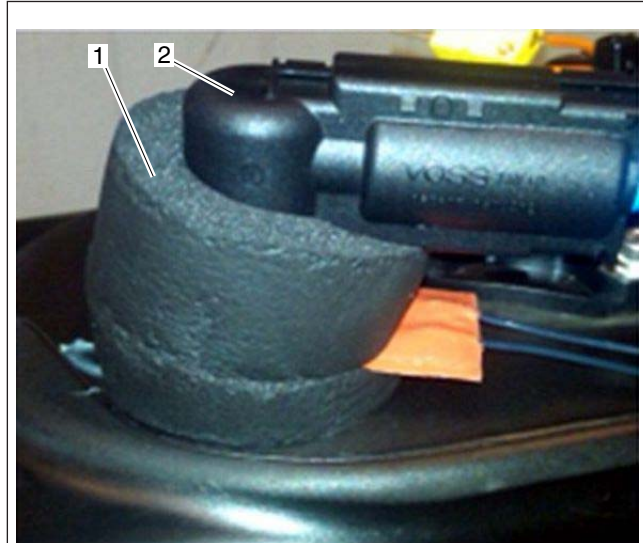
**Fig. 3, Installing the Upper Half of the Insulation**

- 1. Upper Insulation
- 2. DEF Return Line

6. Cut a section of reflective sleeve material 10 in. (250mm) long, and split it lengthwise.
7. Install the lower piece of the insulation with the short edge of the angle-cut side facing the DEF line. See [Fig. 2](#).
8. Peel the tape off of the the return-line fitting heater then put it over the fitting and press it to stick on the DEF fitting. See [Fig. 2](#).
9. Install the upper half of the insulation. See [Fig. 3](#).
10. Connect the DEF return line.
