Technical Bulletin

46 14 03 April 2, 2014 **2015173** Supersedes T. B. V461402 dated February 7, 2014 to modify brake disc statement.

Brake Disc Pulsation or Vibration (U.S. Only)

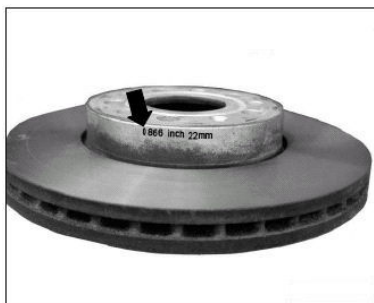
Each brake disc has the minimum allowed thickness cast, stamped or laser-etched into the disc hub.

- Measure the brake disc thickness in 4 locations using either the Pro Cut International™ disc thickness measuring tool Part No. 50-902 or the Hunter Engineering Company disc thickness measuring tool Part No. 25-99-2. Measurements **MUST** be taken at the same distance from the brake disc outer circumference to ensure consistency.

The brake disc thickness measurement must exceed the minimum specification after the machining process is completed in order to be re-used. If the brake disc thickness measurement does not meet this requirement, then replace the brake disc.

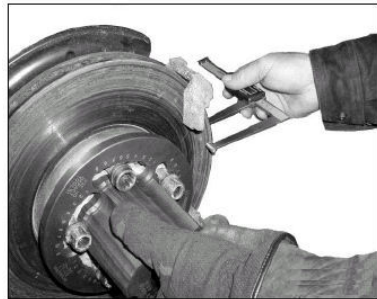
- Follow the brake lathe manufacturer's instructions for set-up and machining.
- Wash the brake disc with a soap and water solution upon completion of resurfacing to remove all machining particles.

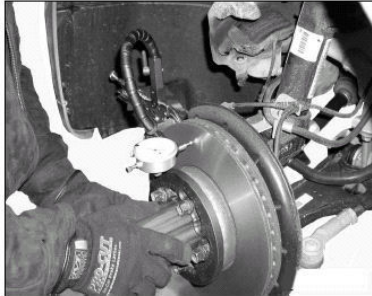
- Measure brake disc lateral run out using Pro Cut Disc Lateral run out measuring kit Part No. 50-700FC or the Hunter Disc Lateral run out measuring kit Part No. 25-128-2 with a dial indicator.
- Run out must not exceed 0.1mm.
- If brake disc exceed the 0.1mm specification replace the applicable brake discs.
