Technical Service Bulletin

44 Steering wheel shimmy, vibration, and/or oscillation

44 14 56 2022563/11 December 8, 2014. Supersedes Technical Service Bulletin Group 44 number 14-50 dated May 14, 2014 for reasons listed below.

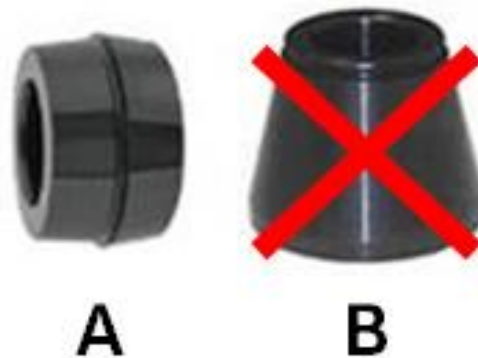
Figure 3. Example of a collet (A) vs. a centering cone (B).

- Ensure that the contact surfaces of the tire balancer flange and wheel are clean. It is mandatory that the appropriate centering collet (Figure 3, A)--not a cone (Figure 3, B)--and a five-finger style clamping plate (Figure 4, A) are used to mount the wheel on the balancer.

Use of these tools ensures proper centering and mounting of the wheel on the balancer. Audi-recommended collets can be ordered through *Equipment Solutions* (part number **HUN2018451**). An incorrect style of clamp could damage the wheel (Figure 4, C).
