# Service Bulletin

**Subject:** Clicking Noise From Front Wheels

**Models:** 2009 - 2015 Cadillac CTS-V Models

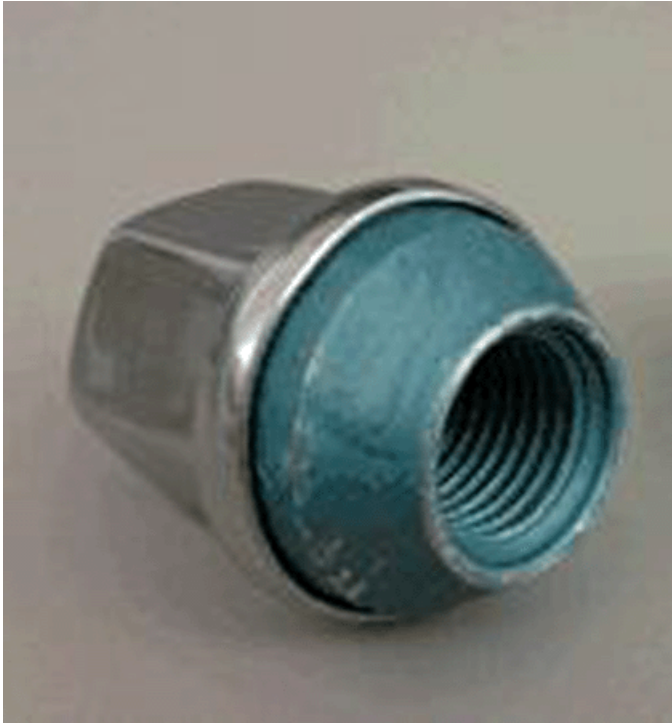
**Note:** Be sure to thoroughly dry the wheel and rotor prior to installation on vehicle.
4. Reinstall wheels using replacement wheel nuts with P/N 9598179 (quantity 20 required for all 4 wheels) (these can be identified with a blue color on the inboard conical portion of the nut (see pic) and torque to spec, 150 Nm (110 lb ft). (If the vehicle already has blue cone nuts, do not replace them again.)
