# Service Bulletin

**Subject:** Unable To Install a CD Or DVD (Slot Misalignment)

**Models:** 2015 Cadillac Escalade Models  
2015 Chevrolet Suburban, Tahoe  
2015 GMC Yukon Models

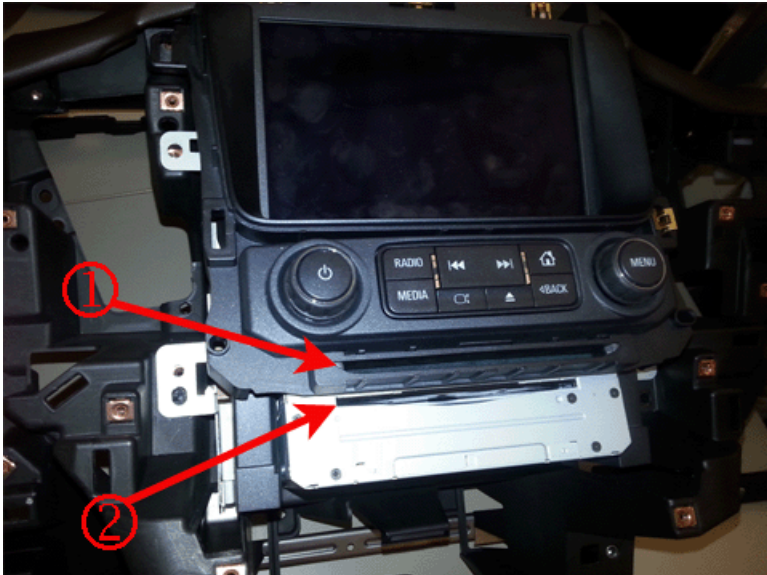
Some owners may comment that they are unable to install a CD or DVD in the player. This concern could be caused by the Integrated Center Stack or ICS (1) not being properly installed, causing a misalignment with the slot in the multimedia player (2), as shown below.

To correct this concern, remove the ICS and multimedia player. Reinstall the multimedia player ensuring the rear locating pin and front two common locating pins are properly engaged. Next, reinstall the ICS ensuring its rear locating pin and front two common locating pins (3) are properly engaged.

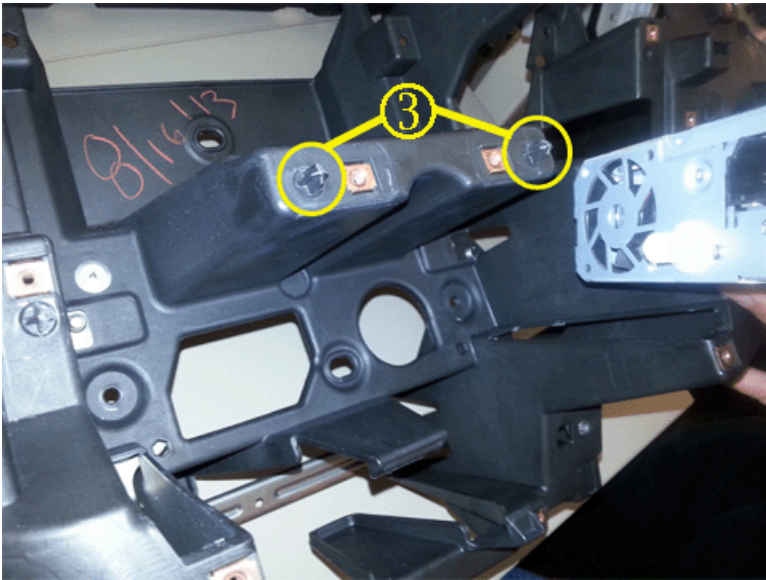
The ICS and multimedia player use two common locating pins (3), as shown below. When the ICS is installed, the two common locating pins (3) may not properly engage into the holes in the back of the ICS, causing the condition.
