Service Bulletin

Bulletin No.: 08-08-49-018E

Subject: Scratches or Scuffs on Console, Center Stack, Door Panels and Steering Wheel Trim Panels (Polish Trim Panels)

Models: 2009-2015 Cadillac CTS-V (All Models)
2013-2015 Cadillac ATS, SRX, XTS
2014-2015 Cadillac CTS Sedan, ELR

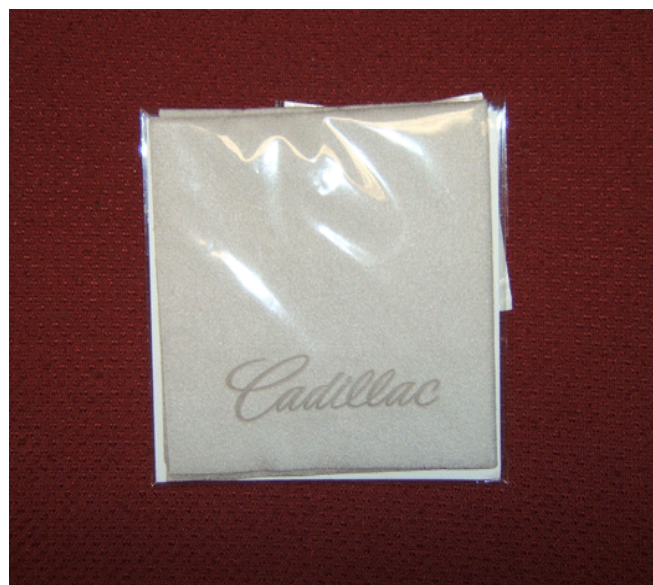
2873573

For vehicles with high gloss surfaces or vehicle displays, use a microfiber cloth as shown in the illustration above to wipe surfaces. Before wiping the surface with the microfiber cloth, use a soft bristle brush to remove dirt that could scratch the surface. Then use the microfiber cloth by gently rubbing to clean. Never use window cleaners or solvents. Periodically hand wash the microfiber cloth separately, using mild soap. Do not use bleach or fabric softener. Rinse thoroughly and air dry before next use.

Important: Do Not attach a device with a suction cup to the display. This may cause damage and would not be covered by the warranty.
