Freightliner  
Service Bulletin

## General Information

## DEF Return-Line Fitting Heater Installation

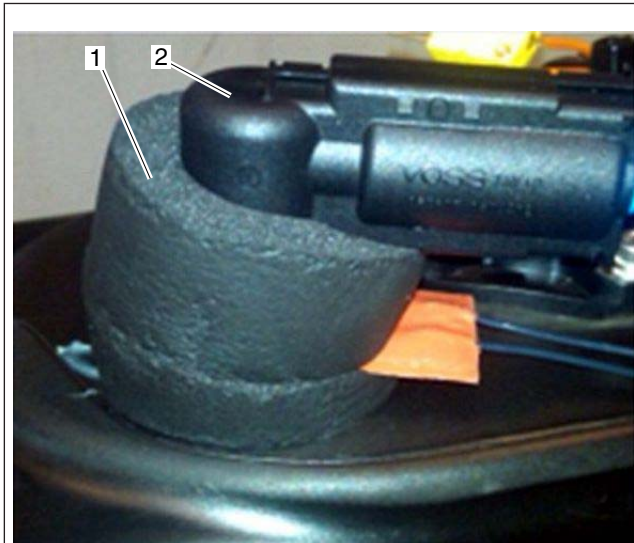
**Fig. 3, Installing the Upper Half of the Insulation**

1. Upper Insulation
2. DEF Return Line

6. Cut a section of reflective sleeve material 10 in. (250mm) long, and split it lengthwise.
7. Install the lower piece of the insulation with the short edge of the angle-cut side facing the DEF line. See [Fig. 2](#).
8. Peel the tape off of the the return-line fitting heater then put it over the fitting and press it to stick on the DEF fitting. See [Fig. 2](#).
9. Install the upper half of the insulation.
10. Connect the DEF return line.
11. Position the reflective sleeve over the fitting and insulation, then secure it with zip ties as needed. See [Fig. 3](#).
12. Locate the DEF heater pigtail connector above the DEF module that matches the connector on the heater pigtail (there is only one). See [Fig. 5](#).
