SP 8-600-003
SERVICE PROGRAM

Autocar Xpert HVAC Performance Upgrade

This Service Program is one of three different programs providing instructions to upgrade the HVAC on certain Autocar Xpert vehicles. Your vehicle may or may not be affected by this Service Program. Confirm your vehicle's VIN against the list beginning on page 25. If your vehicle's VIN is not present on the list you may want to consult Service Program SP 8-600-001 or SP 8-600-002.

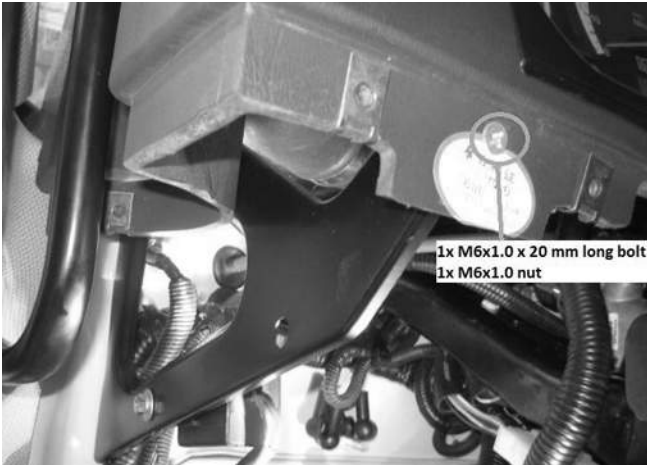
Figure 3-1

1. Remove the bolt/nut assembly on both LH and RH sides of instrument panel and set aside for reinstallation (see Figure 3-1).

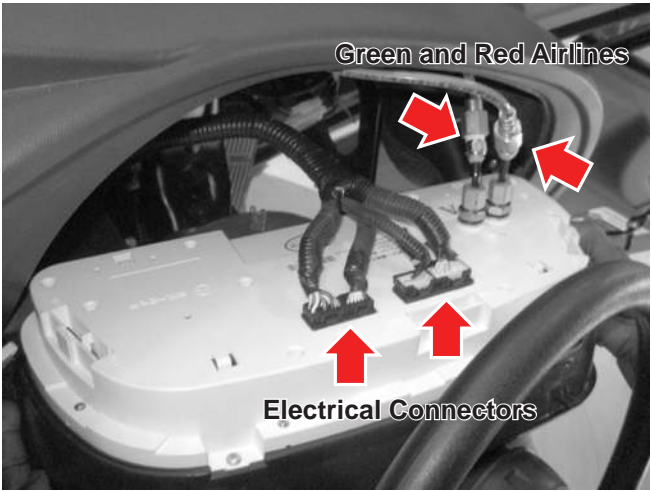
Figure 4-2

5. Using quick-release mechanism on fittings, unhook the green and red airlines from the cluster (see *Figure 4-2*).
6. Disconnect the four electrical connectors from the cluster (see *Figure 4-2*).
7. Remove the instrument cluster and set aside for reinstallation.

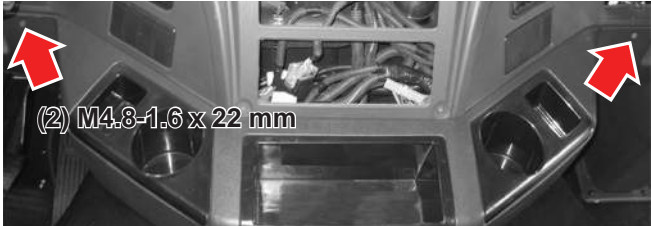
Figure 5-1

1. Remove the cup holders on either side of the lower instrument panel skirt and set aside for reinstallation (see *Figure 5-1*).
2. Remove the screws securing the lower instrument panel skirt and set aside for reinstallation (see *Figure 5-2*).
3. Remove the lower instrument panel skirt and set aside for reinstallation.

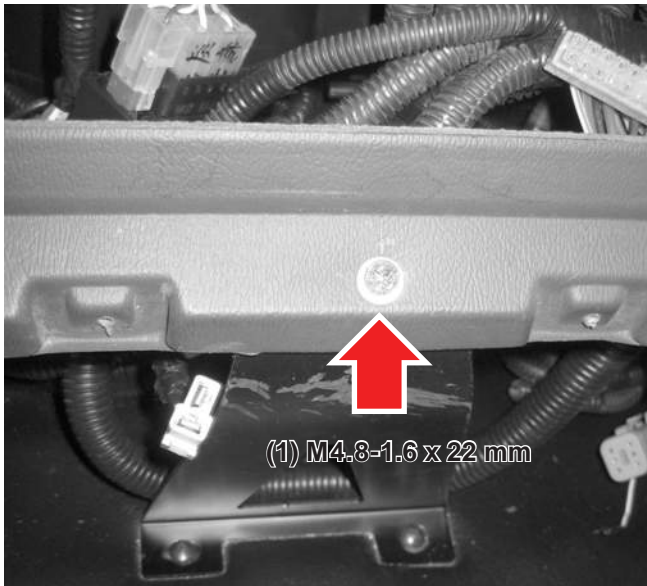
Figure 6-1

1. Remove the screw and washer and set aside for reinstallation (see *Figure 6-1*).

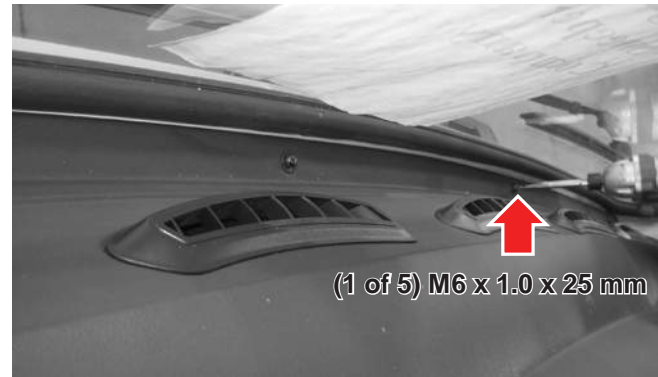
Figure 7-1

1. Remove the screws and washers and set aside for reinstallation (see *Figure 7-1*).

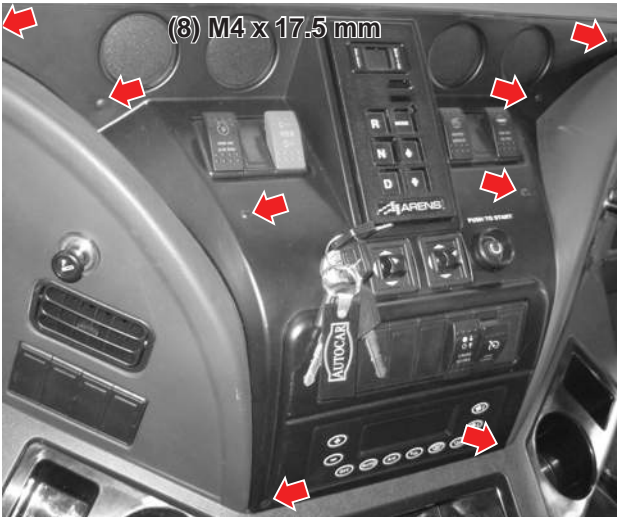
Figure 8-1

1. Remove the eight screw caps and set aside for reinstallation (see Figure 8-1).
2. Remove the eight M4 screws and set aside for reinstallation (see Figure 8-1).

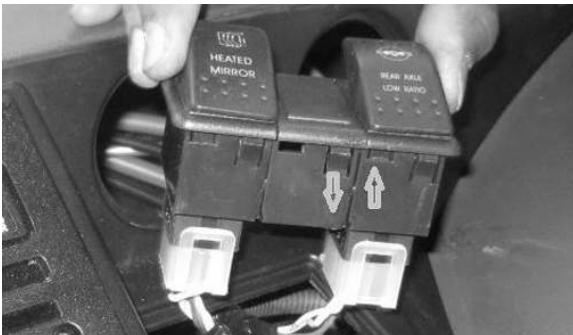
Figure 8-2

3. Pull switches out of their slots and break them apart by pushing one down and the other up (see Figure 8-2).

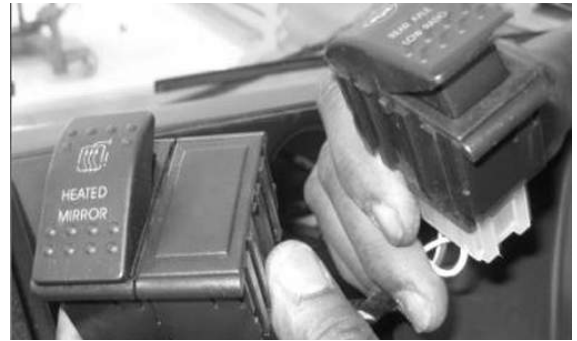
Figure 8-3

4. Push switches through the slots so that the center console panel can be removed (see Figure 8-3).

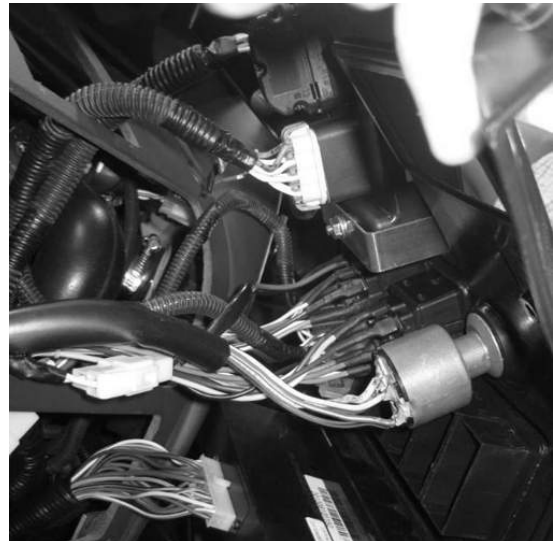
Figure 8-4

5. Disconnect the transmission shift selector connectors, the mirror switch connectors, the ignition barrel connector, push to start button connector, and the HVAC controller connector and set aside for reinstallation (see Figure 8-4).

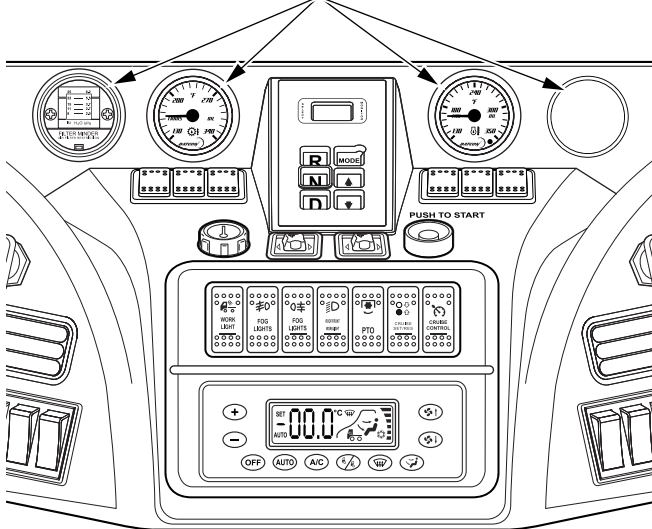
Figure 8-5

6. Remove the gauge panel caps and set aside for reinstallation (see Figure 8-5).

Optional Gauge Locations/Caps

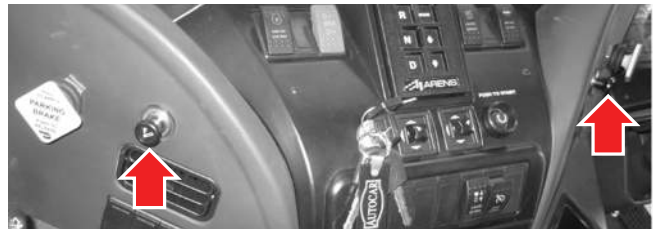
Figure 8-6

8. Locate the terminals/connectors behind the lighters through the access holes in the center portion of the upper dashboard panel (see Figure 8-6).

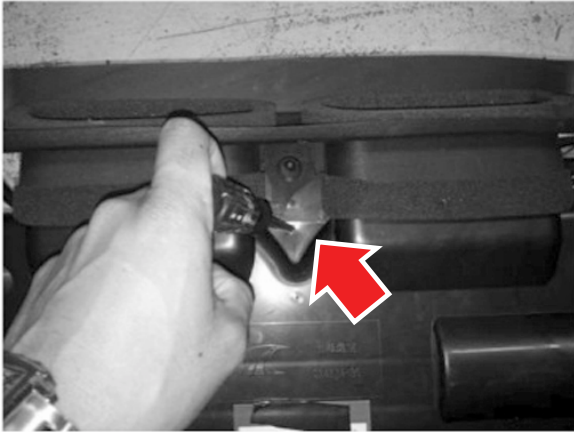
Figure 11-1

1. Remove the screw from the HVAC housing and set aside for reinstallation (see Figure 11-1).

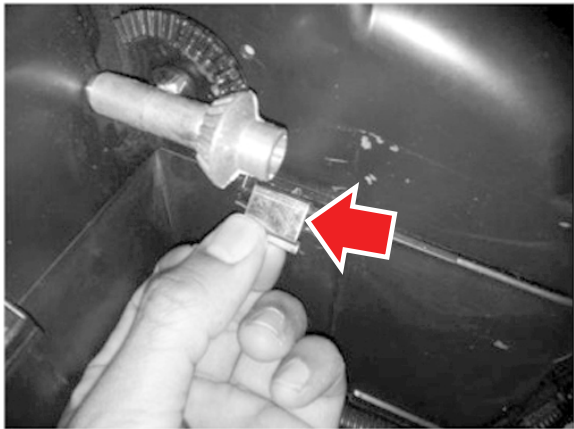
Figure 11-2

2. Remove retaining clips securing the head of the HVAC unit along its perimeter and set aside for reinstallation (see Figure 11-2).

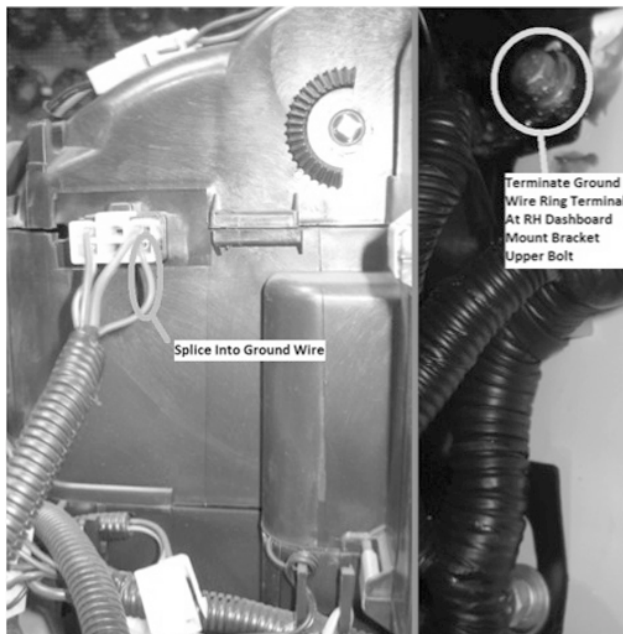
Figure 13-1

The new blower motor draws a higher current than the discarded unit. Additional grounding is required. This is achieved by adding a ground wire that terminates directly at the cab ground stud in the cab's bulkhead.

1. Splice the new ground wire (A6000100-001) to fan speed control module's lower RH purple wire using a soldering iron (smaller purple wire on RH side of the HVAC housing) (see *Figure 13-1*).
2. The ring terminal on the ground wire must terminate at the RH dashboard mount bracket at the upper mount bolt (see *Figure 13-1*).

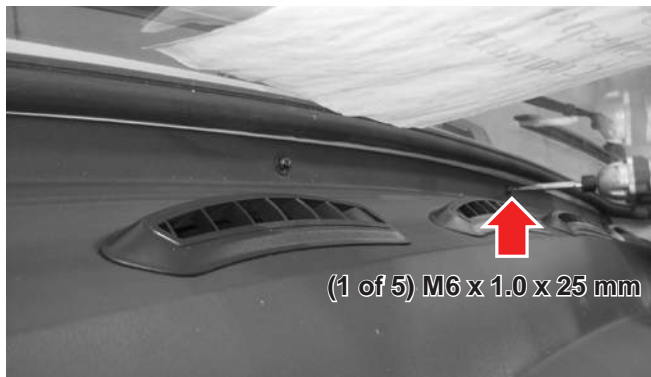
Figure 15-1

1. Reinstall the instrument panel.
2. Reinstall the screws and washers (see Figure 15-1).

Note: Ensure all the screws have been partially fastened before tightening any of them; use a small screw driver or poking tool to line up the holes in the panel and in the sheet metal.

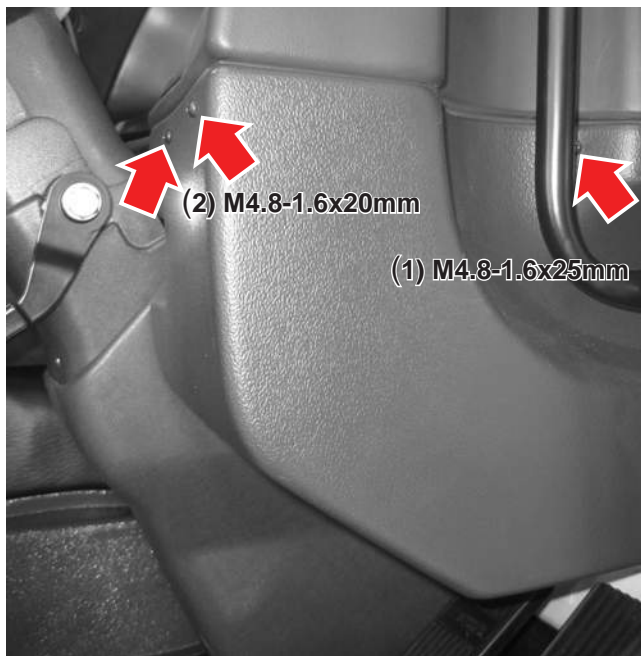
Figure 19-1

1. Align the lower RH instrument panel trim panel with mounting spring nuts on the upper instrument panel (see Figure 19-1).
2. Reinstall the three sheet metal screws, ensuring they are driven through the spring nuts (see Figure 19-1).

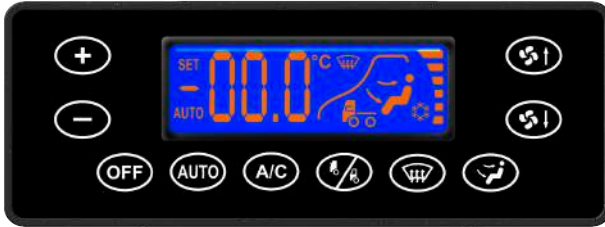
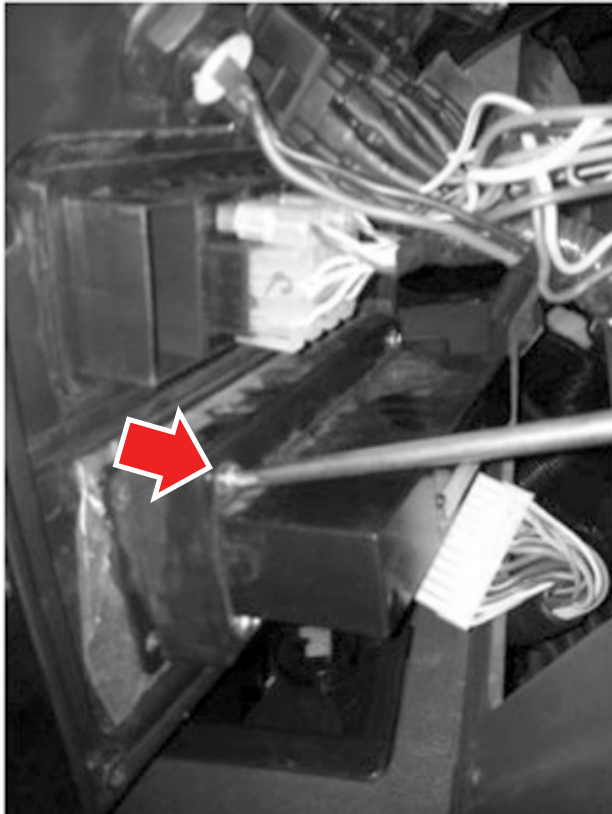
Figure 24-1

1. Remove the four screws affixing the clamp bracket to the rear of the HVAC controller (see Figure 24-1).

3. Install the new controller (A6030018-001) by reversing steps 24-3 to 24-1.

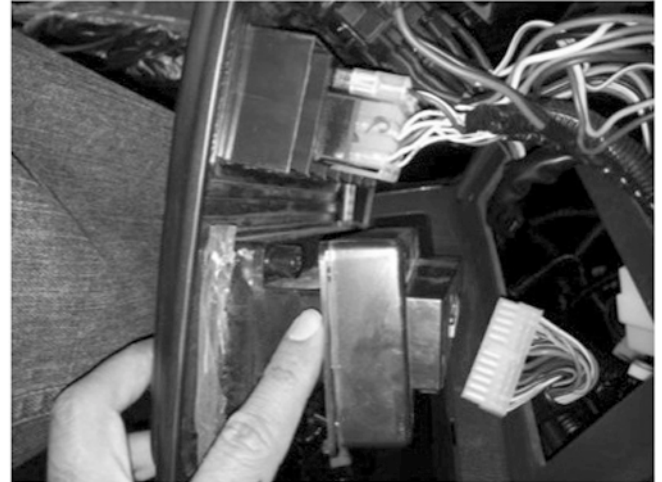
Figure 24-2

2. Remove the clamp bracket (see Figure 24-2).

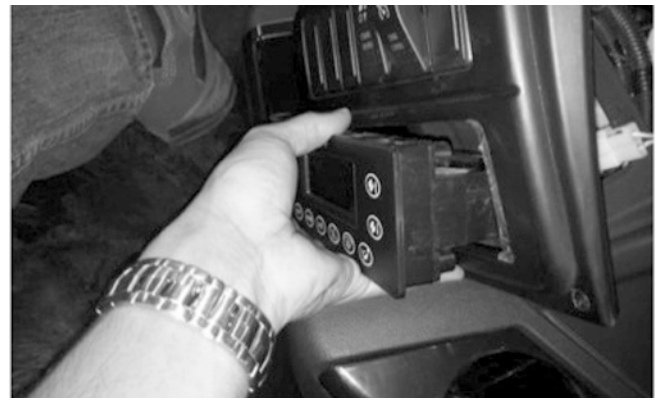
Figure 24-3

2. Slide the old controller out (see Figure 24-3).

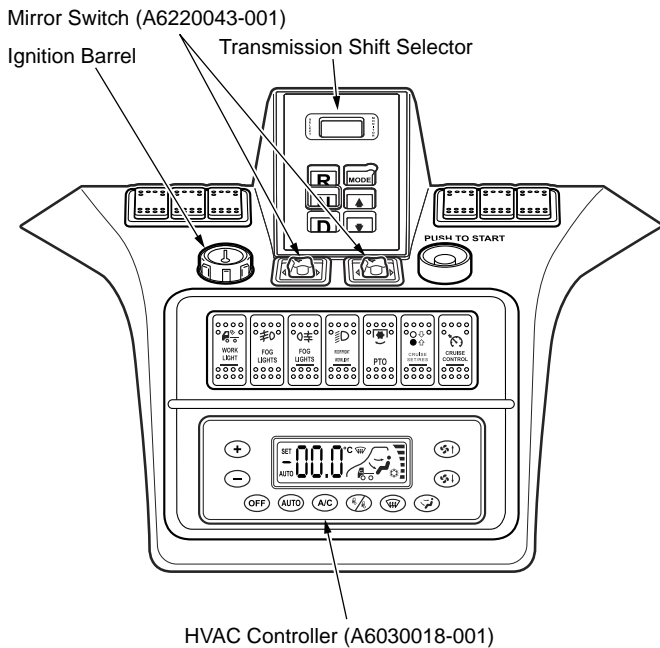
Figure 25-1

1. Reconnect the transmission shift selector connectors (see *Figure 25-1*).
2. Reconnect the mirror switch (A6220043-001) connectors (see *Figure 25-1*).
3. Reconnect the ignition barrel connector and the HVAC controller (A6030018-001) connector (see *Figure 25-1*).

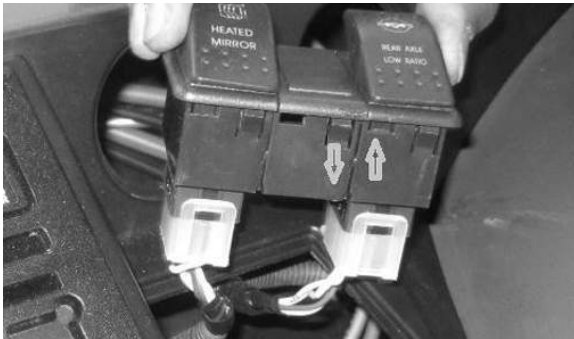
Figure 28-1

1. Route the switches through the slots in the center console panel in their original locations (see *Figure 28-1*).
2. Reassemble the switch banks in the same configuration that they were before breaking apart in step 8-3 (see *Figure 28-1*).
3. Push the switches through the slots in the center console until they snap into place (see *Figure 28-2*).
