Applies To: 2011–13 Odyssey – Check the iN VIN status for eligibility

# Warranty Extension: MIL Comes On With DTCs P0301 Through P0304

(Supersedes 13-081, dated December 20, 2013, to revise the information marked by the black bars)

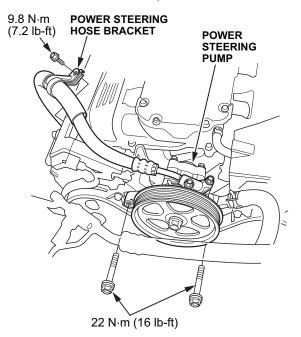
- 21. Remove the drive belt.
- 22. Remove the drive belt auto-tensioner.
- 23. Remove the power steering pump bolts, power steering hose bracket, then secure the power steering pump out of the way.

NOTE: Do not remove any of the hoses.

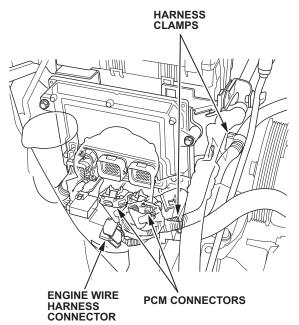
32. Remove the PCM connectors and harness clip. Remove the battery cables from the underhood fuse box.

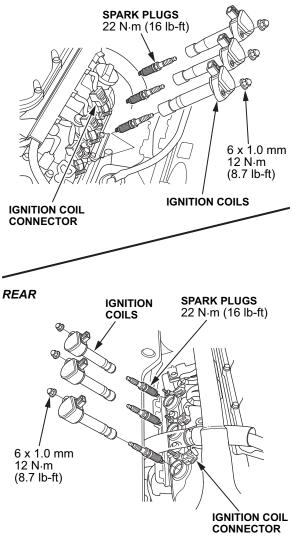
#### FRONT

33. Remove the appropriate Ignition coils based on diagnosis.

NOTE: Depending on diagnosis, you will either have to remove the rear bank ignition coils or both ignition coil banks.

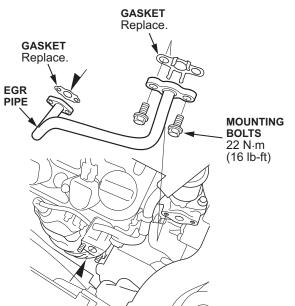
38. Remove the EGR pipe mounting bolts, then remove the EGR pipe.

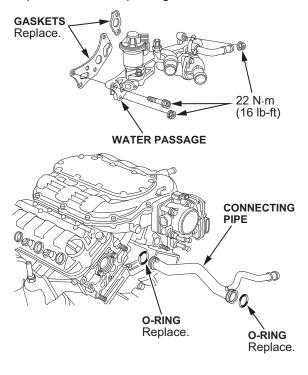
39. Separate the water passage from the heads.

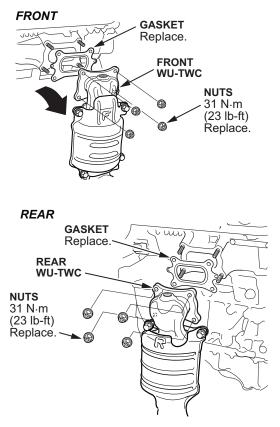
40. Remove the appropriate WU-TWC, depending on diagnosis.

NOTE: Set the WU-TWC aside and cover the opening with shop towels to prevent coolant from entering.

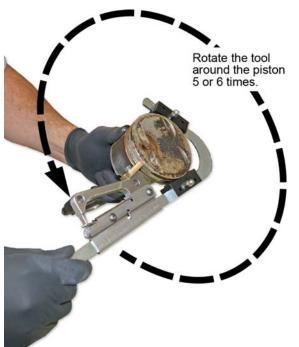
Hold the piston steady and rotate the tool counter-clockwise five to six times to remove any carbon deposits in the piston ring grooves.
Do not rotate the tool clockwise.

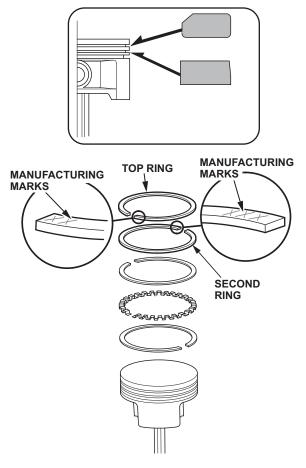
9. Install the piston rings as shown.

NOTE: The first (top) ring has a 1D manufacturing mark and the second (middle) ring has an SPR manufacturing mark. The manufacturing marks must be facing upward.

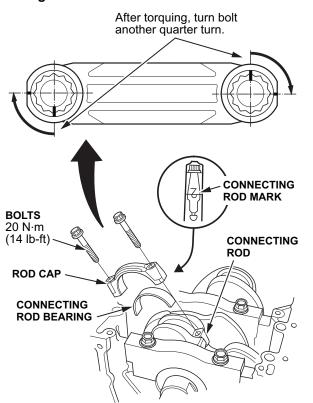
Apply new oil to the connecting rod bolt threads and flanges. Torque the bolts to 20 N•m (14 lb-ft), then tighten the connecting rod bolts an additional 90 degrees.
