Applies To: **2008-12 Accord V6 A/T** – Check the iN VIN status for eligibility

Warranty Extension: MIL Comes On With DTCs P0301 Through P0304 (Supersedes 13-078, dated October 9, 2013; see REVISION SUMMARY)

The piston rings on certain cylinders may rotate and align which can lead to spark plug fouling. This can set DTCs P0301 through P0304 and cause the MIL to come on.

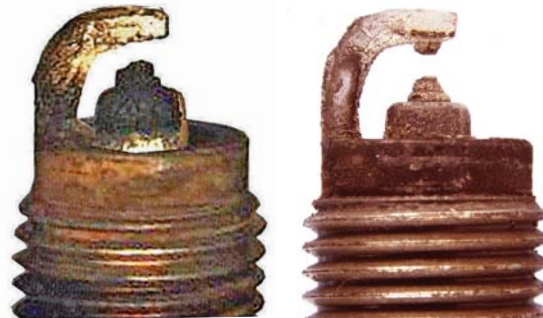
NOTE: Below are examples of good and fouled spark plugs.

GOOD

NO GOOD

4. Note which DTCs are stored in the vehicle.
 - If the vehicle has one or more of the following stored DTCs: P0301, P0302, P0303, go to REPAIR PROCEDURE B to clean the pistons, replace the piston rings on cylinders 1–3, and replace the spark plugs on cylinders 1–4.
 - If the vehicle has DTC P0304 with or without any of the other three DTCs stored, go to REPAIR PROCEDURE B to clean the pistons, replace the piston rings on cylinders 1–4, and replace the spark plugs on cylinders 1–4.

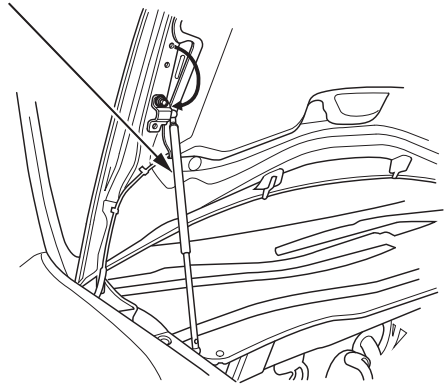
HOOD SUPPORT STRUT

- Use fender covers to avoid damaging painted surfaces.
 - To avoid damaging any wires and terminals, unplug the circuit connectors carefully while holding the connector portion.
 - Mark all the circuits and hoses to avoid misconnection. Make sure they do not contact other circuit wiring, hoses, or interfere with other parts.
1. Using both hood support struts prop up the hood in a wide open position.

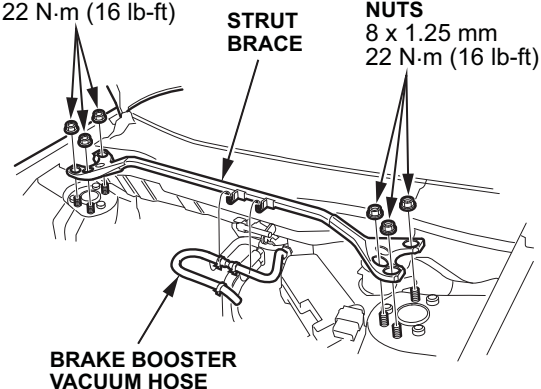
2. Relieve the fuel pressure.
3. Remove both front wheels so you can fully lower the vehicle.
4. Remove the strut brace.

8 x 1.25 mm
22 N·m (16 lb-ft)

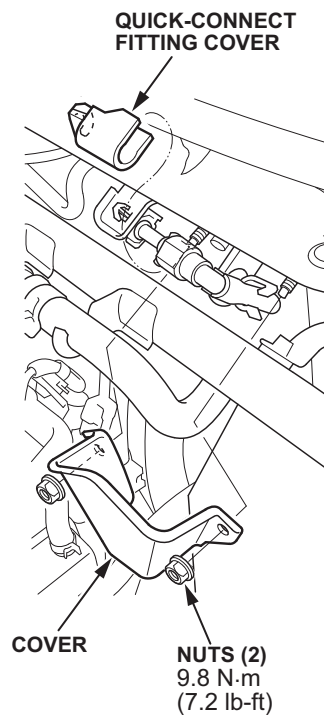
6. Disconnect the fuel feed hose line at the bulkhead.

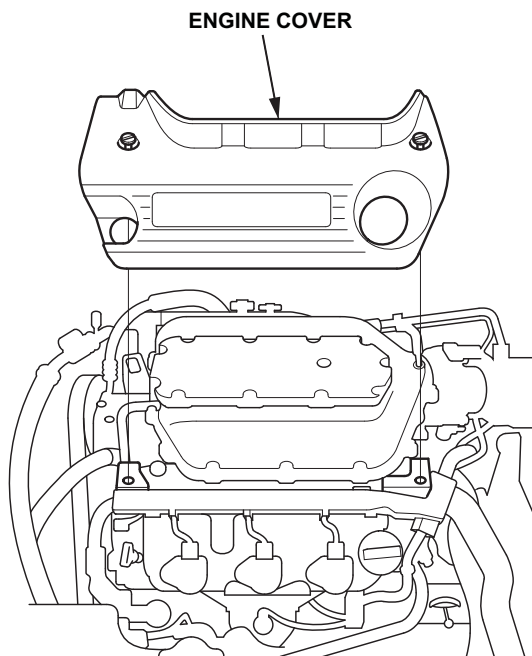
7. Remove the engine cover.

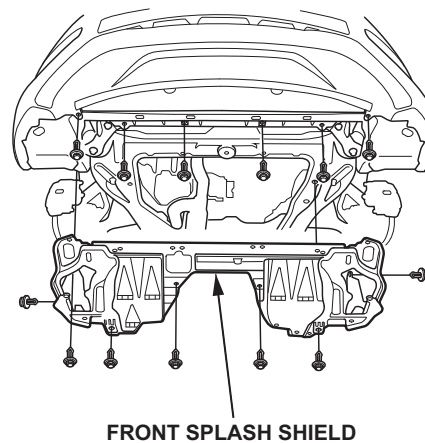
10. Remove the front splash shield.

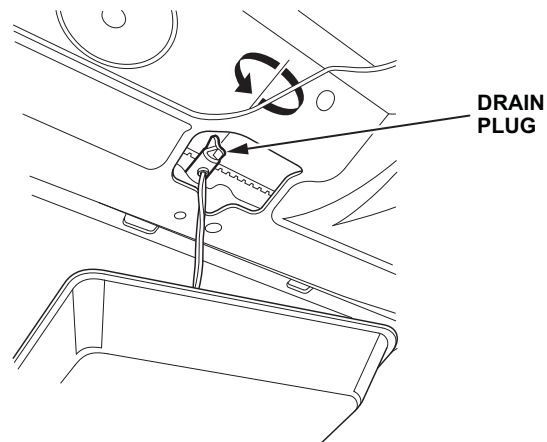
12. Loosen the drain plug on the radiator, and drain the coolant.

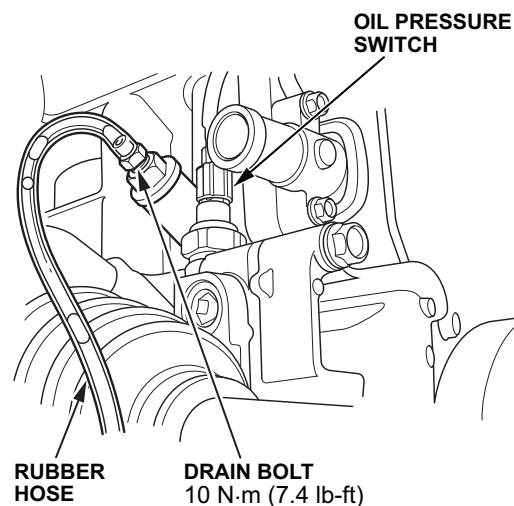
13. Install a 5/16th inner diameter rubber hose on the drain bolt located at the rear of the engine block, loosen the drain bolt, and drain all remaining coolant. Then disconnect the oil pressure switch connector.

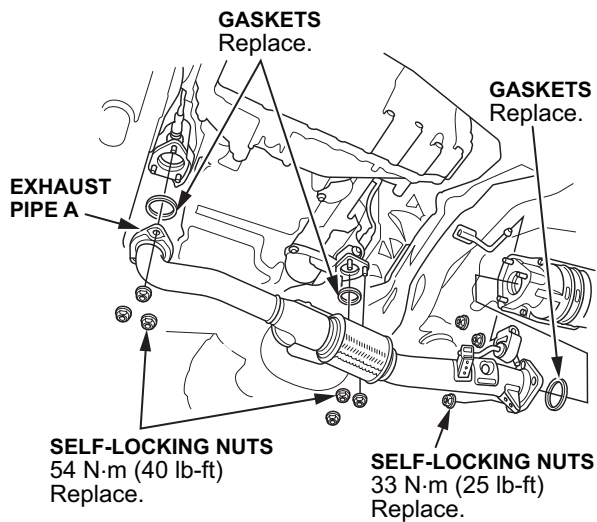
14. Remove exhaust pipe A.

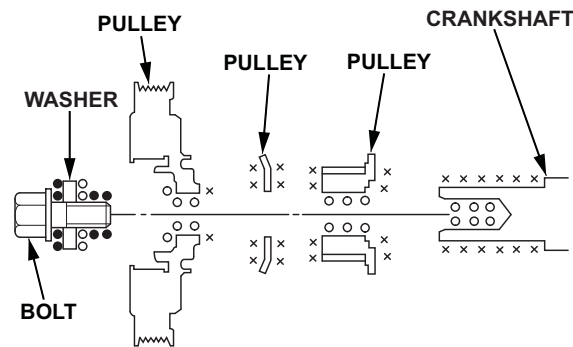
17. Remove the crankshaft pulley bolt but not the pulley.

NOTE: Make sure to apply new oil to the bolt flange and threads before reinstallation.

X : Remove any oil

O : Clean

● : Lubricate with new engine oil

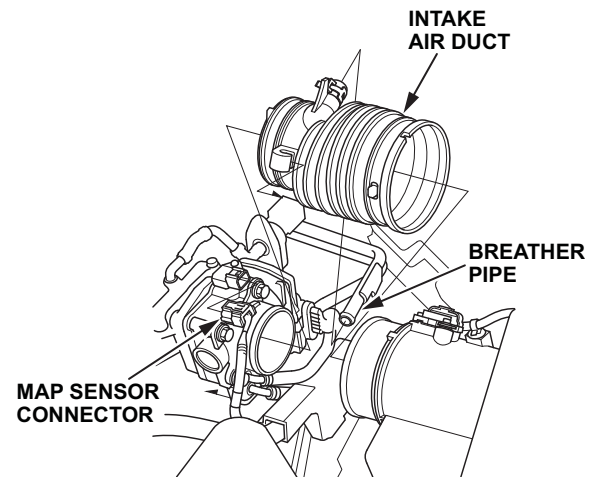
19. Disconnect the MAP sensor connector and the breather pipe, then remove the intake air duct.

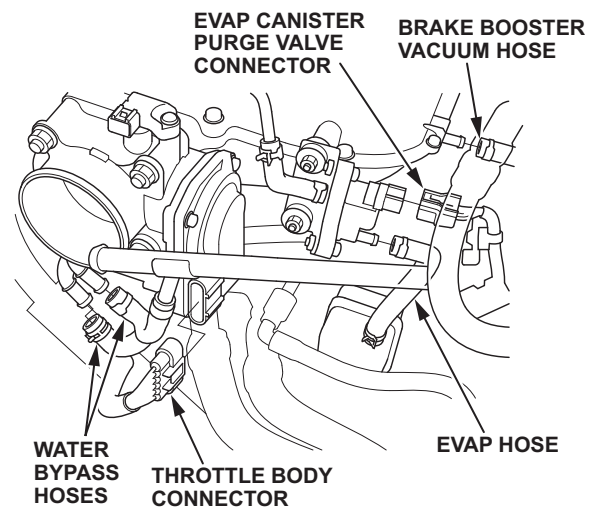
20. Disconnect the throttle body connector, the EVAP canister purge valve connector, the EVAP hose, the brake booster vacuum hose, and the vacuum hose.

21. Disconnect and plug the water bypass hoses.

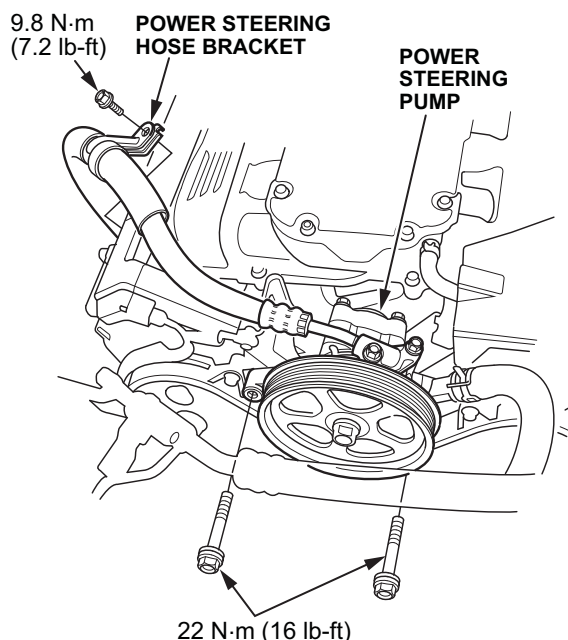
24. Remove the power steering pump bolts, the power steering bracket then secure the power steering pump out of the way.

NOTE: Do not remove any of the hoses.

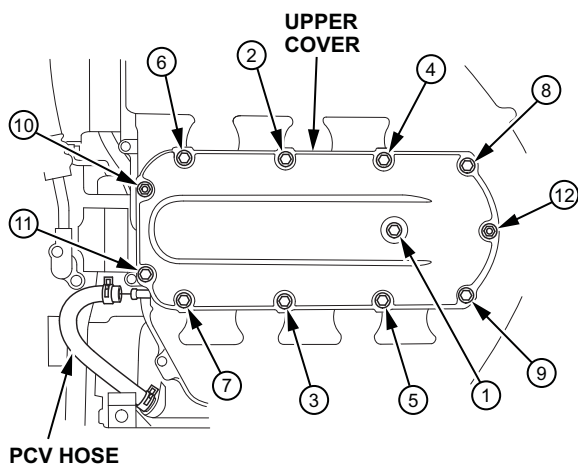
25. Remove the engine harness holder bolt on the side engine mount.
26. Set the engine to TDC cylinder one.
27. Remove the crankshaft pulley.
28. Remove the timing belt.
29. Remove the timing belt idler pulley.
30. Remove the engine intake upper cover bolts and nuts. Then remove the cover and the PCV hose.

6 x 1.0 mm
12 N·m (8.7 lb-ft)

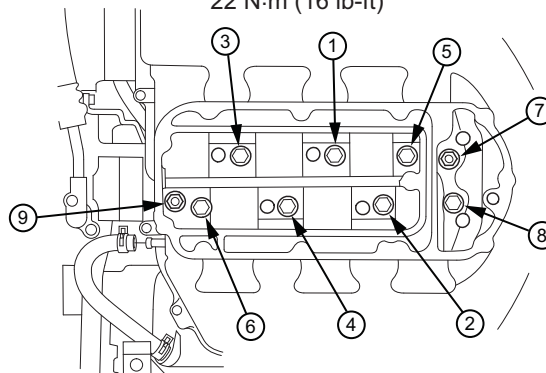
31. Remove the intake manifold bolts and nuts in three steps, then remove the intake manifold.

SPECIFIED TORQUE
22 N·m (16 lb-ft)

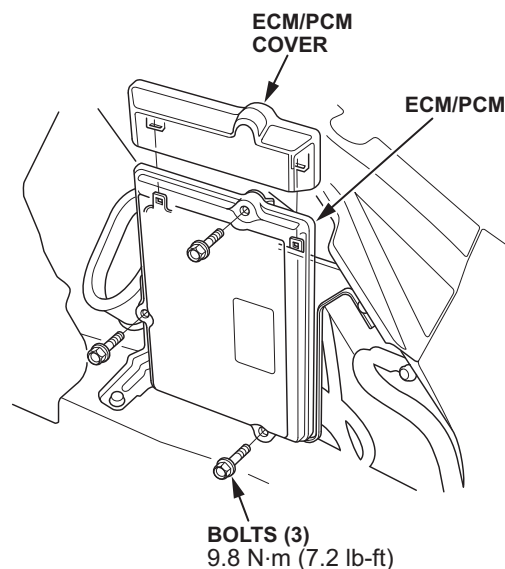
32. Remove the PCM cover.

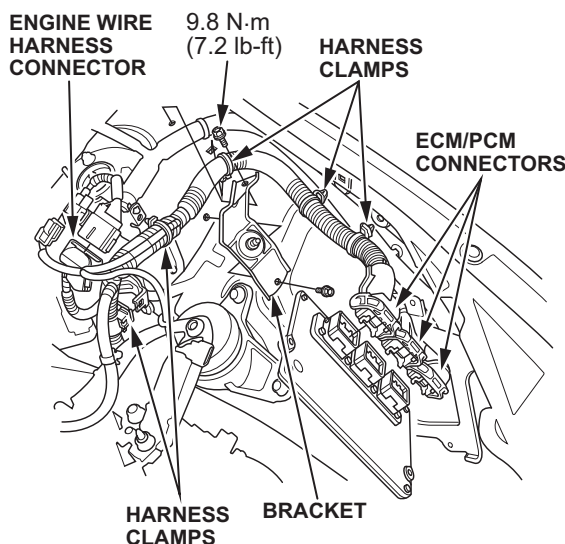
33. Remove the PCM connectors and harness clip. Remove the battery cables from the underhood fuse box.

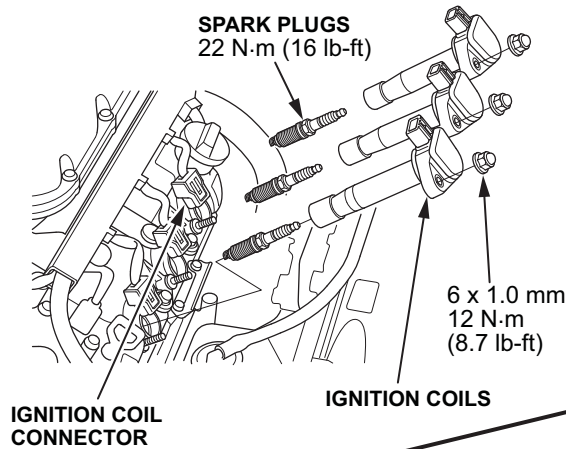
FRONT

34. Remove the appropriate Ignition coils based on the diagnosis.

NOTE: Depending on the diagnosis, you will either have to remove the rear bank ignition coils or both ignition coil banks.

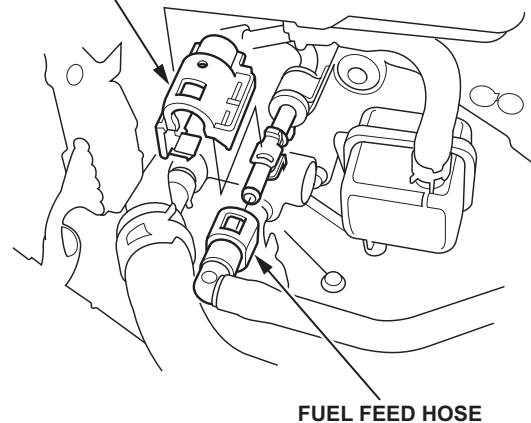
QUICK-CONNECT FITTING COVER

36. Remove the quick-connect fitting cover, then disconnect the fuel feed hose.

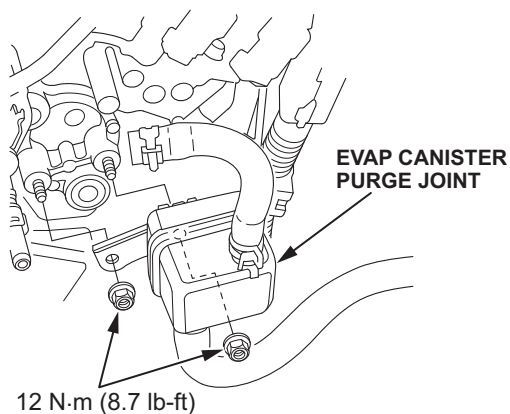
37. Remove the EVAP canister purge joint with the bracket.

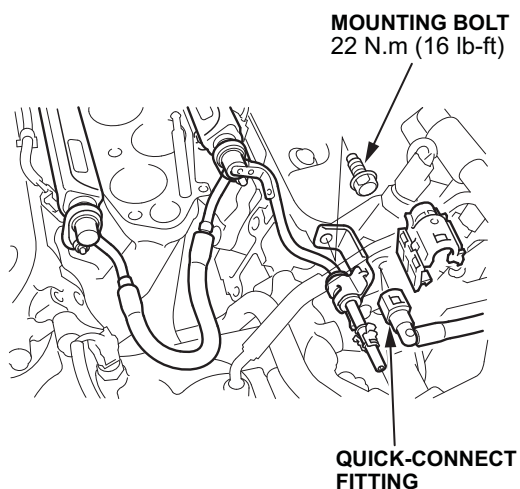
38. Remove the fuel rail connecting joint hose.

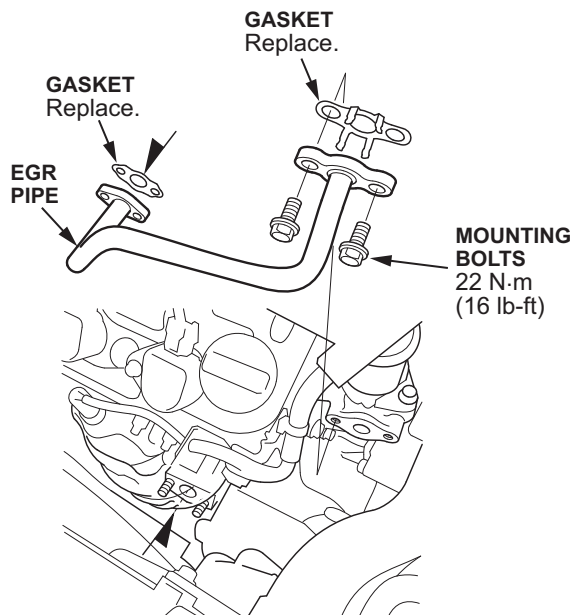
39. Remove the EGR pipe mounting bolts, then remove the EGR pipe.

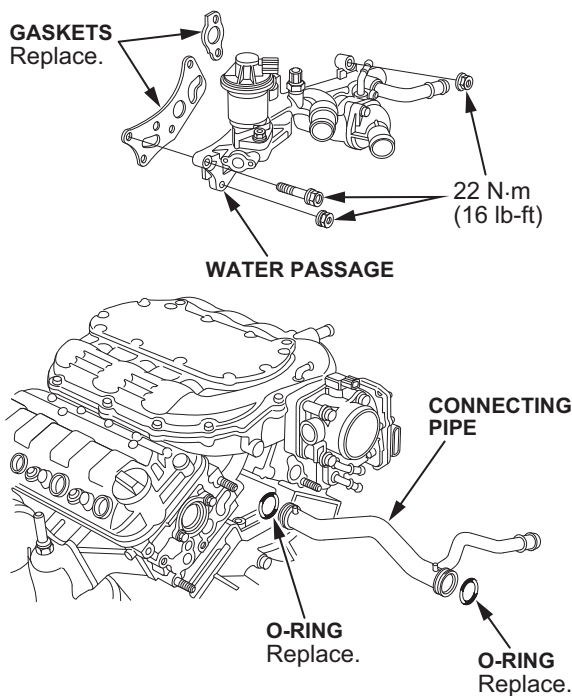
40. Separate the water passage from the heads.

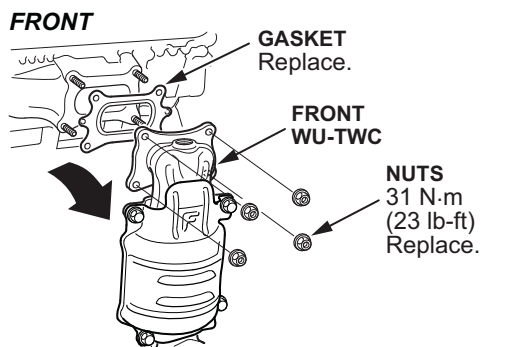
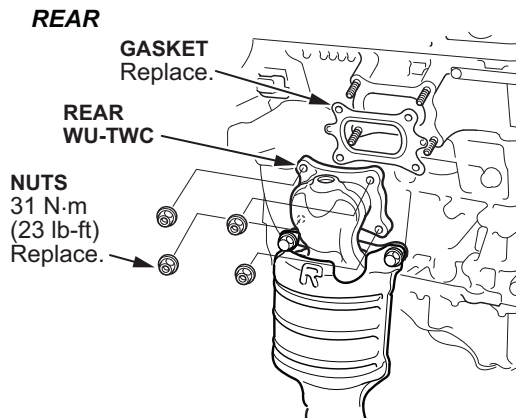
41. Remove the appropriate WU-TWC depending on diagnosis.

NOTE: Set the WU-TWC aside and cover the opening with shop towels to prevent coolant from entering.

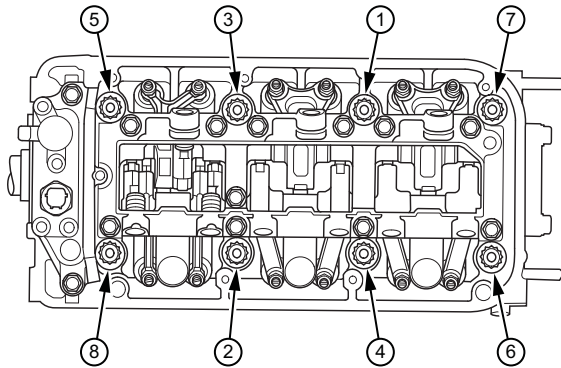
FRONT

42. Remove the appropriate head with the injector base attached.

NOTE: Depending on diagnosis, you will remove the rear bank head or both heads.

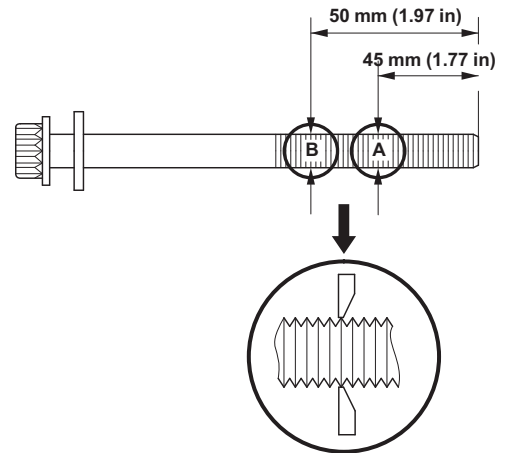
43. Measure the head bolts to determine if they need replacement. If either diameter is less than **11.3 mm (0.445 in)**, replace the cylinder head bolt.

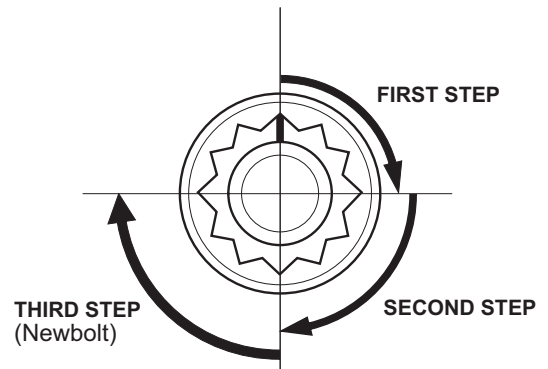
NOTE: Below are the head bolt torque specifications for reinstallation.

- First step: torque the cylinder bolts in sequence to **29 N•m (22 lb-ft)**.
- Second step: tighten in sequence an additional **90 degrees**.
- Third step: tighten in sequence an additional **90 degrees**.
- If the bolts are new, tighten an additional **90 degrees**.

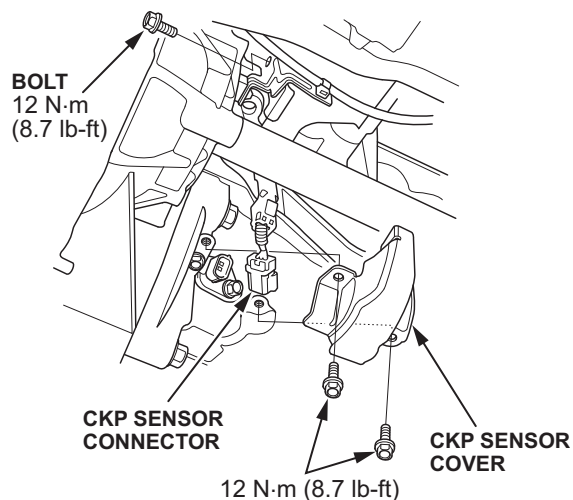
45. Remove the CKP sensor cover and bolts, then disconnect the CKP sensor connector.

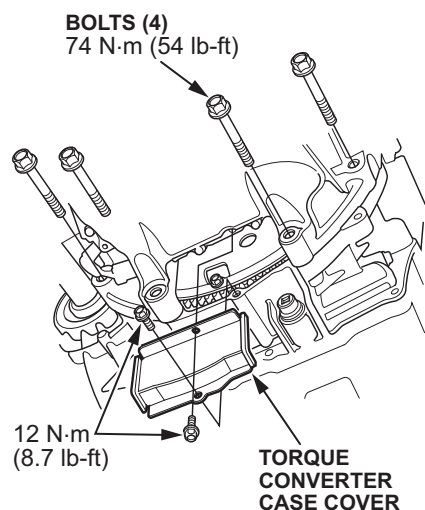
46. Remove the torque converter case cover and the four bolts securing the oil pan to the transmission.

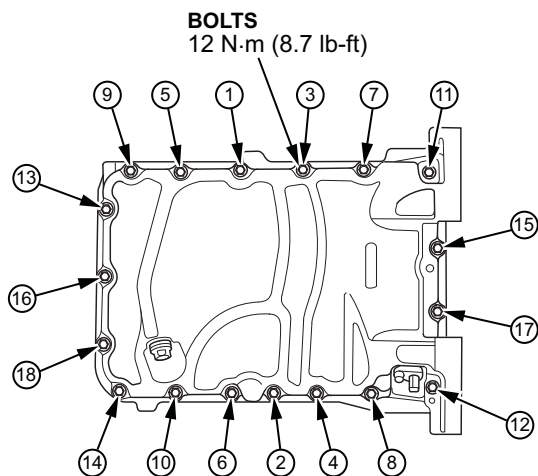
47. Remove all bolts securing the oil pan.

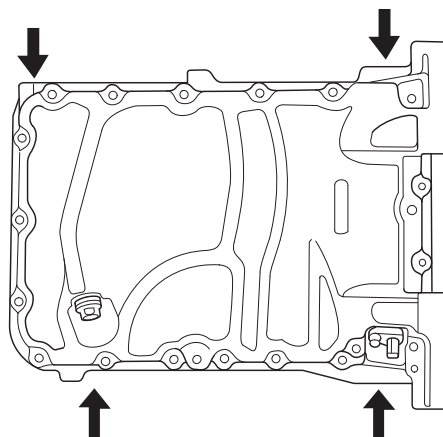
48. Using a flat blade screwdriver, separate the oil pan from the engine block in the areas shown.

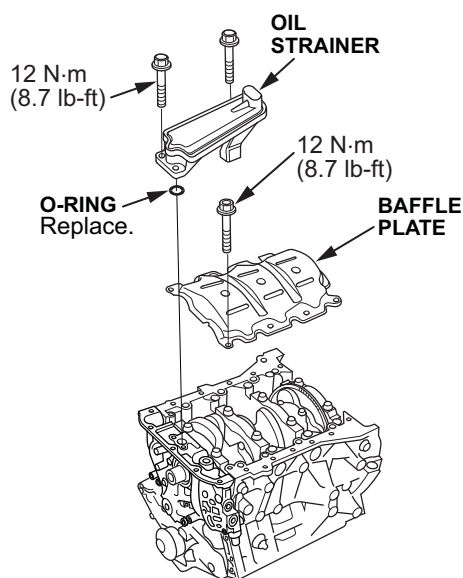
49. Remove the oil strainer and baffle plate.

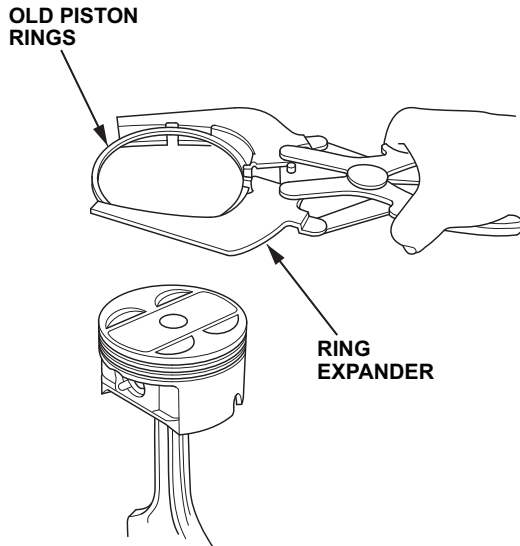
1. Remove the piston rings from the piston using a ring expander. Be careful not to damage the piston.

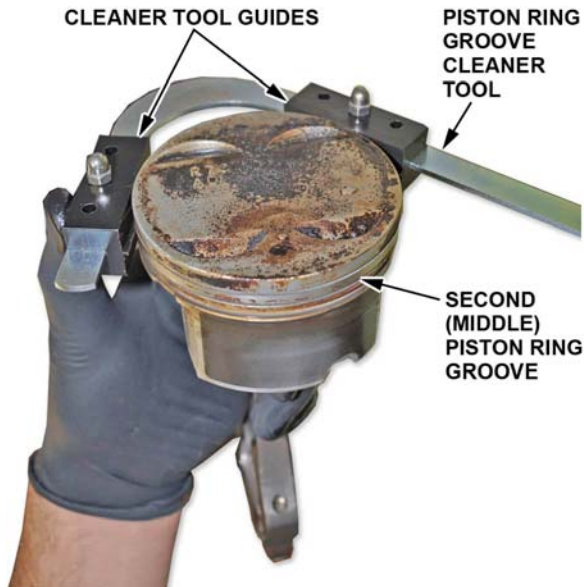
2. Spray the piston head and piston ring grooves thoroughly with Honda throttle plate cleaner.
3. While holding the piston upright in your left hand, take the piston ring groove cleaner tool in your right hand and line up the cleaner tool guides with the second (middle) piston ring groove.

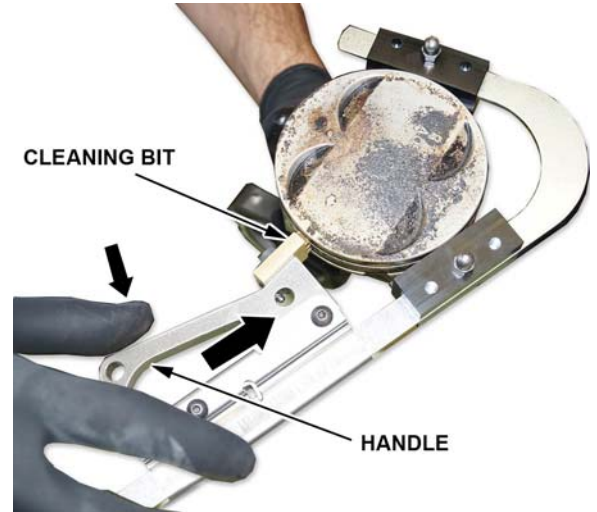
4. Press the handle on the piston ring groove cleaner tool and slide the cleaning bit onto the appropriate piston ring grooves.

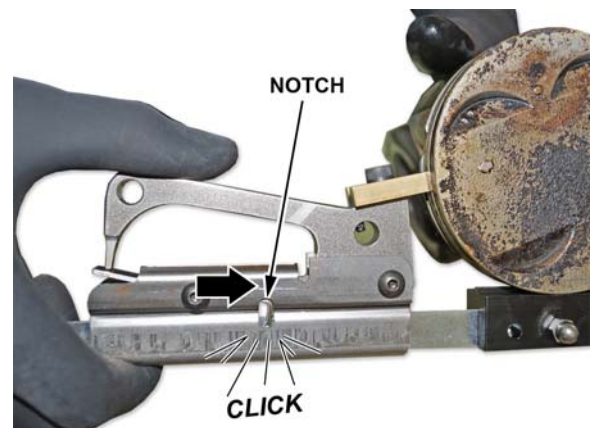
5. Once the cleaning bit is in the appropriate ring grooves of the piston, make sure the tool handle clicks in to place.

NOTE: There is only one notch on the tool for the handle to engage.

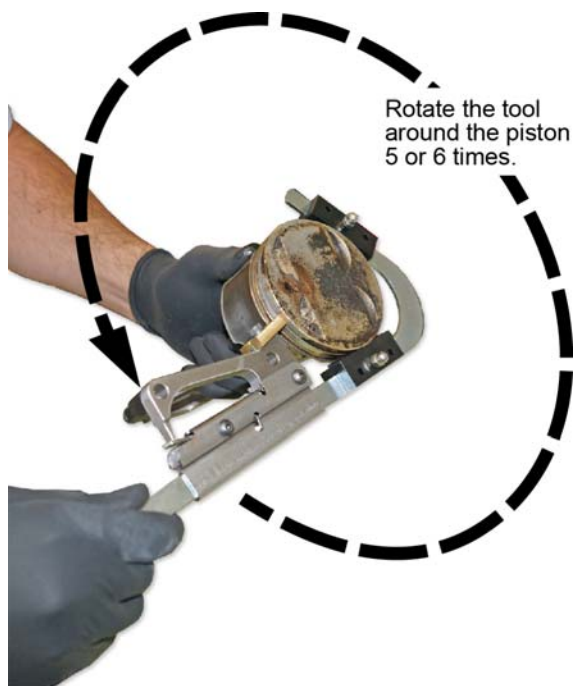
6. Hold the piston steady and rotate the tool counter-clockwise five to six times to remove any carbon deposits in the piston ring grooves. **Do not** rotate the tool clockwise.

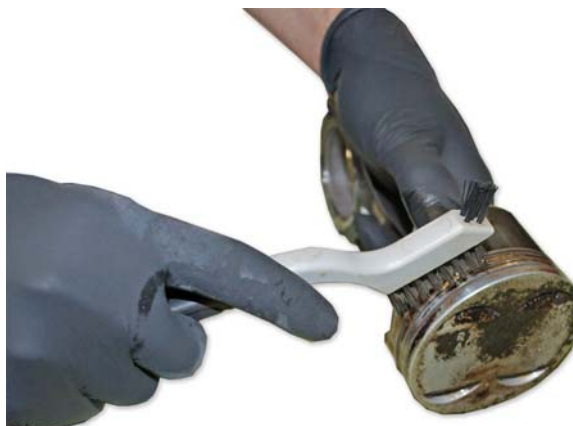
7. Remove the piston groove cleaning tool and clean off the carbon from the tool bit.

8. Finish cleaning the piston with throttle plate cleaner and the nylon brush. **Do not** use a steel wire brush.

NOTE: Below are some examples of before and after pictures. Depending on mileage and running conditions, the pistons will achieve different levels of cleanliness.

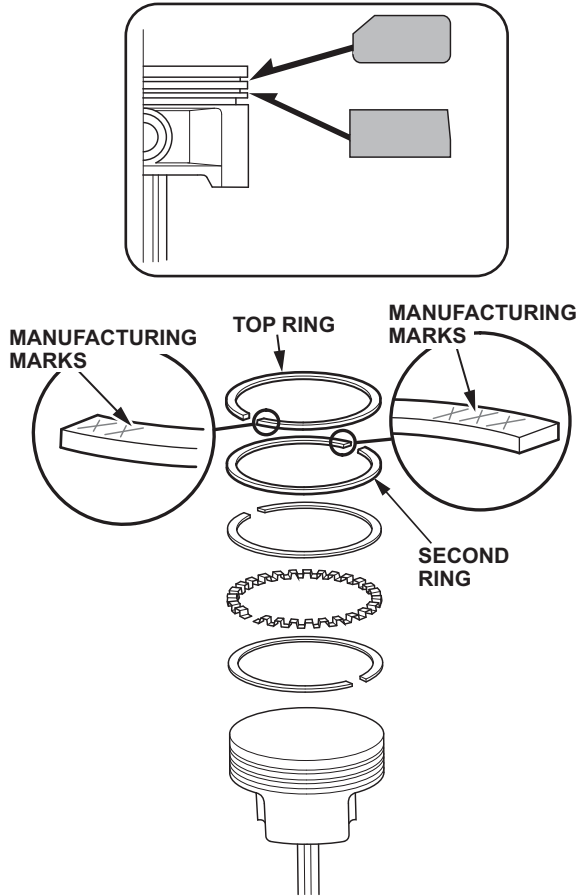
9. Install the piston rings as shown.

NOTE: The first (top) ring has a 1D manufacturing mark and the second (middle) ring has an SPR manufacturing mark. The manufacturing marks must be facing upward.

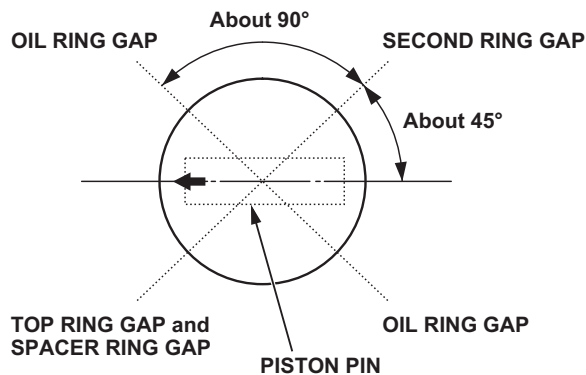
10. Position the ring end gaps as shown.

NOTE: If the ring gaps are not positioned correctly, excessive blowby may occur.

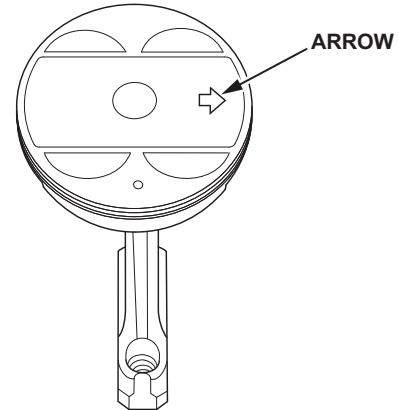
12. Install the piston/connecting rod assembly into the cylinder bore with the arrow on top of the piston facing the timing belt side of the engine.

NOTE: Be careful not to damage the cylinder wall when installing the piston.

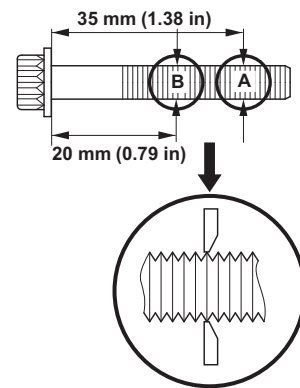
13. Measure the diameter of the connecting rod bolts to determine if they need replacement. Calculate the difference in diameter between point A and point B. It should not be more than **0–0.1 mm (0–0.004 in)**.

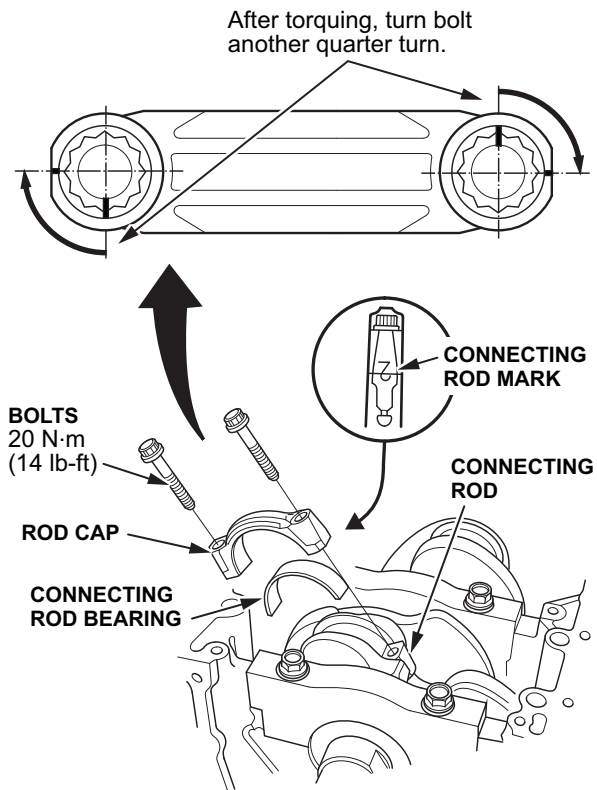
14. Apply new oil to the connecting rod bolt threads and flanges. Torque the bolts to **20 N•m (14 lb-ft)** then tighten the connecting rod bolts an additional **90 degrees**.
