ATB 51110-51160 REV1 (1403)

Safety Recall: 2014 Civic Tire Damage During Vehicle Assembly**(Supersedes 14-014, dated March 7, 2014, to revise the information highlighted in yellow)****AFFECTED VEHICLES**

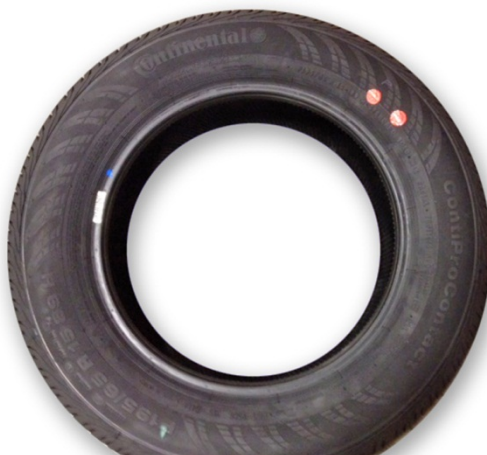
- If tire replacement is needed, you must use Continental Contipro Contact tires or Firestone Affinity S4 Fuel Fighter tires from The Tire Rack. These tires will have two red dots (marker) on the sidewall indicating that the tires are for this campaign only.
- Not all of the 9,800 vehicles affected by this recall will require tire replacement. Please do not order a large number of tires without verifying needs first.
