**Document ID:** IK1200915  
**Revision:** 8  
**Created:** 6/7/2013  
**Last Modified:** 4/29/2014  
**Author:** Steven Bell

**Title:** 2010 IBB Valve Bridges Falling Off

**Applies To:** EPA 2010 11L & 13L Engines

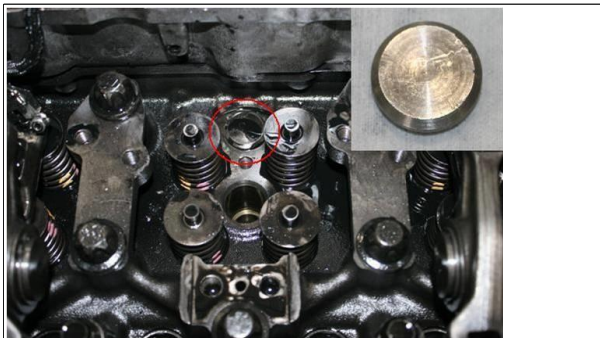
Figure 1:  
1. Injector Hold Down Spacer

- 1) Transfer 6 injector hold down spacer pucks beneath the injector hold downs over to the new head (Figure 1)
- 2) Compare new and old head gaskets. An 11L head gasket on a 13L engine will stop the engine from turning over once the head is torqued down since the bore size is smaller than a 13L Piston.
  - A) 11L Gasket does NOT have a notch at the RR corner of the cylinder head gasket (Figure 2)
  - B) 13L Gasket does have a notch at the RR corner of the cylinder head gasket (Figure 3)
- 3) Be sure to properly time the cam gear per the service manual.
- 4) Reuse the Cam Bearings unless they are damaged

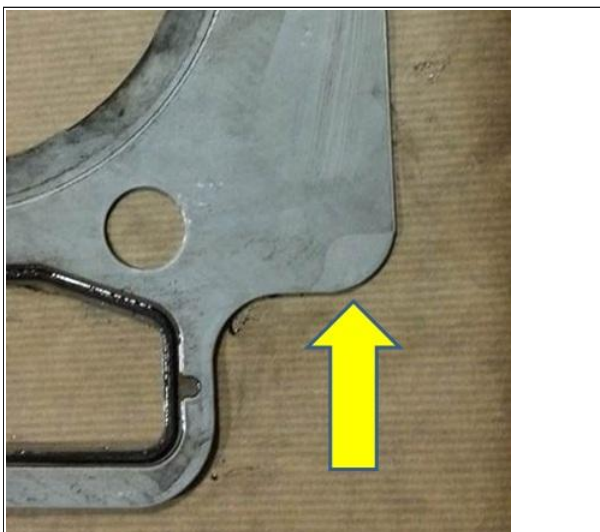
Figure 2:  
1. 11L Head Gasket

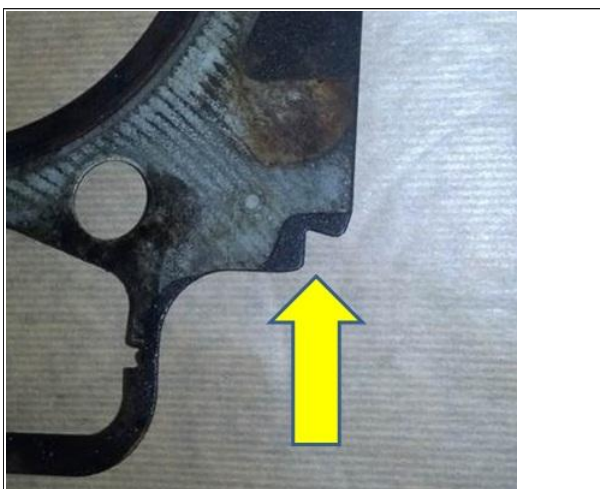
Figure 3:  
1. 13L Head Gasket
