T-SB-0087-13      Rev1      July 23, 2013

# HV Battery Cooling Fan Maintenance for Severe Usage Vehicles

| YEAR(S) | MODEL(S) | ADDITIONAL INFORMATION |
|---|---|---|
| 2012 – 2014 | Camry HV | |

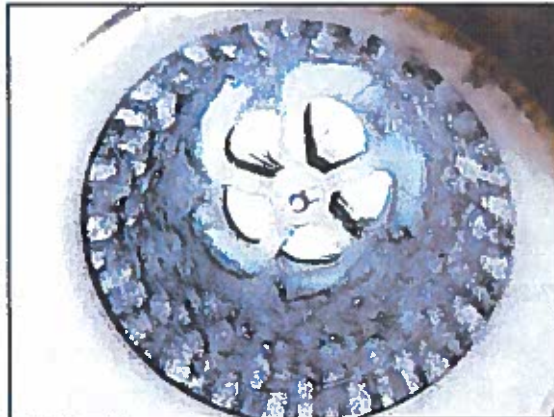
For vehicles that are used under certain severe operating conditions, the HV Battery Cooling Fan may exhibit an excessive buildup of dust, lint, or other debris that can reduce the efficiency of the HV Battery Cooling System. HV Battery Cooling Fan maintenance and cleaning should be performed to address this condition.

Figure 1. HV Battery Cooling Fan BEFORE Cleaning

3. Using vacuum, and compressed air, if necessary, clean any dust, lint, or debris buildup from the HV Battery Cooling Fan blades, module, and ducts.

- Do NOT attempt to clean the HV Battery Cooling Fan while it is installed in the vehicle. Doing so may cause dust or debris to enter the HV Battery Case.
- Failure to secure the fan blades while cleaning can result in electronic circuit failure due to overturning.
