# BeSpoke Premium Audio Featuring Aha - Map Update Process

Service  
Category Audio/Visual/Telematics

Section Navigation/Multi Info Display

## Applicability

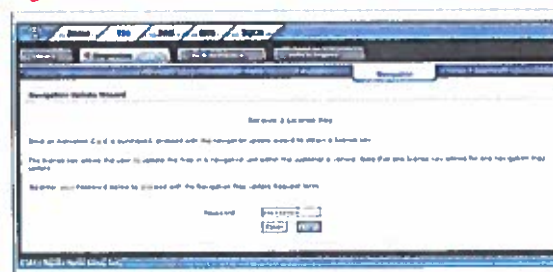
Figure 1.

1. Log into TIS.
2. Log into *Navigation Update Wizard*.
  - A. Click on the *TIS* tab.
  - B. Click on the *Diagnostics* tab.
  - C. Click on the *Navigation* tab.
  - D. Re-enter your password.
  - E. Click *Login*.

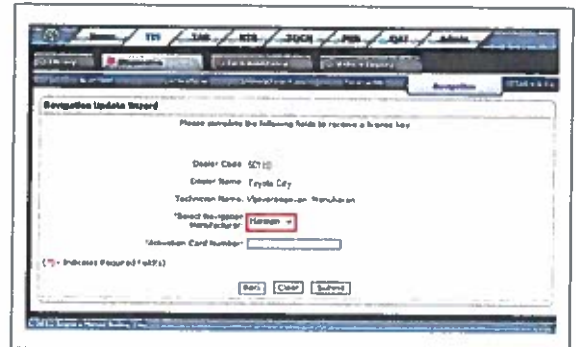
Figure 2.

3. Select *Harman* from the *Select Navigation Manufacturer* dropdown.

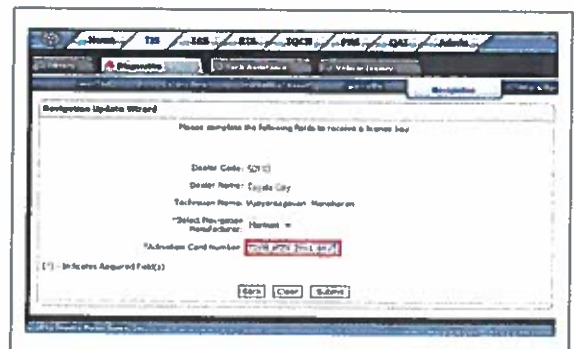
Figure 3.

4. Enter the *Activation Card Number* from the inside of the pamphlet (obtained from parts department).

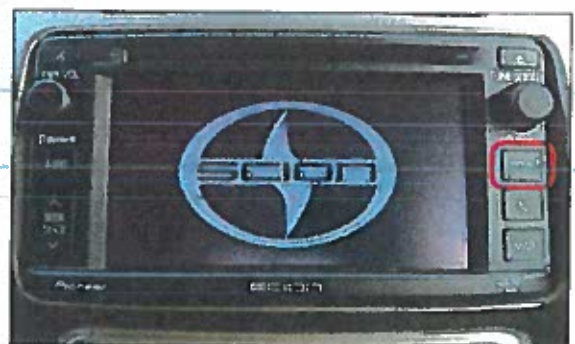
Figure 4.

5. Click *Submit*.
6. Cycle Ignition ON (Ready OFF/Engine OFF).
7. Press the *SETUP* button on the navigation head unit.

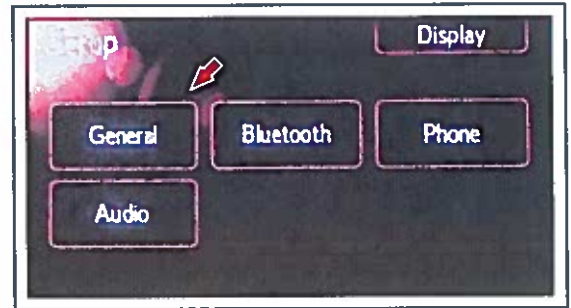
Figure 5.

8. Select *General*.

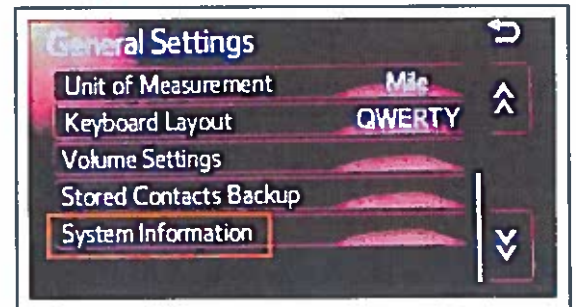
Figure 6.

9. Press the down arrow and then select *System Information*.

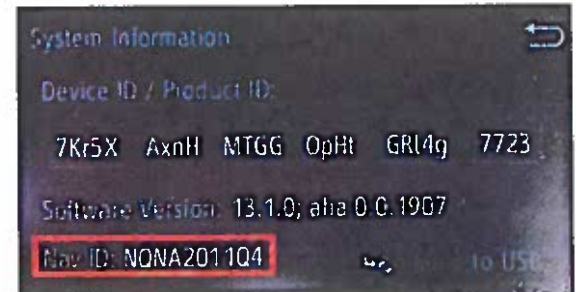
Figure 7.

10. Record the *Nav ID*, located on the bottom left of the navigation screen.

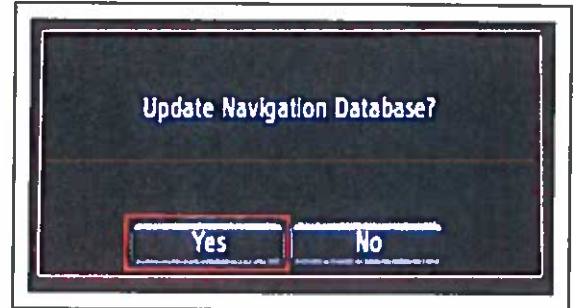
Figure 8.

12. Select Yes.

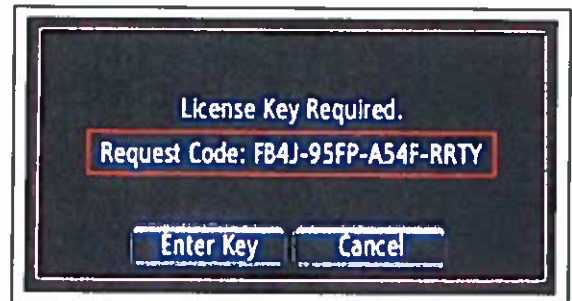
Figure 9.

13. Record the *Request Code* from the navigation screen.

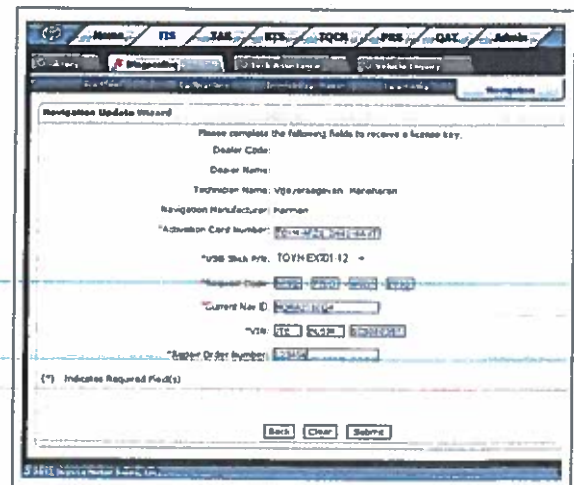
Figure 10.

14. Enter navigation data into the *Navigation Update Wizard* form.

- Select the correct USB part number (found on the SST packaging; starts with "SCIH").
- Input the *Request Code*.
- Input *Current Nav ID*.
- Input *VIN*.
- Input *Repair Order Number*.
- Click *Submit*.

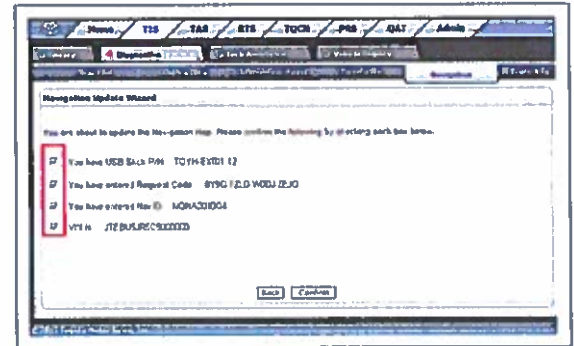
Figure 11.

15. Check off each item after confirming that it is correct. If any of the information is incorrect, click *Back*.

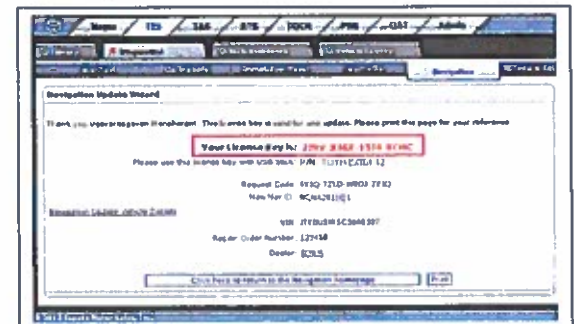
Figure 12.

16. Click *Confirm*.
17. Note the License Key that is generated (print this page if necessary).

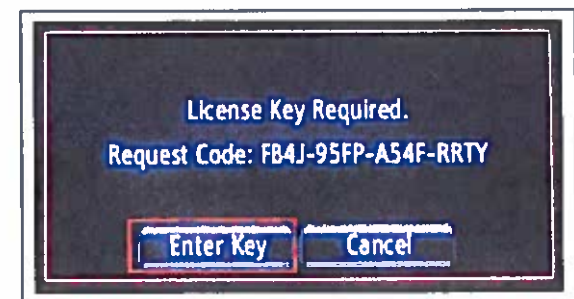
Figure 13.

18. Select *Enter Key*.

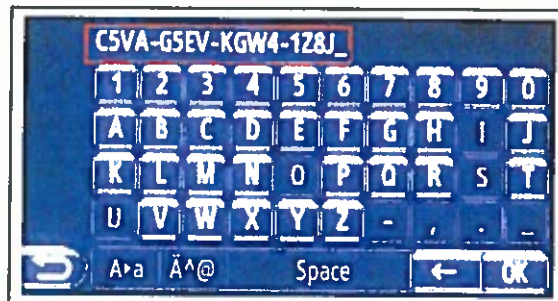
Figure 14.

19. Enter the License Key from step 17.

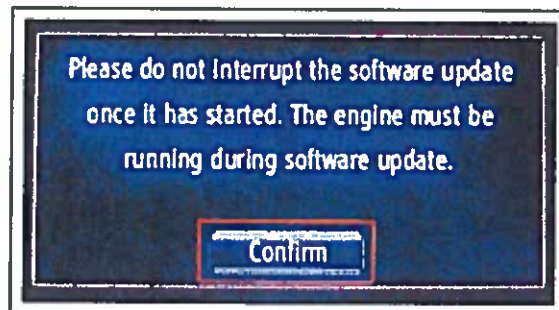
Figure 15.

20. Select OK.
21. Select Confirm.

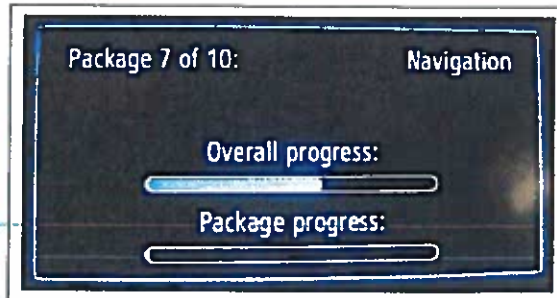
Figure 16.

22. Navigation Map Update will begin automatically. The installation will update 10 packages (includes system software and Gracenote® updates) during this process and will automatically advance through each update.

If a battery charger is connected to the vehicle to maintain constant voltage, the vehicle does NOT need to be running (ensure that the vehicle ignition is ON (Ready OFF/Engine OFF)).

This process will take about 35 minutes.

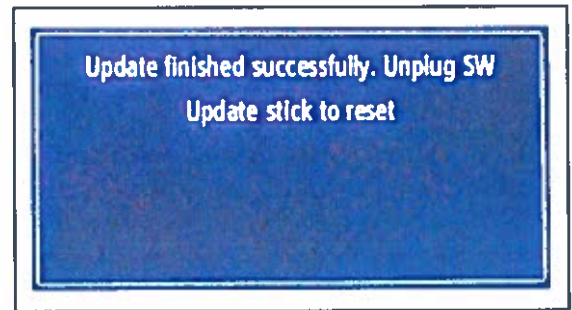
**Figure 17.**

23. Remove the USB Drive SST from the vehicle to complete the Map Update.
