Fuel Door Difficult to Open

Service
 Category Engine/Hybrid System

Section Fuel System

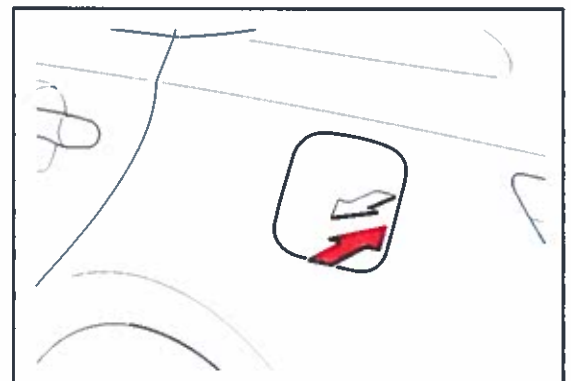
Figure 1.

1. Open the fuel door lid by pressing on the center of the rear edge of the fuel filler door.

- Doors must be unlocked to open the fuel door lid.
- If the fuel filler door cannot be opened by pressing the rear edge of the fuel filler, remove the cover inside the trunk, and pull the lever to manually unlock the fuel filler door.

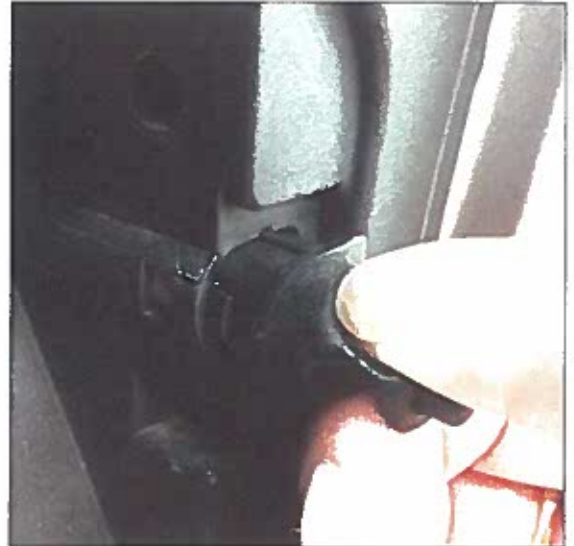
Figure 6.

- B. Push the Fuel Filler Opening Stopper Assembly all the way into position.

Ensure the Fuel Filler Opening Stopper is fully installed and the tab is engaged.
