Best practices when performing TSIB L-SB-0008-12

Brake (front)

2010-2014 LS460 FSPORT

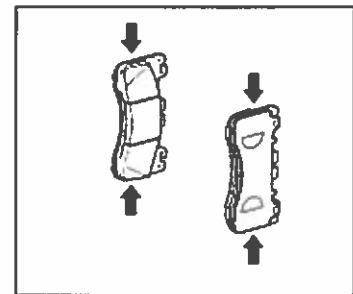
Application point of grease

1. Do not polish and/or grind the brake disc.
Also, do not replace the brake disc unless the disc thickness is less than 33.0 mm (1.30 in.).
2. Grease is included with the front disc brake pad kit. Apply a light coat of disc brake grease to the edges of the brake pads as shown in the illustration. And, ensure there is no oil and/or grease on the friction surfaces of the pads and the disc.
3. Make sure the single slotted pad is installed on the inside location of the brake disc.
