Subject	Navigation Micro SD Card Error		Market	USA
Service Category	Audio/Visual/Telematics		Section	Navigation/Multi Info Display
Applicability	Generation 8 Navigation

Navigation Micro SD Card Error

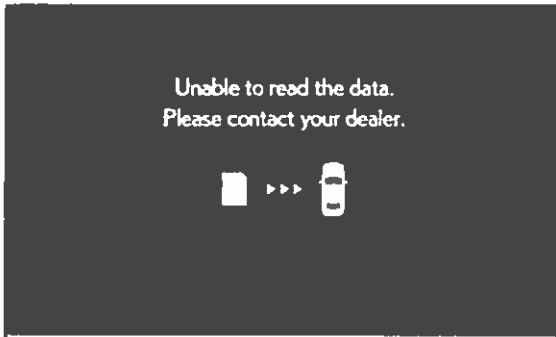
Navigation microSD card reads an error when missing or swapped from another vehicle.

Error message when micro SD card is swapped from another vehicle.

- Do not interchange mSD cards. Each mSD card is "paired" with head unit.
- Once an mSD card is paired with a vehicle, it may not be swapped into a different vehicle.
- A new mSD card is "unpaired" and becomes "paired" when inserted into a vehicle.
- Service exchange radios come in "unpaired" service mode and accept used mSD cards.
- If an mSD card is swapped, returning it to the original vehicle will remedy the problem.

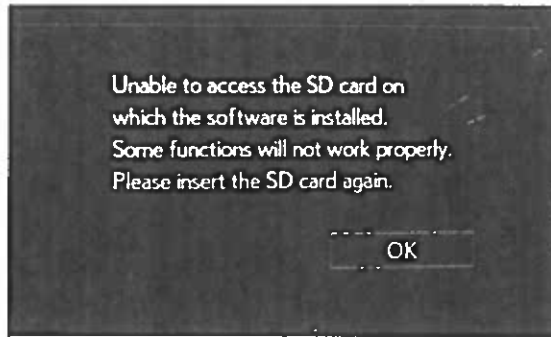
Error message when micro SD card is missing.
