Bulletin No.: PIP5241

## Service Bulletin

Subject: Appearance Of Cracks In Engine Block Deck Surface.

Models: 2013-2015 Buick Encore

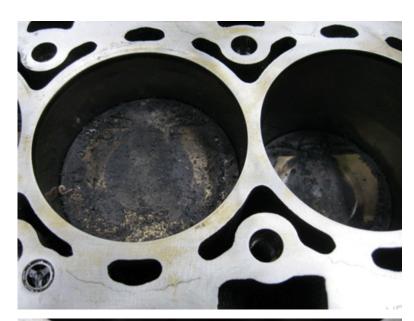
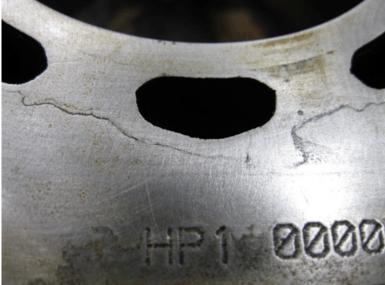
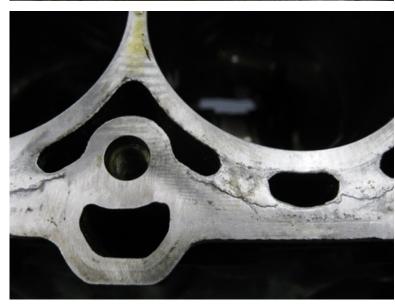
During engine block service, a technician using improper block deck cleaning methods may see lines in the block deck surface. (See photos below).

These lines may be mistaken for cracks.

These lines are the result of using abrasive pad / bristle devices to clean the gasket surface of the engine components. See the latest version of bulletin 00-06-01-012 for complete details on the use of these devices.

If slight traces of these lines are seen after using the proper gasket surface cleaning methods, they will not affect cylinder head gasket sealing.
