# Service Bulletin

File in Section: 08 - Body and Accessories

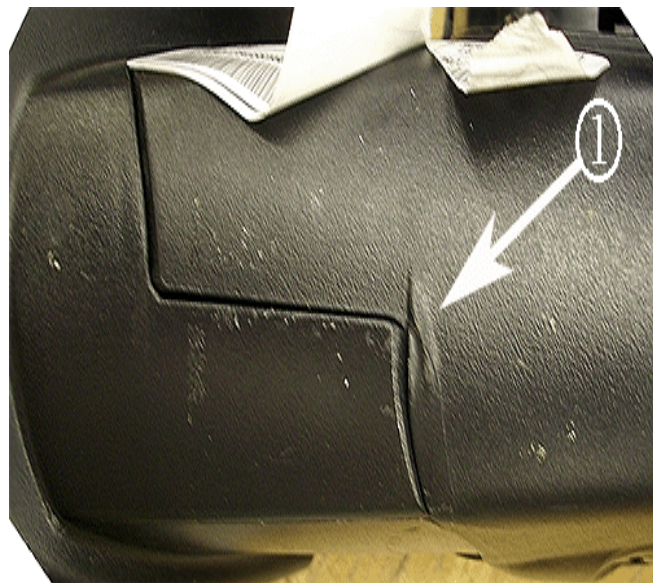
#### Distortion of the Mirror Arm

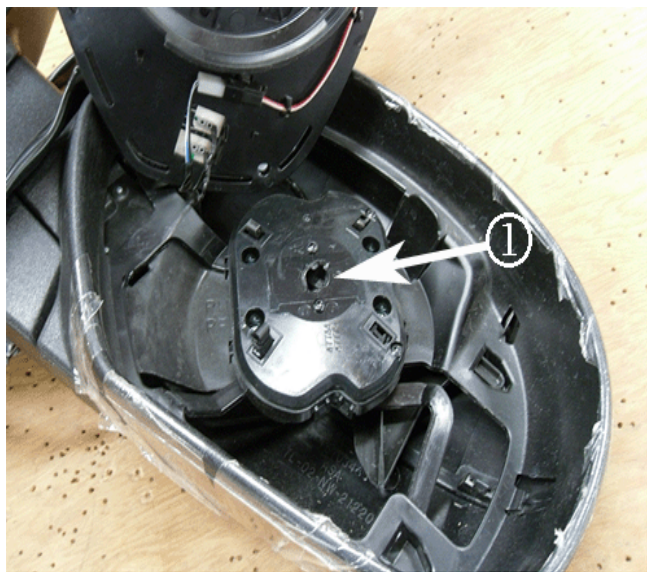
#### Glass Sheared Off the Actuator
