Applies To: **2003–05 Civic** – Check the iN VIN status for eligibility

January 17, 2014

Voluntary Driver's Airbag Study

(Supersedes 13-099, dated November 9, 2013, to revise the information marked by the black bars)

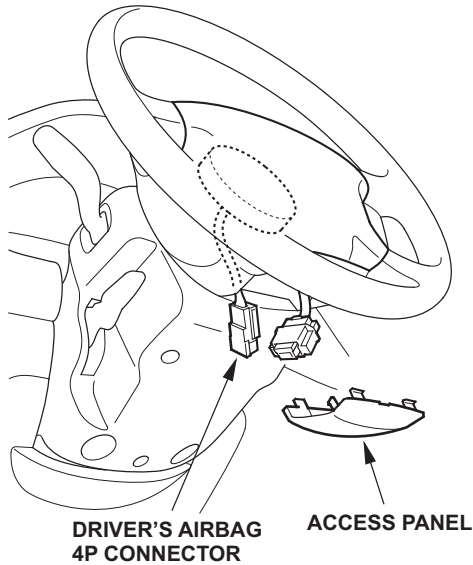
1. Make sure you have the audio or navigation unit anti-theft code before starting work.
2. Disconnect the negative battery cable, and wait at least 3 minutes before beginning work.
3. Remove the access panel from the steering wheel, then disconnect the driver's airbag 4P connector from the cable reel.

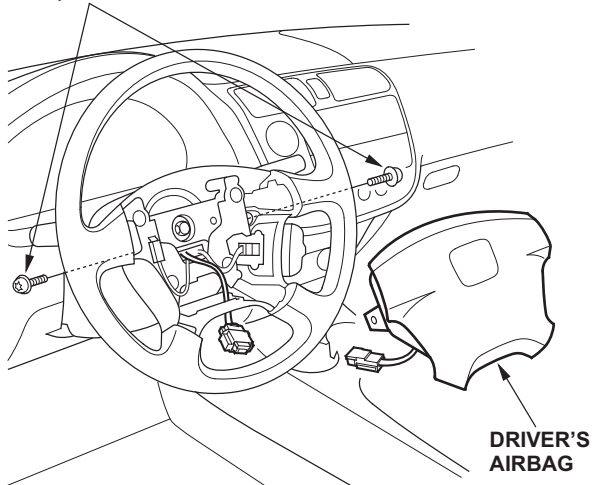
4. Remove the two Torx bolts using a Torx T30 bit, then remove the driver's airbag.

TORX BOLTS
9.8 N·m (7.2 lb-ft)
Replace.

13. Place the driver's airbag in the steering wheel, and secure it with new Torx bolts. Torque the Torx bolts to **9.8 N•m (7.2 ft-lb)**.

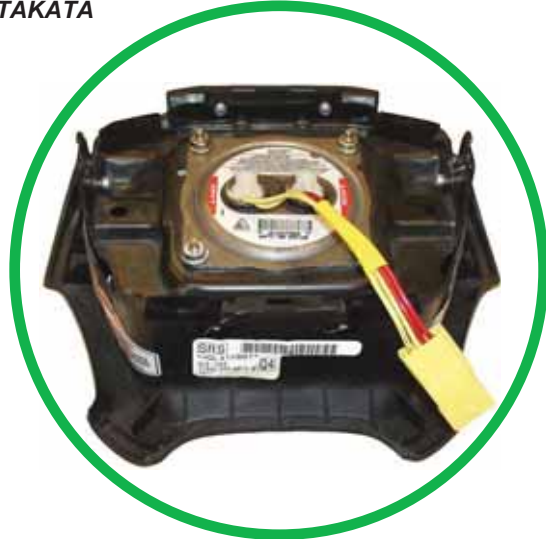
TAKATA

5. Compare the airbag to the images below to determine if the inflator is made by Autoliv or Takata.
 - If the airbag is made by Takata, go to step 6 to replace the inflator.
 - If the airbag is made by Autoliv, the airbag is not part of the study. Follow steps 13–17 to reinstall the airbag **using new Torx bolts**.

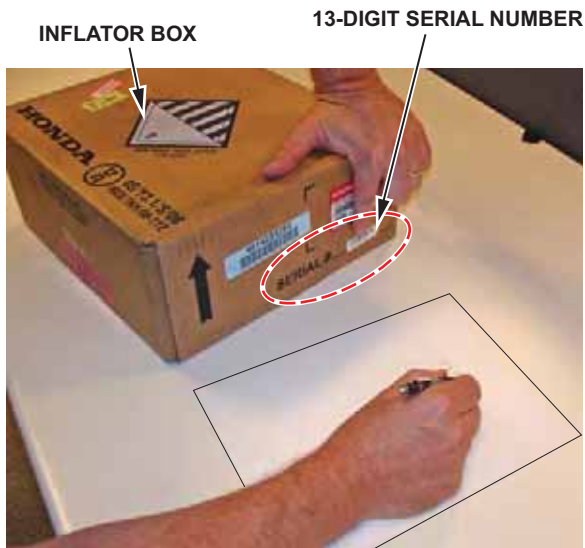
6. Write down the 13-digit serial number located on the right side of the new inflator's box. Your warranty clerk must enter this 13-digit serial number in the Diagnostic Trouble Codes field on the warranty claim.

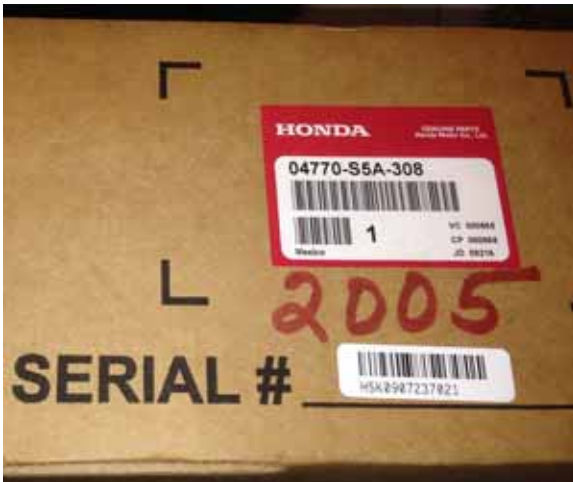
7. Write 2005 on the inflator's box close to the serial number.

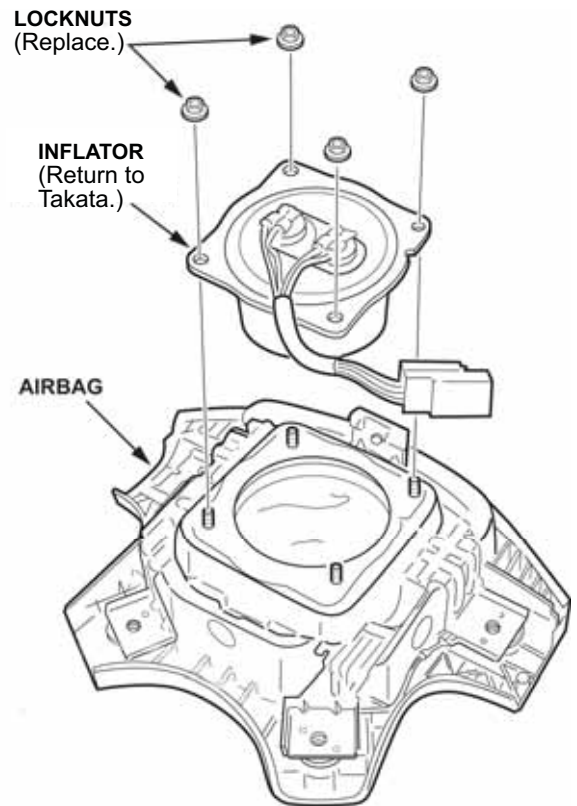
9. Using needle-nose vise grips, remove the four locknuts from the inflator. They will not be reused.
NOTE: Do not remove the inflator from the airbag until you complete step 10.

12. Install the new inflator in the airbag with new locknuts. Torque the locknuts to **3.9 N•m (2.8 ft-lb)**.
