This Service Information bulletin supersedes SI 36 01 13 **dated February 2013.**

**NEW** Steering Wheel Vibration at Speeds Between 37 and 80 mph

**NEW** F30 (3 Series Sedan)

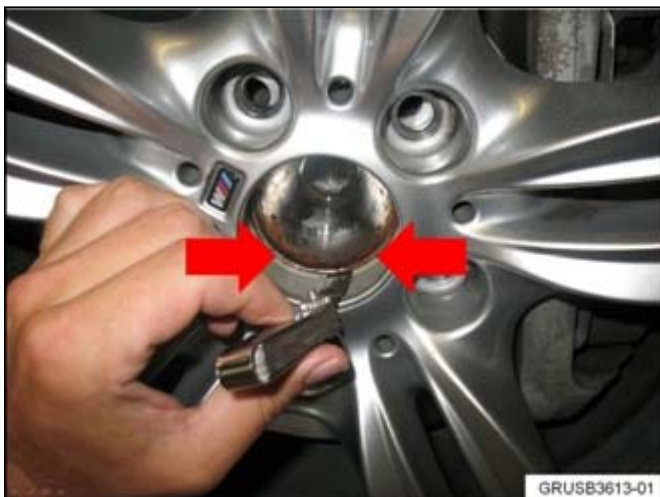
Check the wheel centering of the light-alloy rim on the wheel hub. To do so, clean the contact surfaces of the wheel hubs and the light-alloy rims, and only slightly tighten the wheels.

Using a feeler gauge at the bottom position, determine the maximum play. Play of 0.1 mm is still within the permissible tolerance. Play of 0.15 mm or greater is outside the permissible tolerance.

**Document the clearance check at each wheel.**

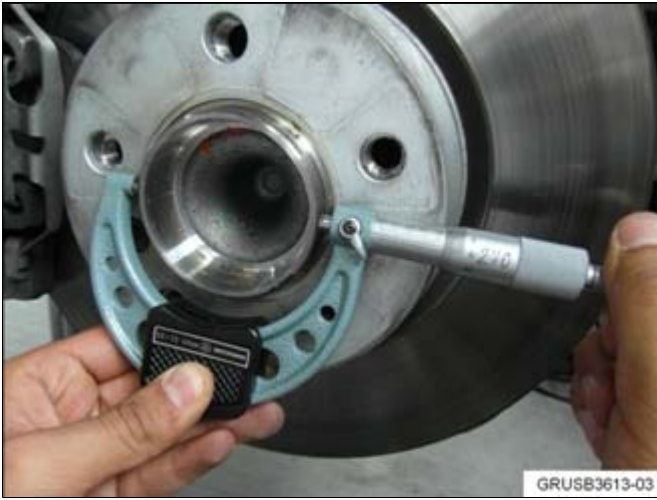
If there are tolerance variations, the affected components (wheel bearing/drive flange) must be measured individually. Nominal values for wheel bearing/drive flange: 72.47 mm-72.50 mm (caliper gauge measuring equipment)

If the tolerance is too great, the wheel bearing/drive flange must be replaced. If the tolerance is too great and the wheel bearing/drive flange is within tolerance, the corresponding rim(s) must be replaced.
