Engine Running or Starting Problems Due To Damage to DME

E84 (X1)

With the N20 engine

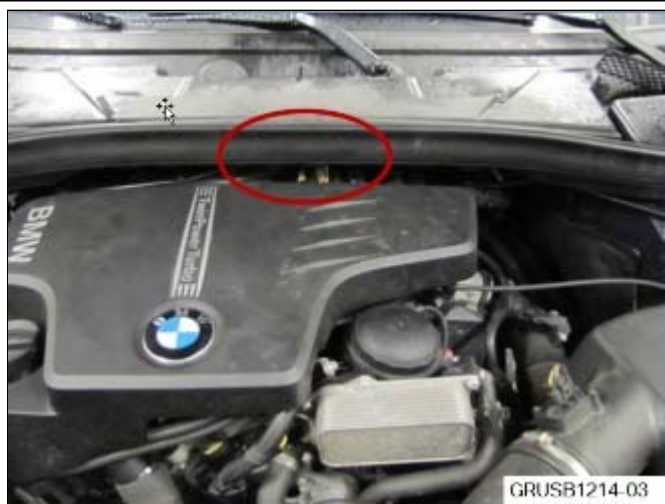
This is where the DME connectors are located.
Check that the engine cover, seal, and all cowl components are installed properly.

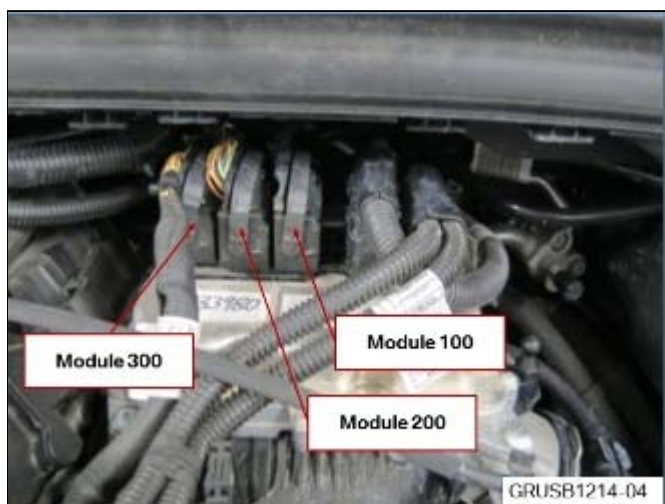
Modules 100, 200, and 300 need to be carefully inspected.

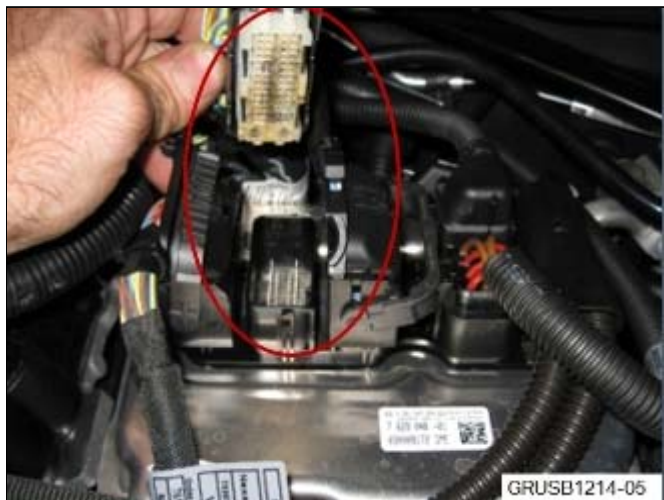
If corrosion or damage is found, the DME and affected engine harness module(s) need to be replaced.

Sealing improvements to the DME harness connectors for Modules 100, 200, and 300 were introduced into vehicle production beginning on 3/16/2014.

The sealing improvements have also been included for the engine harness module replacement parts.
