US 12671805-02

On-board computer's ambient temperature reading too high

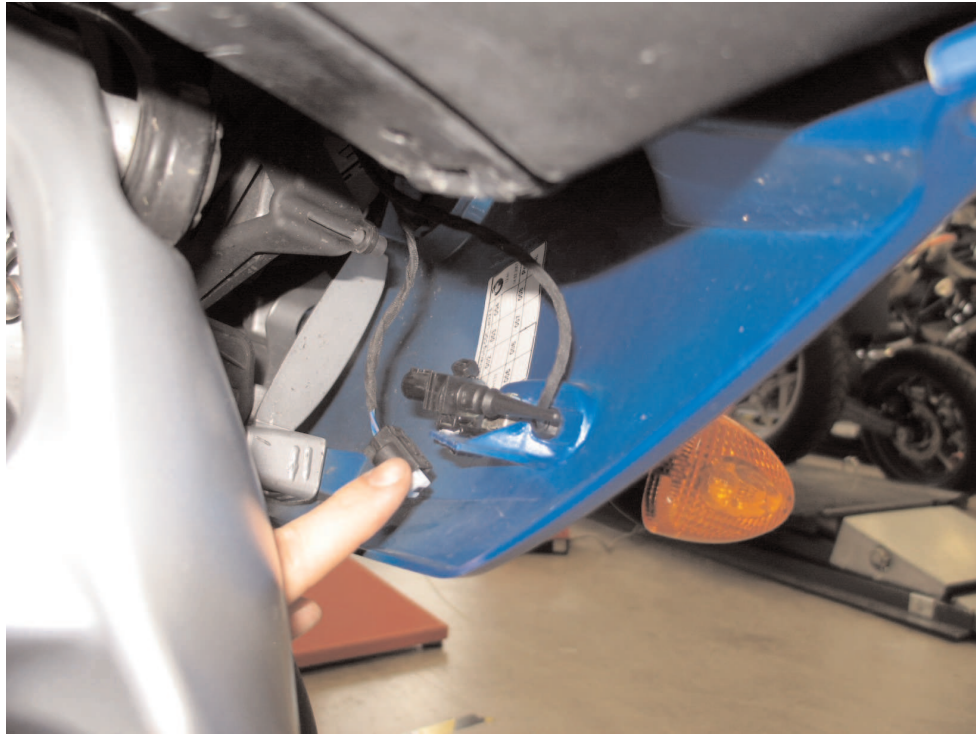
Figure 1

3. Disconnect connector X9007 from the temperature sensor, see Figure 1.

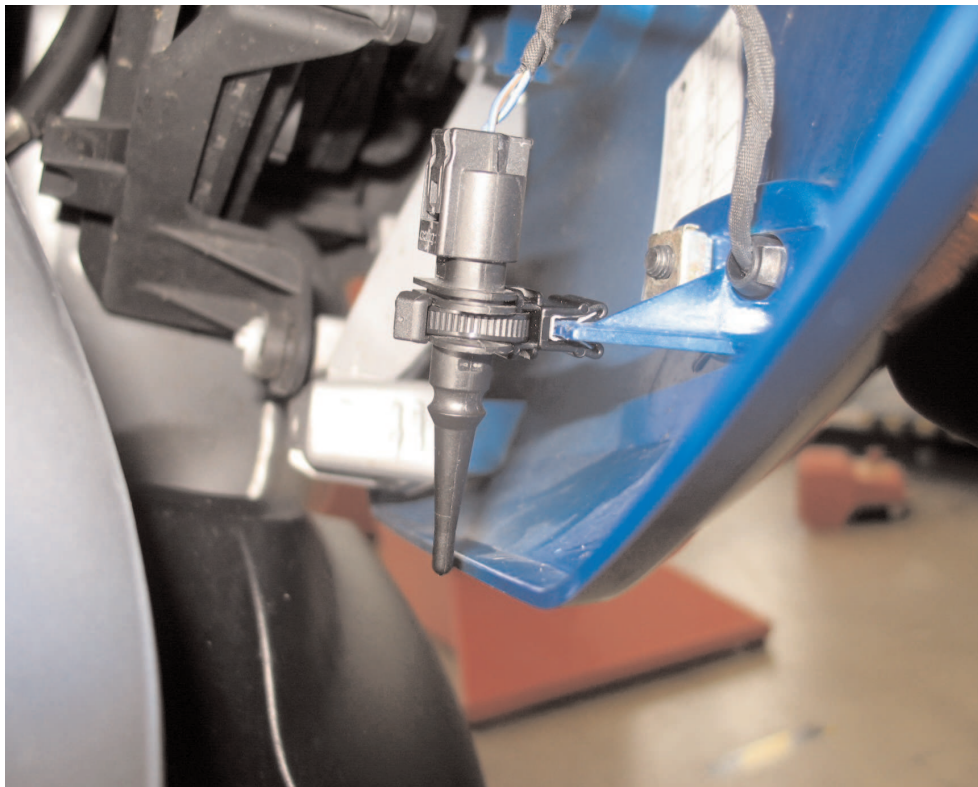
5. Secure the temperature sensor to new retaining clip 61 13 6 915 982, see Figure 2
