## Noises from flat spring core in backrest

Topic number	LI91.10-P-059387
Version	1
Design group	91.10 Front seats
Date	07-12-2014
Validity	Model series 204 up to VIN .....A108622 F105087 R014455
Reason for change	Validity and damage code updated
Reason for block

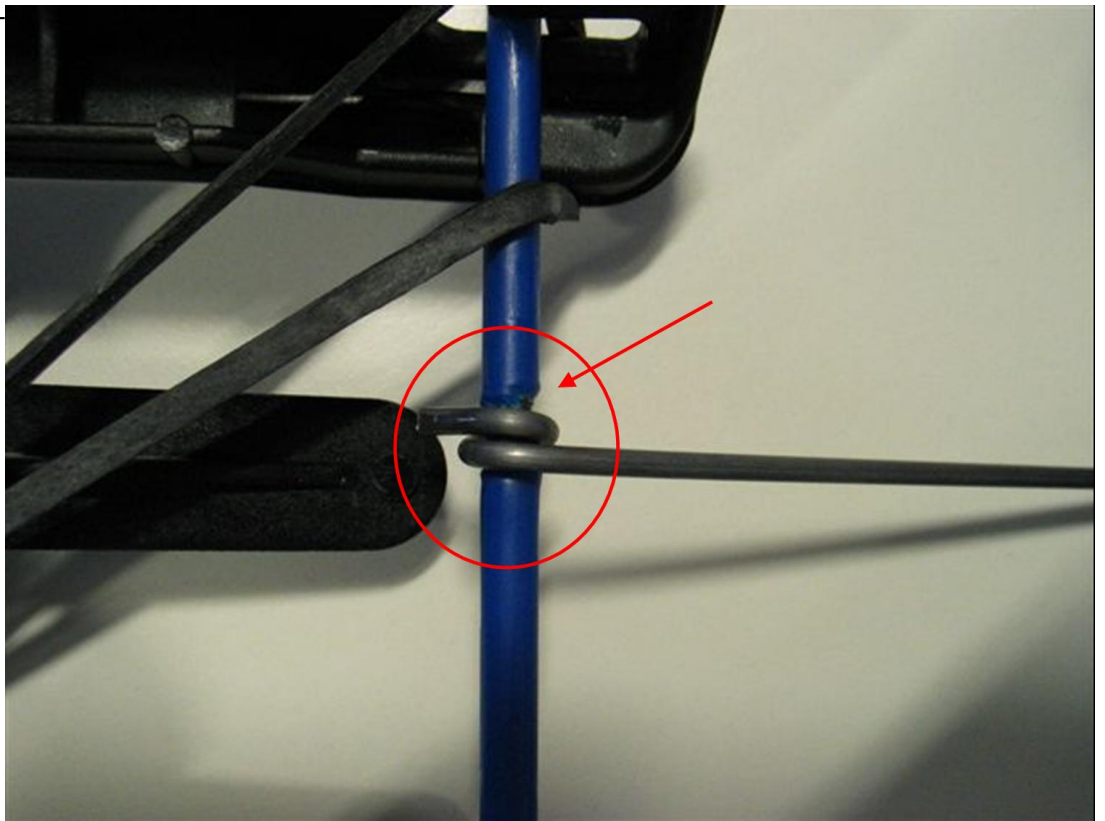
Quetschung\_an\_Umman-  
telung\_1.jpg:

The blue sheathing on the vertical wires of the flat spring core may exhibit crush marks at the connecting points with the horizontal wires. If this is the case, there is direct contact between the metal wires. This chafing effect can produce noises.

Attachments	
File	Description
Quetschung_an_Ummantelung_1.jpg	Crush marks on blue wire sheathing
Quetschung_an_Ummantelung_2.jpg	Crush marks on blue wire sheathing

1. Detach seat-back lining.
2. Apply lubricant to nodes of spring mat wires.
