Humming noise from engine compartment

Topic number	LI43.05-P-058344
Version	1
Design group	43.05 Vacuum pump
Date	01-31-2014
Validity	G 500, G 65 AMG as of code XZ2
Reason for change	
Reason for block

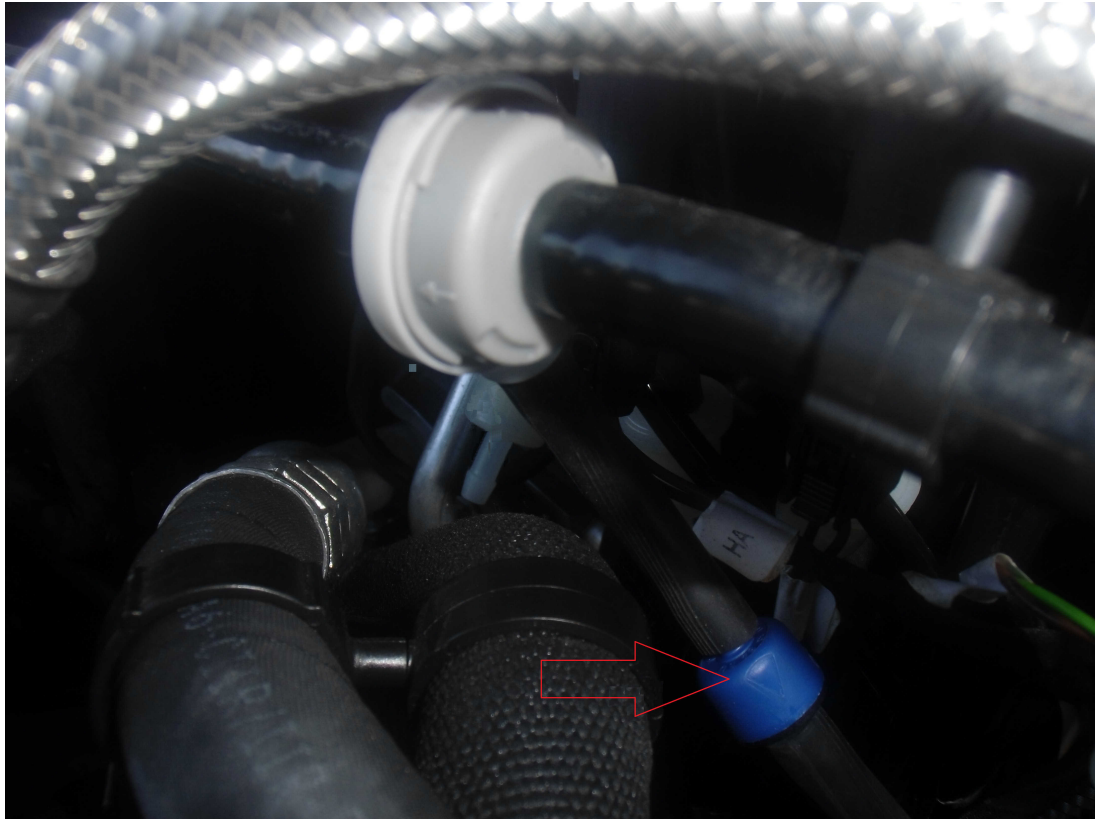
Durchflussrichtung.jpg:

Attachments	
File	Designation
Durchflussrichtung.jpg	Valve flow direction
Verbauort.jpg	Installation location

Part number	ES1	ES2	Designation	Quantity	Note	EPC	Other ma- ke part
A 002 140 84 60			Valve	1	Flow direction to pump.	X

Install check valve as shown in the attached pictures.

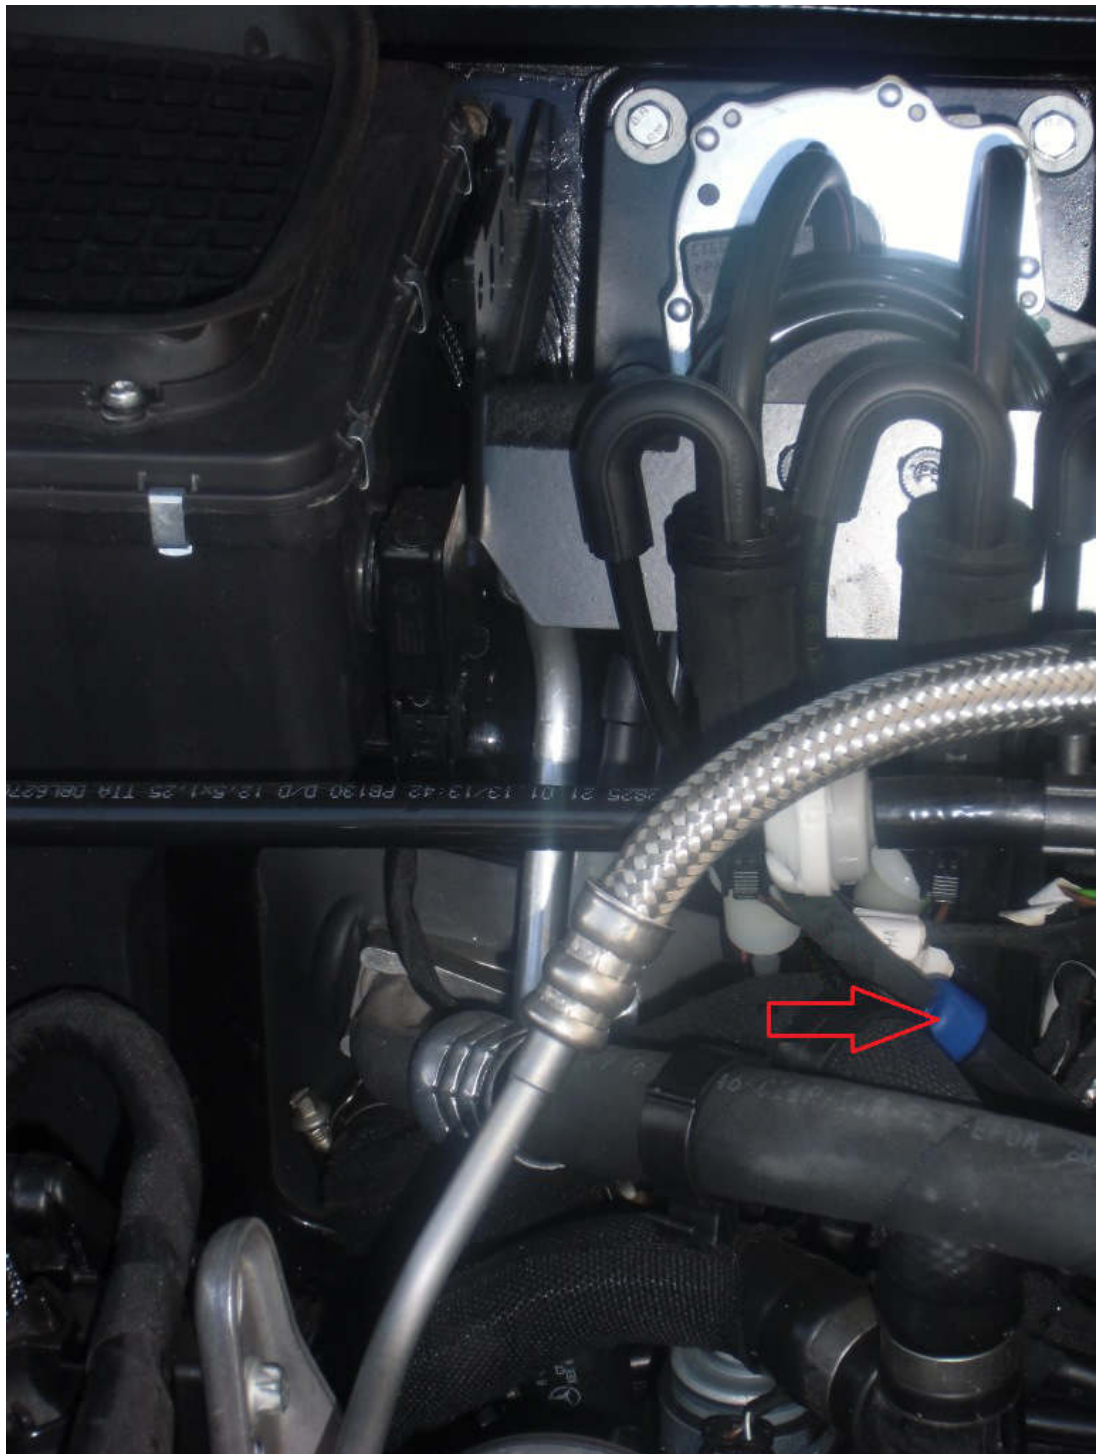
Verbauort.jpg:

Interlock switch vacuum pump runs constantly, check valve missing.
