L83X-
A.07.14
+
L83X-
A.08.14

Coolers and air ducts replacement

All Lamborghini Model Aventador LP-700 MY 12 13 e 14 Coupè e Roadster from VIN CLA00091 to VIN ELA02377.

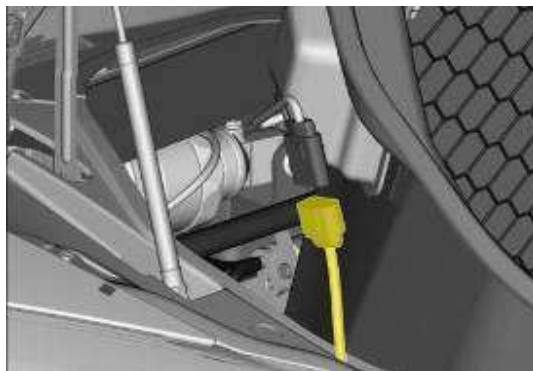
Lift trunk and disconnect plug from the 12V socket.

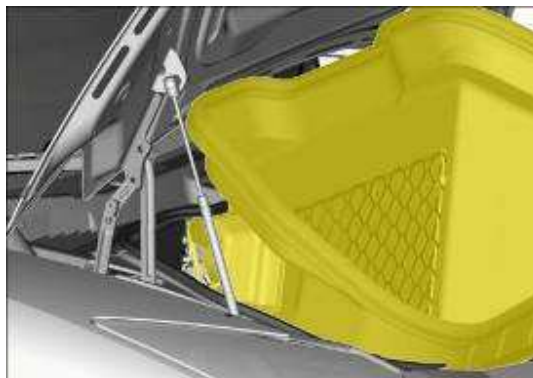
Remove trunk to get access to battery.

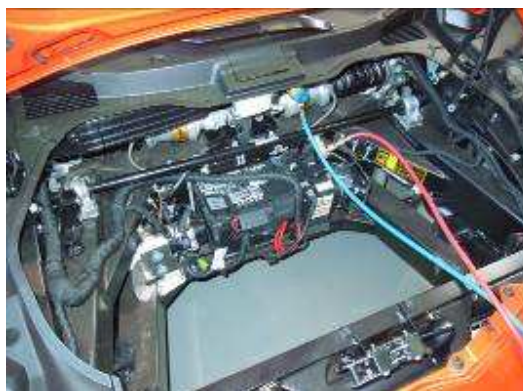
4. A/C system discharge.

- Connect hoses of A/C charging station to vehicle through HP and LP quick connectors.
- Operate phase of refrigerant fluid savage.

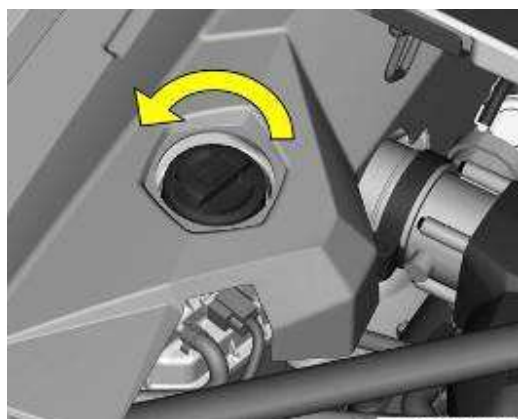
9. Cooling system draining.

Twist coolant cap off .

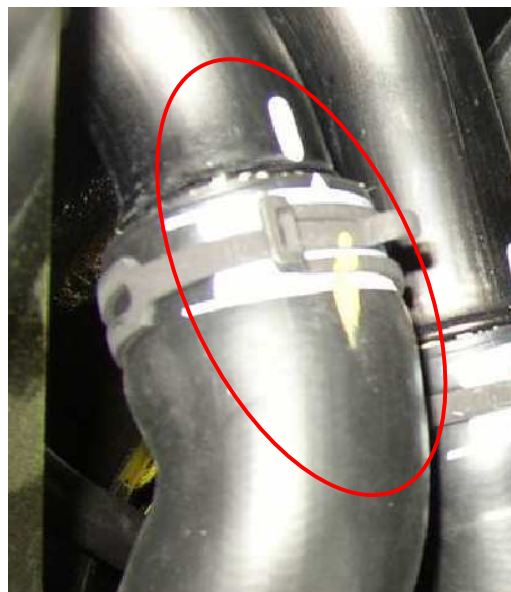
During reassembly align marks respectively present on radiator and pipe, to install component as it was in origin. **If any marks are present**, use a **marker pen** to sign them before disassembly.

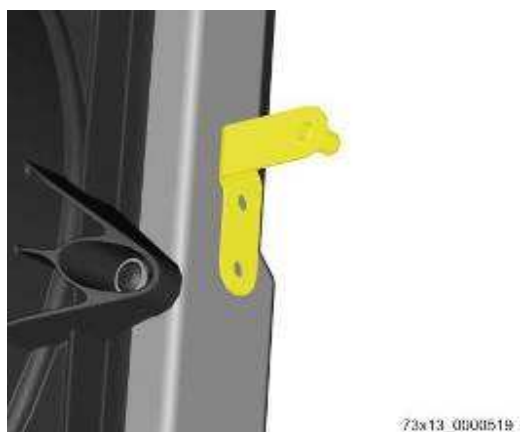
12. Disassembly of left radiator assembly and cooler replacement.

Remove 2 screws that holds clamp mount and free cooler mount.

Screw tightening.

Torque: **10Nm.**

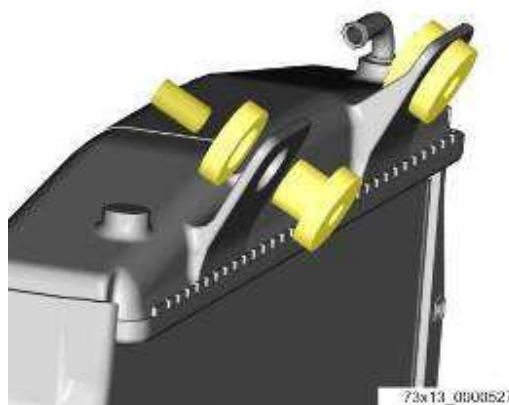
Remove washer, buffers, spacers and brackets which fix cooler to chassis.

Now replace cooler.

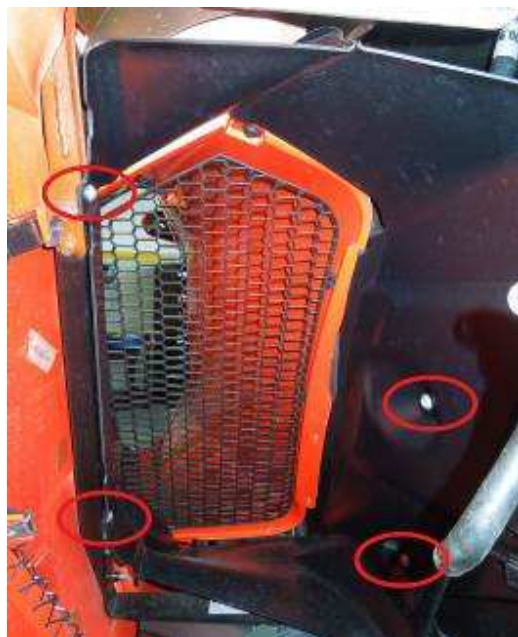
13. Air duct disassembly.

Remove 4 screws and take component off.

Screw tightening.

Torque: **9Nm**

Replace air duct .

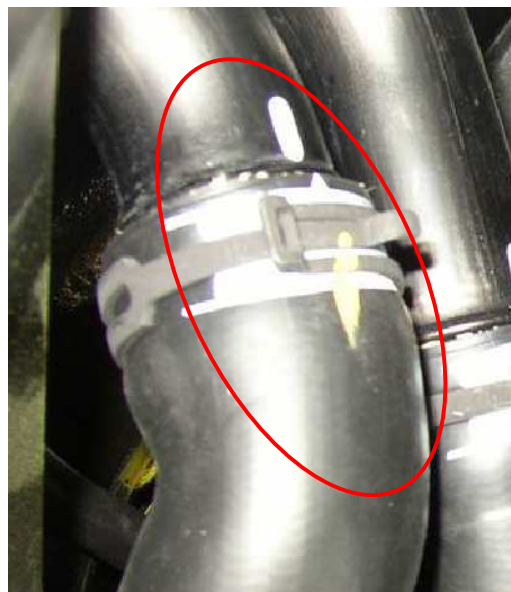
During reassembly align marks respectively present on radiator and pipe, to install component as it was in origin. **If any marks are present, use a marker pen to sign them before disassembly.**

Replace at each reassembly **cable clamps**

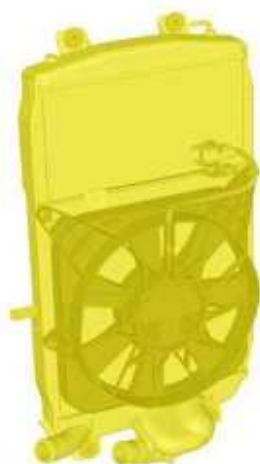
73x13_0000517

Now remove right radiator assembly that includes electric fan, cable clamp bracket, washers, spacers, buffers and condenser; now it is necessary to disassembly in to parts to replace cooler.

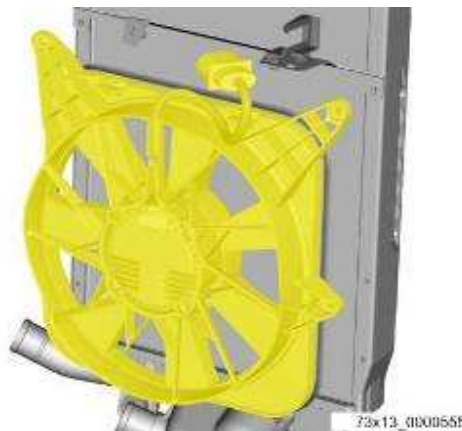
18. Disassembly of left radiator assembly.

Disconnect wiring harness plug and remove 4 screws and separate electric fan from radiator assembly, then remove bracket plug.

Screw tightening.

Torque: **10 Nm**

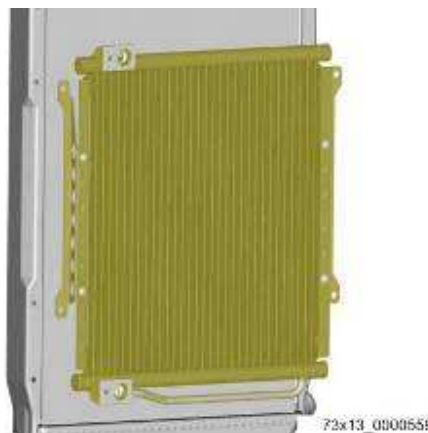
73x13_0000559

Remove 4 screws that hold condenser and separate it from radiator assembly.

Screw tightening.

Torque: **5 Nm.**

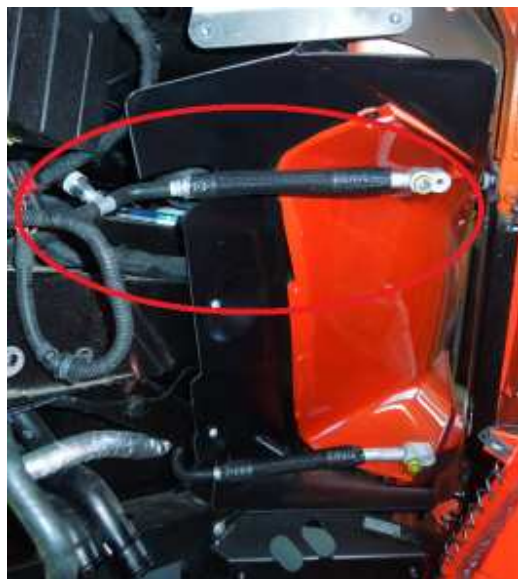
19. Air duct disassembly .

To remove easily left duct, release from chassis and remove a part of air conditioning hose.

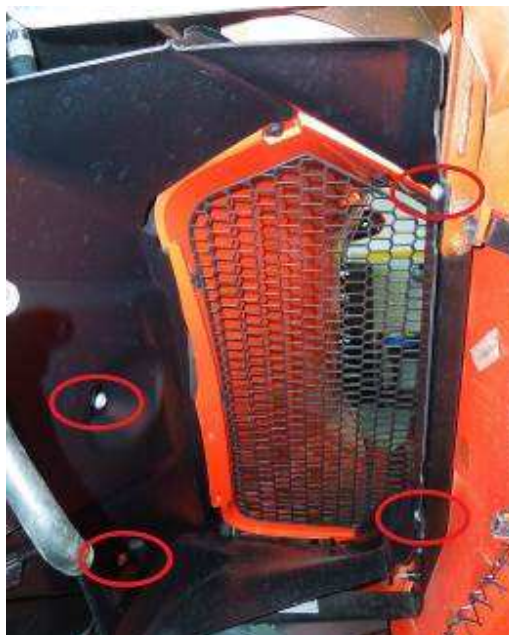
Remove 4 screws that hold duct and separate it from vehicle.

Screw tightening.
Torque: **9Nm**

Replace air duct .
