L83X-  
A.09.14  
+  
L83X-  
A.10.14

**To:** Official After Sales Network  
**Subject:** Air duct update.  
**Date:** 11<sup>th</sup>/07/2014  
**Pages:** 10

Air duct update.

All Lamborghini Model Aventador Coupè Roadster MY 12,13 and 14 from VIN CLA00091 to VIN ELA02533.

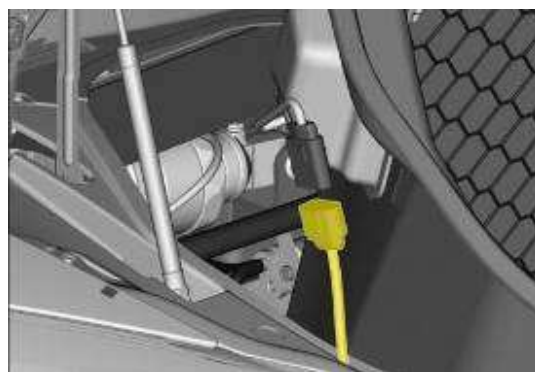
Lift trunk and disconnect plug from the 12V socket.

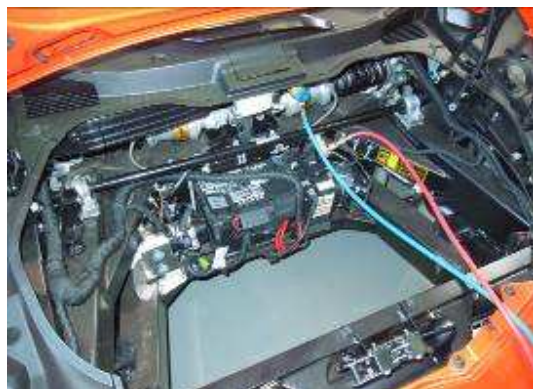
4. A/C system discharge.

- Connect hoses of A/C charging station to vehicle through HP and LP quick connectors.

- Operate phase of refrigerant fluid savage.

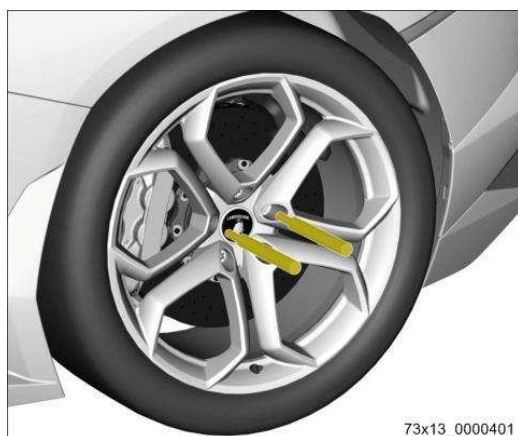
5. Rear tire disassembly.

In order to avoid rims and brake discs damages use centering tool (p/n. 65395009) as shown in picture. This procedure must be performed on both sides.

Wheel bolt tightening.  
Torque: **160 Nm**

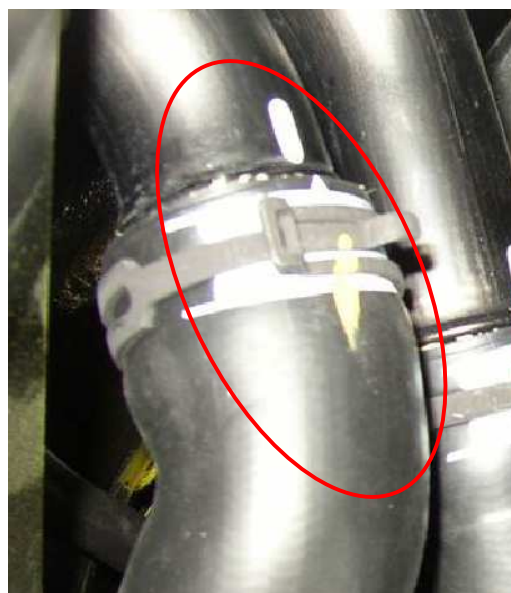
During reassembly align marks respectively present on radiator and pipe, to install component as it was in origin. **If any marks are present**, use a **marker pen** to sign them **before disassembly**.

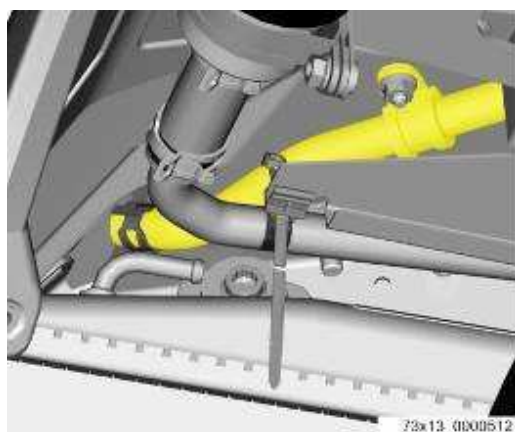
Open 2 cable clamps of coolant lines still connected to cooler and extract two pipes..

**Replace** at each reassembly **cable clamps**

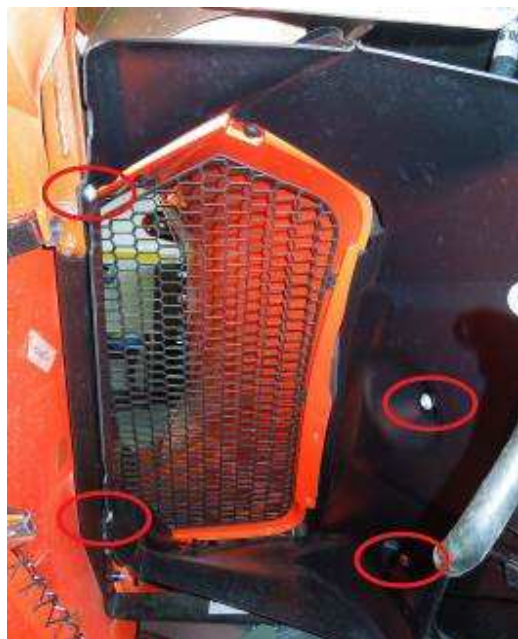
12. Air duct disassembly.

Remove 4 screws and take component off.

Screw tightening.  
Torque: **9Nm**

Replace air duct.

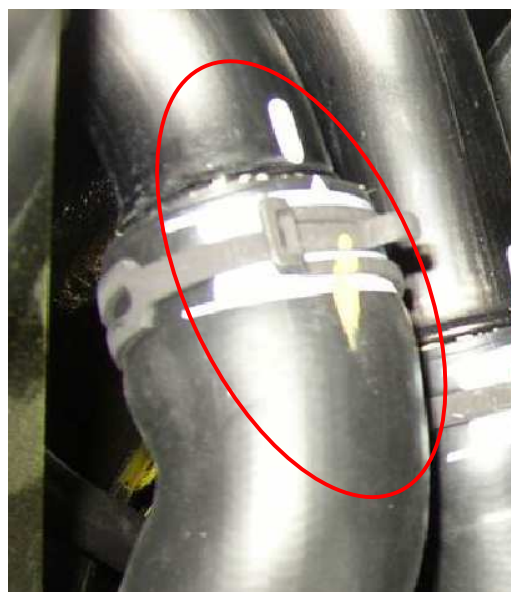
During reassembly align marks respectively present on radiator and pipe, to install component as it was in origin. **If any marks are present, use a marker pen to sign them before disassembly.**

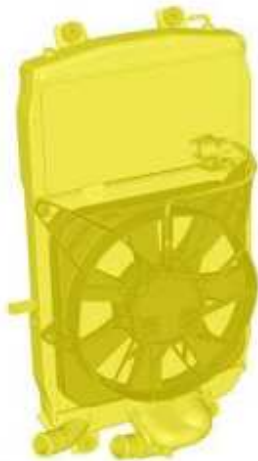
73x13\_0000517

Now remove right radiator assembly that includes electric fan, cable clamp bracket, washers, spacers, buffers and condenser.

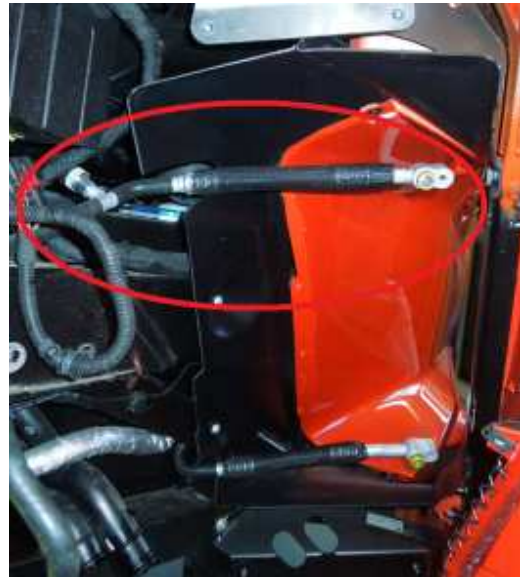
### 17. Air duct disassembly.

To remove easily left duct, release from chassis and remove a part of air conditioning hose.

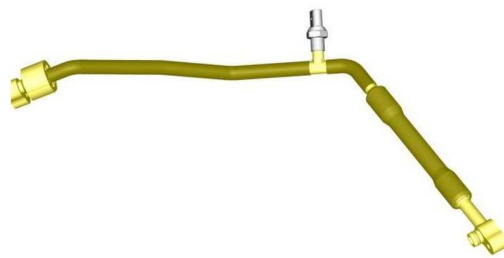
73x13\_0003509

Disconnect plug of pressure switch.

Release cable clamp that fix it to chassis.

At last remove screw that fix hose and then take it off.

Screw tightening.  
Torque:: **9Nm**

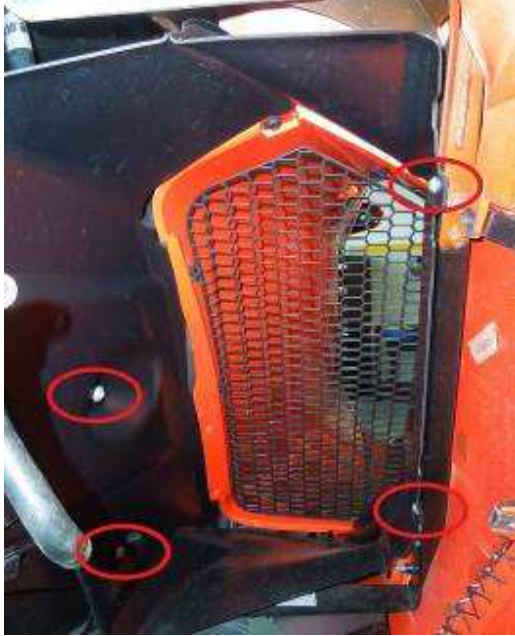
Remove 4 screws that hold duct and separate it from vehicle.

Screw tightening.  
Torque:**9Nm**

Replace air duct.
