SERVICE BULLETIN

AT13-016a
 NTB13-077a
 August 18, 2014

CVT FLUID LEVEL CHECK SERVICE INFORMATION

APPLIED VEHICLES: 2013-2015 Pathfinder (R52) 2013-2015 Altima Sedan (L33)

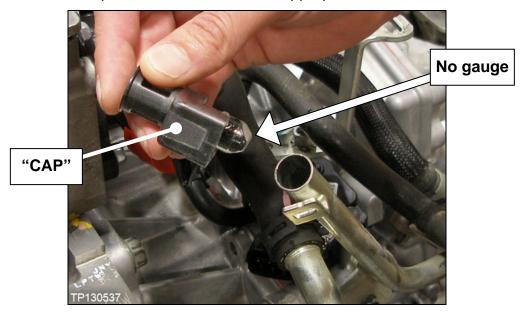
Applied vehicles equipped with a CVT have a "cap" that appears to be a fluid level gauge. This "cap" will NOT have a gauge or "dipstick". This is normal. Do NOT replace the "cap" because it is thought to have a "dipstick".

The fluid level is not checked from this location. The fluid level for applied vehicles is checked from the oil pan (refer to the appropriate section of the Electronic Service Manual (ESM)). Whenever checking, filling, or topping off a CVT's fluid level of an applied vehicle for any reason, use the procedure outlined in the appropriate section of the ESM.
