SERVICE BULLETIN

Classification: EL14-044	Reference: NTB14-098	Date: October 13, 2014
-----------------------------	-------------------------	---------------------------

2014 ROGUE; DTE DOES NOT RESET AFTER BATTERY DISCONNECT/DISCHARGE AND THEN REFUEL

APPLIED VEHICLES: 2014 Rogue (T32)

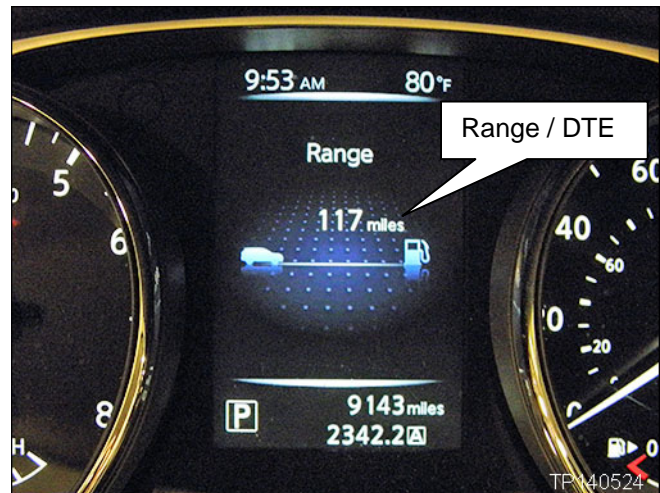
- The battery was disconnected, or the battery was discharged, and then after reconnecting or recharging the battery
- Fuel was added to the fuel tank, and then after adding fuel
- The Range or DTE (Distance To Empty) reading on the Vehicle Information Display did not reset.

NOTE: If the above incident should occur, the Range/DTE will reset and function correctly after the 2nd and subsequent refueling.

Reprogram the Vehicle Information Display (METER/M&A) per the Service Procedure in this bulletin.
