TECHNICAL BULLETIN  
LTB00566NAS3  
07 APR 2014

Fuel Gauge Operation Inaccurate

**Situation:** The fuel gauge may be inoperative or inaccurate.

**Cause:** These issues may be caused by fretting corrosion across the fuel sender harness pins inside the fuel tank.

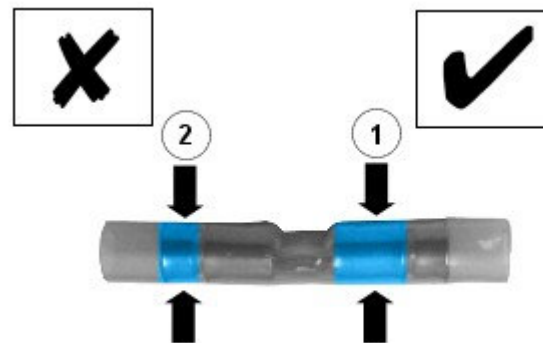
E155408

When installing the splices, make sure that the splice is crimped in the correct location.

- 'Tick' / '1' - correct crimp location.
- 'X' / '2' - incorrect crimp location.

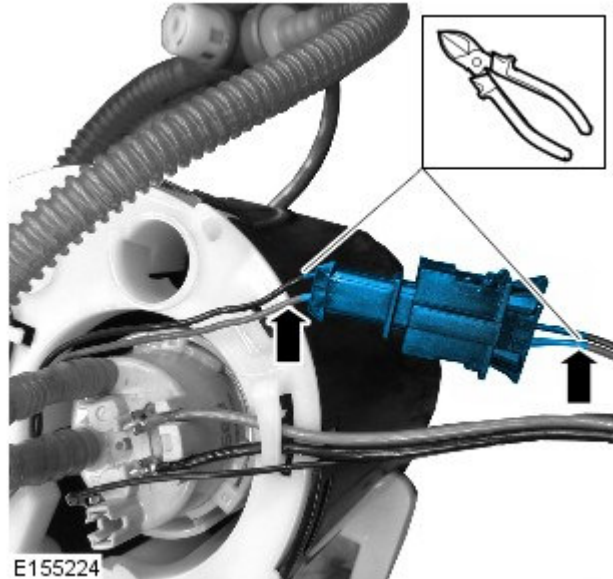
Identify a black two-pin connector to be removed.

- Cut wiring as close to the connector as possible.

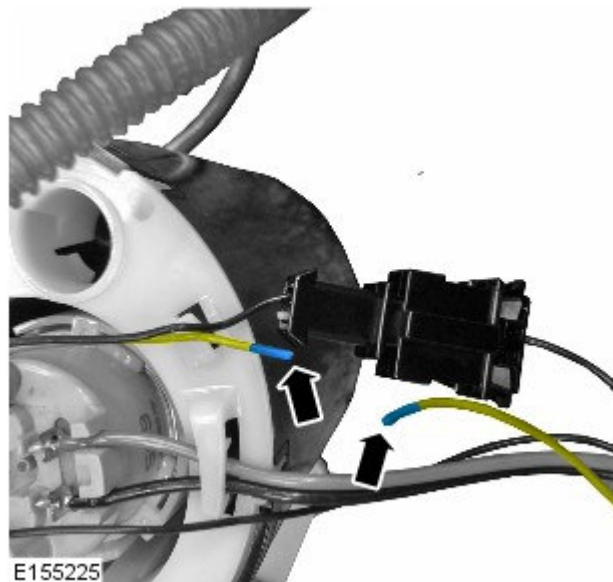
5. Using a suitable tool, remove 5mm of insulation from the end of each wire.

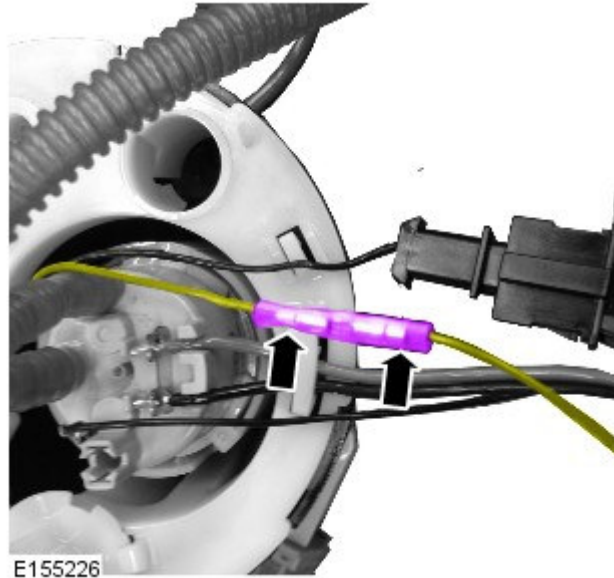
E155226

Using Crimping Tool 418-116A / YRW500010, install and crimp a splice to the ends of each wire.

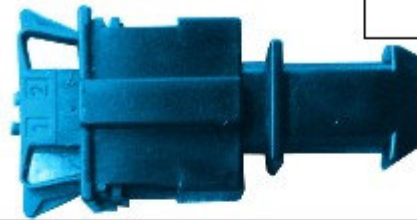
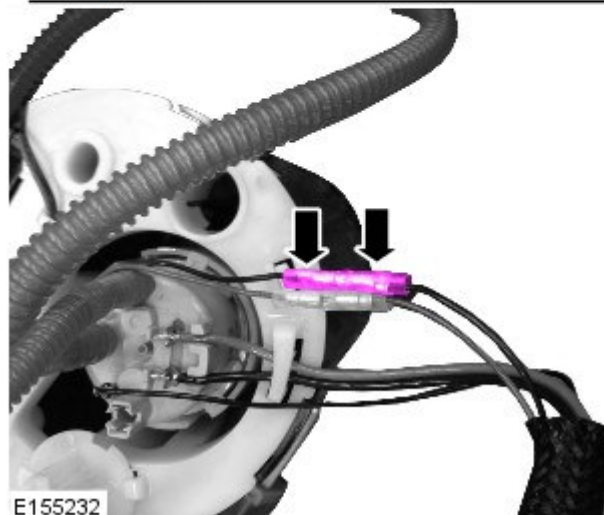
E155232

**7.** Repeat steps 5-6 to the other wire in the connector.

- Discard the connector.

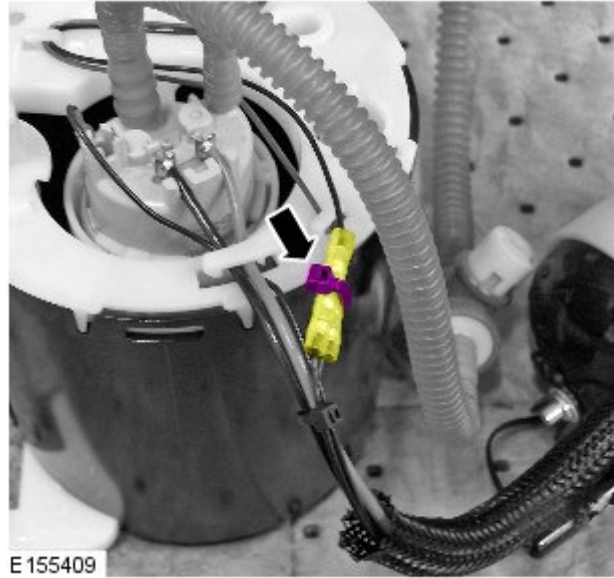
**9.** Using a suitable tie strap, secure the two splices together.

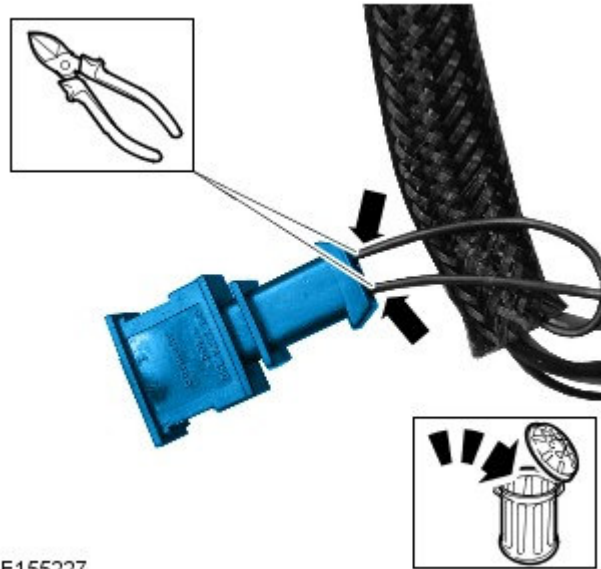
Identify the ground connector (two black wires) to be removed.

- Cut wiring as close to the connector as possible.
- Discard the connector.

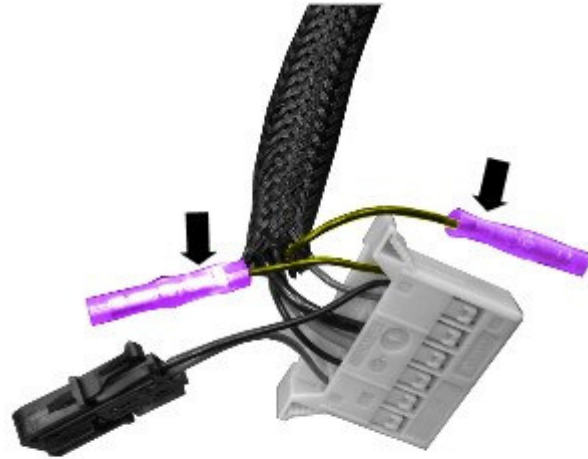
E155228

Using Crimping Tool 418-116A / YRW500010, install and crimp a splice to the end of each wire.

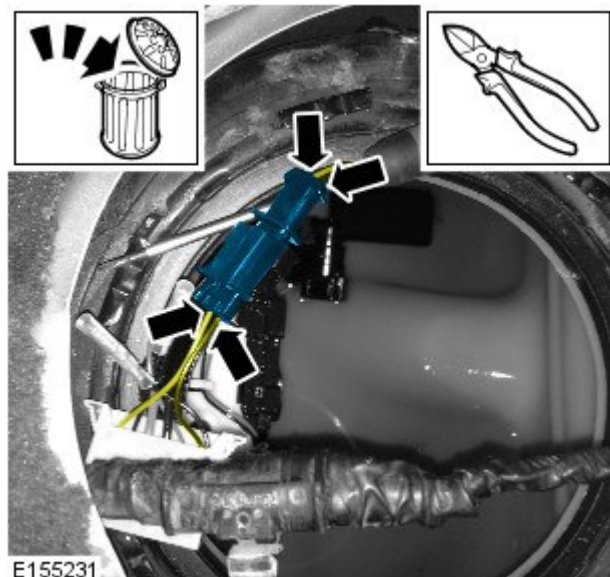
E155231

Identify the connector to be removed.

- Carefully withdraw the connector out of the tank.
- Cut the wires shown as close to the connector as possible.
- Discard the connector.

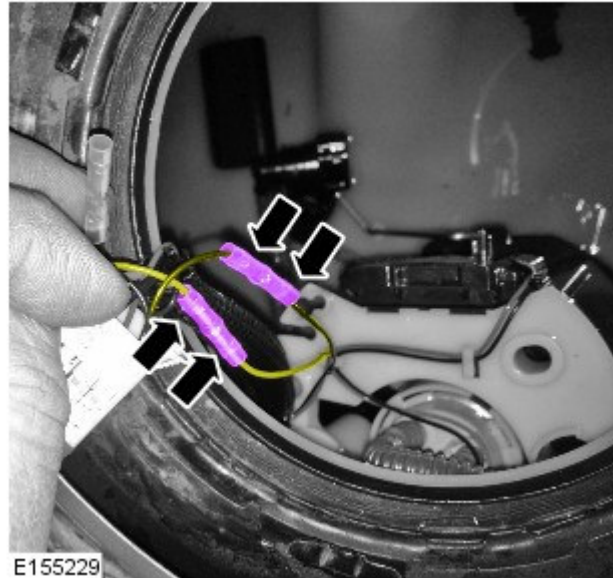
Using a suitable tool, remove 5mm of insulation from the end of each wire.

- Using Crimping Tool 418-116A / YRW500010, install and crimp a splice to the ends of each

- wire.
- Using a suitable tie strap, secure the two splices together.

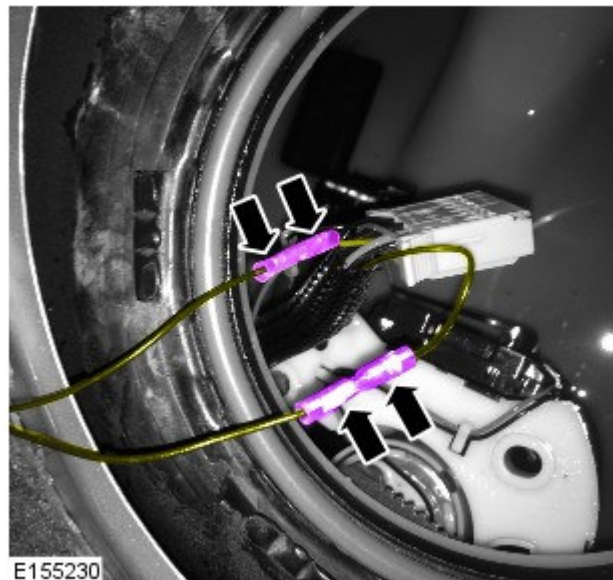
Connect the two ground wires from the base of the fuel tank flange to the two splices installed in step 12.

- Position the fuel tank flange close to the fuel tank.
- Using a suitable tool, remove 5mm of insulation from the end of each wire.
- Using Crimping Tool 418-116A / YRW500010, install and crimp a splice to the ends of each wire.
- Using a suitable tie strap, secure the two splices together.
