# TECHNICAL BULLETIN

## LTB00631NAS2

#### Compact Key Handset - Lower-Level Service Repair

**Situation:** The face of the compact key handset may peel away from the handset main body or the handset case may be bulging.

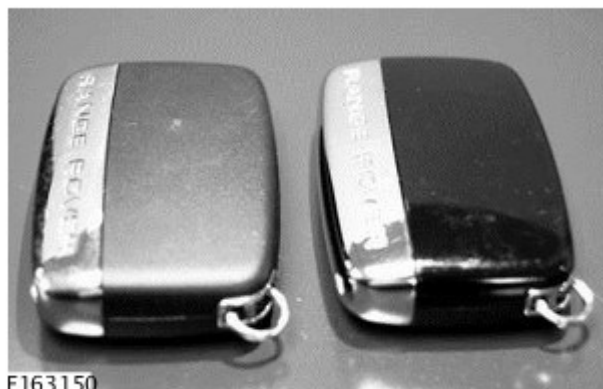
1. Identify the type of compact key handset currently fitted to the vehicle to ensure a like-for-like replacement handset is fitted:

- Left = matte finish.
- Right = gloss finish.

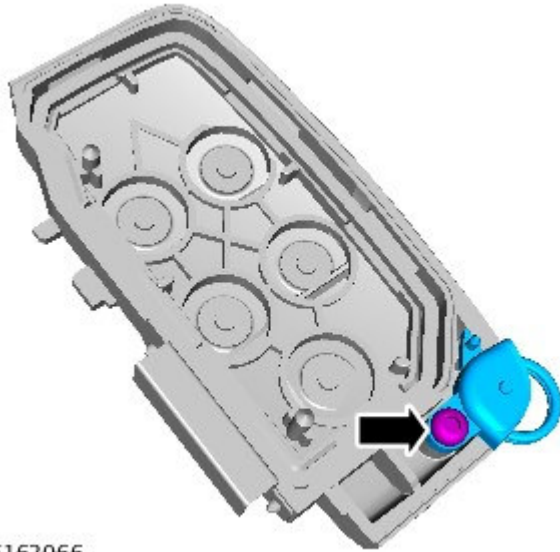
E162066

8. Remove the key ring retainer; place to one side.

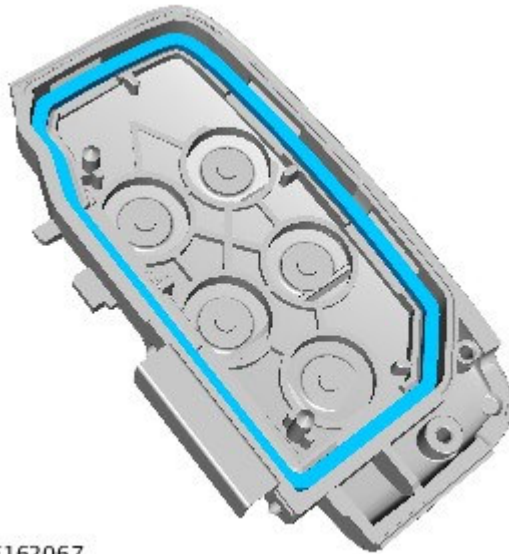
E162067

**9.** Remove the silicone seal from the lower case; place to one side.

- Discard the upper case.
-

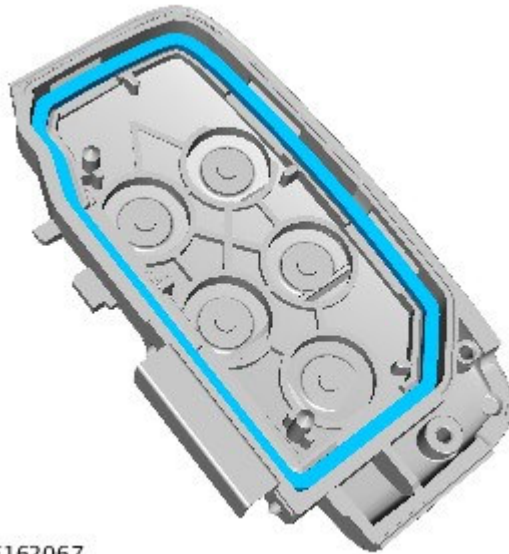
E162067

**11.** Install the silicone seal to the upper case.

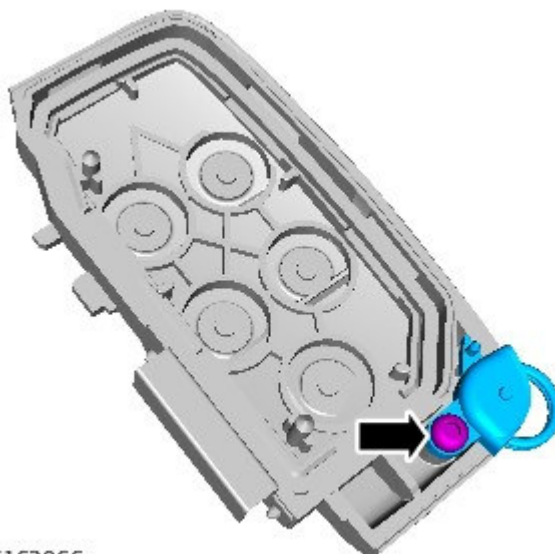
E162066

**12.** Install the key ring retainer to the upper case:

- Tighten to 1Nm.

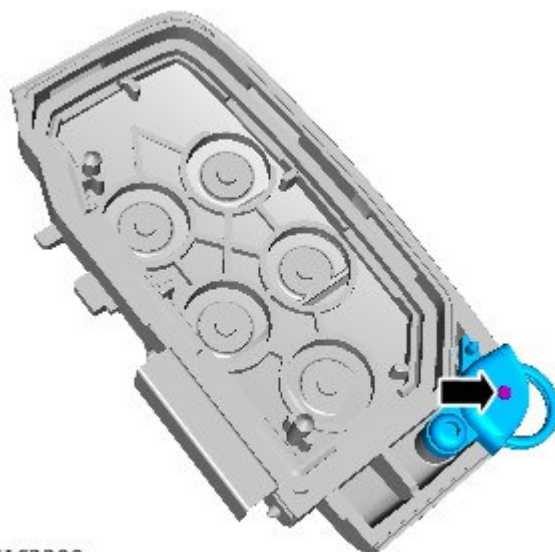
E162299

- 13.** Make sure the key ring retaining pin is present in the upper case.
